INVESTIGATION OF ENVIRONMENTAL IMPACTS ON SANDSTONE BLOCKS AT LUXOR TEMPLE AND CONCEPTS FOR CONSERVATION

Sandstone blocks were used in the construction of Luxor temple. However, they, especially cement materials, were at a great risk because of being affected by various deterioration factors. Groundwater started to rise in and around the temple, causing serious deterioration aspects of the blocks. Therefore, the current study was conducted to focus on the role of pores and cement regarding the deterioration process of sandstone blocks in the temple. In order to conduct systematic investigation, it adopted SEM – EDX, PLM and XRD. Also, physical and mechanical properties were examined to evaluate the components of the sandstone, under the present environmental conditions. It also interpreted the investigations of on-site evaluation tests (non- and less-destructive). It also focused on other methods, e.g. humidity and salt analysis. The study ended develops some recommendations that fit sandstone address in Luxor Temple.

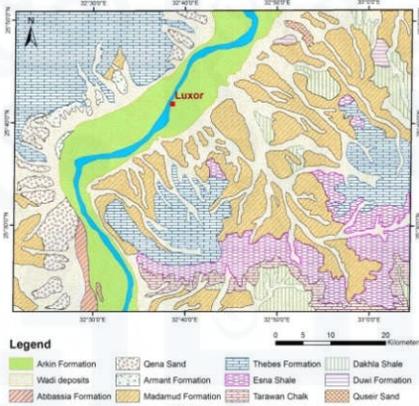
Geologic setting of the study area has been studied by many authors, it is noted that the area's sedimentary composition can be classified (from top to base) into quaternary, tertiary and upper cretaceous rock units (Fig. 4). Quaternary rock units are divided into Holocene deposits (Arken formation; modern River Nile sediment) and Pleistocene deposits (Armant formation, Qena sand, Abassia formation and Wadi deposits). Tertiary rock units include Pliocene rocks (Madmoud formation) and the Lower Eocene -Palaeocene (Thebes's formation, Esna shale and Tarawan Chalk). Upper Cretaceous rocks include the Dakhla shale, Duwi formation and Qusir shale

Fig. (4) Geology of Luxor City [14].

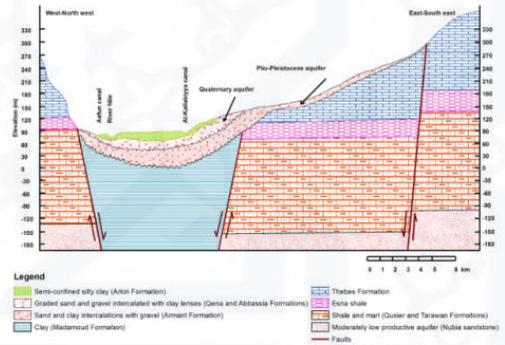
upper Holocene aquitard. It is a good source of water and it is fed by canals [12]. In this aquifer, ground water is pumped through pores, and water is transferred to the Nile [13]. The aquifer of Plio-Pleistocene is the secondary one in Luxor city and is represented by Armant Formation [15] (Fig.5).

Fig. (5) Hydrogeologic cross section [5]

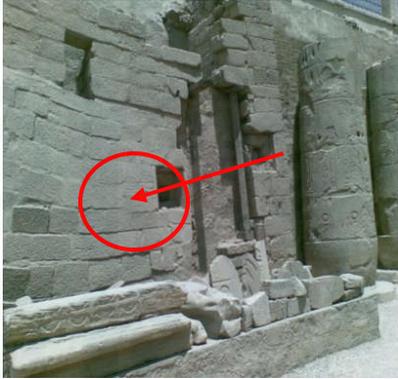
Fig. (6) Differential tendency on the walls of Luxor temple

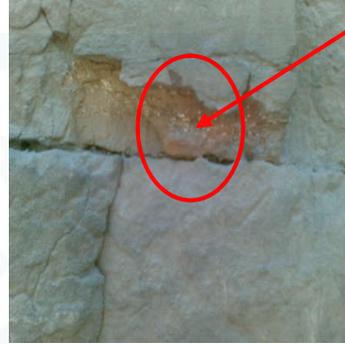
Fig. (7) Stress on the lower parts of Luxor temple's walls

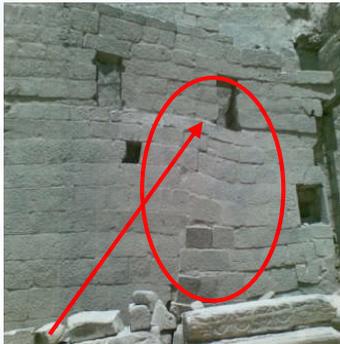
Fig. (8) Differential tendency on the walls of Luxor temple

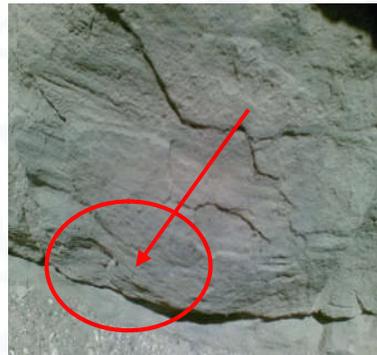
Fig. (9) Soil on the lower parts of Luxor temple's walls

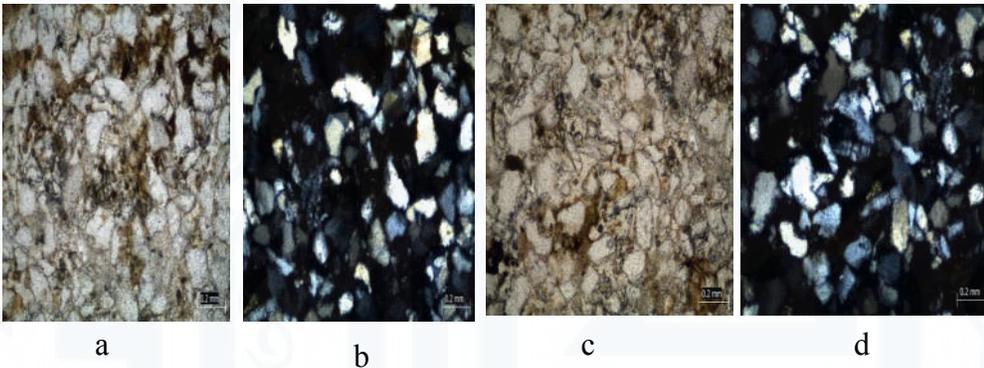
Samples taken from Luxor temple were examined under the polarized microscope and showed that, the percentage of quartz is the highest as it reached 94% and it took different forms. Other components were as follows: feldspar (5%), rock fragments (0.5%), and cement materials (10%). It was also found that the percentage of porosity and permeability was high [38] (Fig.11a, c). Some clay minerals (Fig.11a, c) and iron oxides were also found. Crystals of quartz appeared unequal in their dimension and volumes; they were of great and moderate granulation. Furthermore, it was indicated that angular quartz granules were transformed into semi-angular, showing that they didn't move far during the processes of deposition (Fig.11b, d). In other samples, quartz crystals were rounded and semi-rounded and they moved far during the processes of deposition. There was also an erosion of the edges of some crystals and that extended to the interior part. These results were supported by XRD examination showing that quartz was the main compound with little percent of salts (halite NaCl).

Fig. (11) A sample of sandstone from Luxor Temple X25

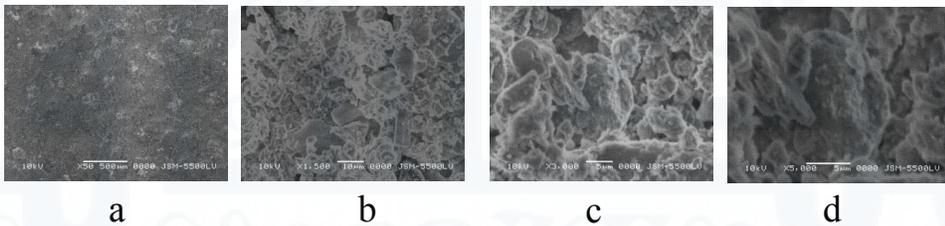
The samples studying by SEM were identified as quartz (SiO_2) (Fig.12a.b.c.d) and other salts were submitted by XRD and EDX and XRF such as halite (NaCl) and gypsum ($\text{CaSO}_4 \cdot 2\text{H}_2\text{O}$) and notice decayed of grains of quartz (Fig.13 a.b.c.d). Samples show a damage of cement materials and a breaking in the granules of sandstone (Fig.12a, b). Other samples show a differential of quartz grains, and a collapse of the stone's internal structure (Fig.13c,d).

Fig. (12) A sample of sandstone examined under SEM, showing the

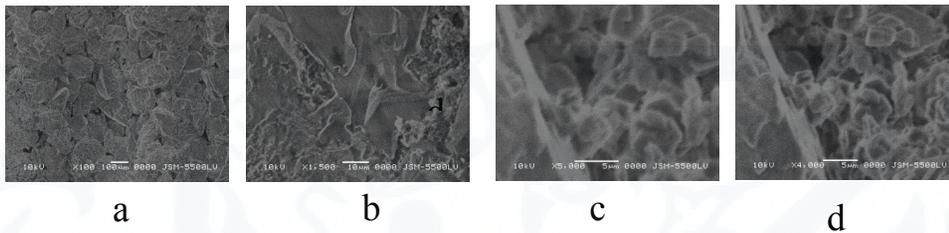
Fig. (13) A sample of sandstone under SEM, illustrating the damage of cement materials and the differential of quartz grains form

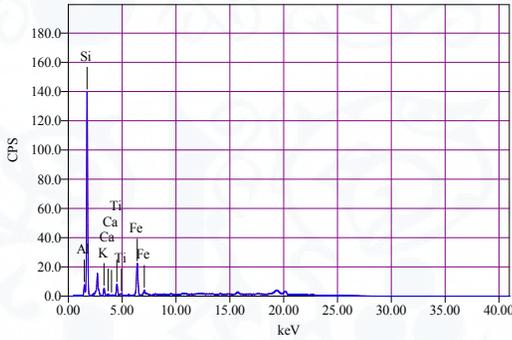
EDX micro analytical methods were conducted to identify the samples and evaluate their components which indicates that the elemental arrangement of the samples collected from different places could be put in a decreasing order according to their concentration as follow: Si(78.92-85.89%), Al (6.09-7.15%), Fe (5.81-2.56%), K (4.65-1.95%), Ti (3.77-2.06%) and Ca (0.76-0.39%)(Fig.14) (Tab.1)This helped in understanding the weathering mechanisms affecting the temple, in second sample Si(77.12-84.32%), Al (6.94-8.09%), Fe (6.44-2.88%), K (4.32-1.84%), Ti (3.93-2.28%) and Ca (2.24-0.59%) (Fig.15) (Tab.2). The first and second samples contained Si (as the main component). However, the absence of chlorine (Cl) and sodium (Na) indicated the non-crystallization of halite on the wall reliefs. The analysis also indicated a low concentration of calcium (Ca) that indicated the existence of gypsum and anhydrite salts on the sandstone. In addition, the moderate amount of Aluminum (Al) and potassium (K) could be attributed to feldspars and phyllosilicates. On the contrary, the presence of relatively high amounts of iron and small amounts of titanium was attributed to the origin of these samples, atmospheric pollution and presence of accessory minerals such as Fe – Ti bearing phases; they played a significant role in deterioration.

Fig. (14): EDX spectrum of the sandstones (under study)

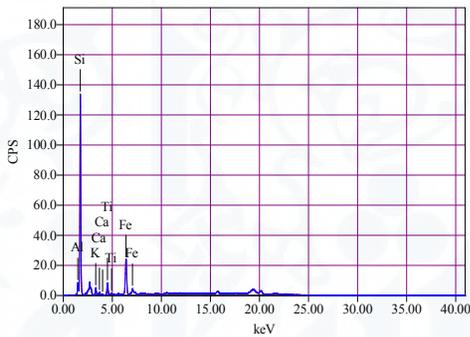
Fig. (15): EDX spectrum of the sandstones (under study)
