The present clinical study aims at comparing the clinical performance of two high viscous glass ionomer based restorative materials in treatment of occluso-proximal carious lesions using Atraumatic Restorative Treatment (ART).

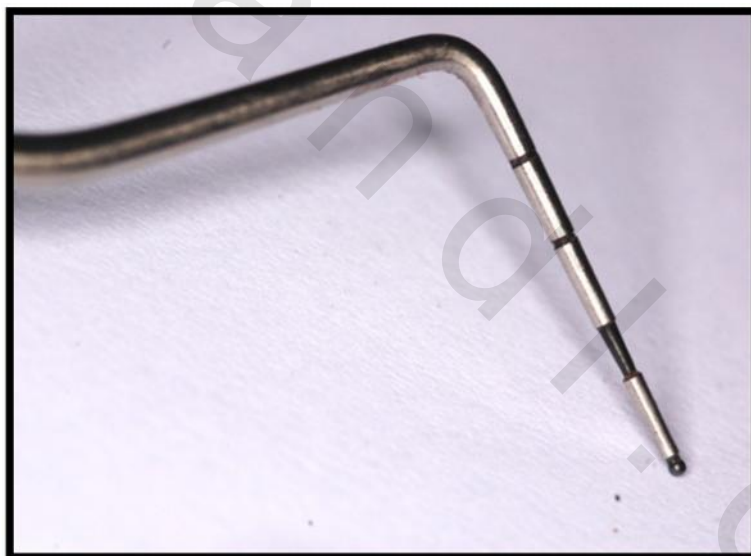
**Figure 22: Community periodontal index (CPI) probe**

Two calibrated independent examiners, who were blind to the type of the GIRMs, carried out the direct clinical evaluation. The evaluation was done using a mirror and 0.5 mm ball-end of a metal CPI probe under a good illumination using ART criteria (Figure 22).

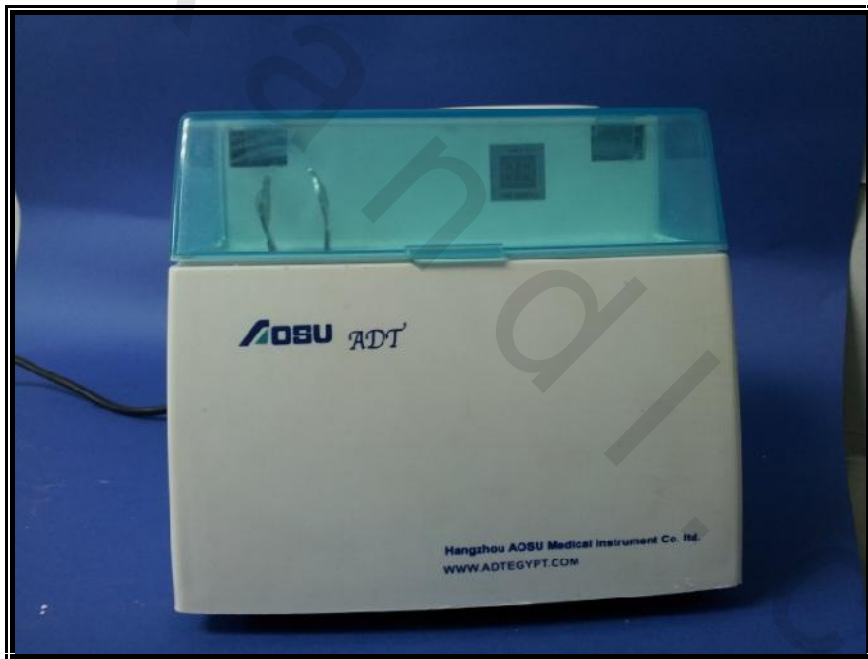
**Figure 24: Amalgamator**

Afterwards, the glass ionomer capsules were mixed according to manufacturer's instructions using an amalgamator (Figure 24). Fuji IX capsules were mixed for 10 seconds while ChemFil Rock capsules were mixed for 15 seconds. The capsules were evacuated into the cavity and the glass ionomer was pressed in its place using the press-finger technique, where a slight pressure was applied on the entire occlusal surface until the initial setting **Scholtanus and Huysmans (2007)**. After the initial setting of the material, the matrix holder, band and the wooden wedge were removed. Carving was done to the proximal part of the restoration using ART carver to give the tooth its normal contour and anatomy. The occlusion was checked using an articulating paper (Figure 20). The excess was removed using ART carver (Figure 19), and the surface of the restoration was coated with a layer of Vaseline. The post operative instructions were given to the patient not to eat or brush on the restored side for at least two hours after the tooth was restored. Meanwhile, each patient was instructed to do the regular oral hygiene measures confirming the use of tooth brush twice daily. Finally, restorations were inspected at every recall appointment and the

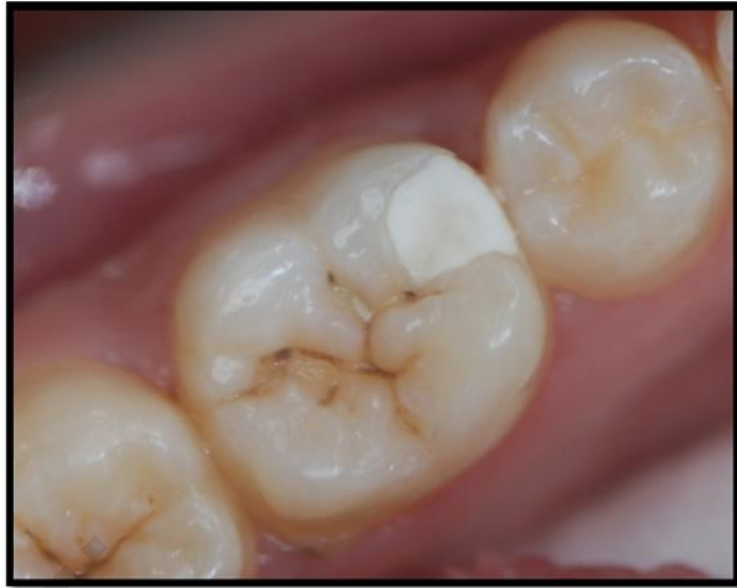
**Figure 31: A representative photograph of a cavity restored with ChemFil Rock HVGIRM at baseline evaluation**

At baseline evaluation, Figures (31, 36 and 44) show representative photographs and positive replicas for the ChemFil Rock HVGI restorations of both genders. While those for Fuji IX HVGI restorations were presented in Figures (41 and 47).

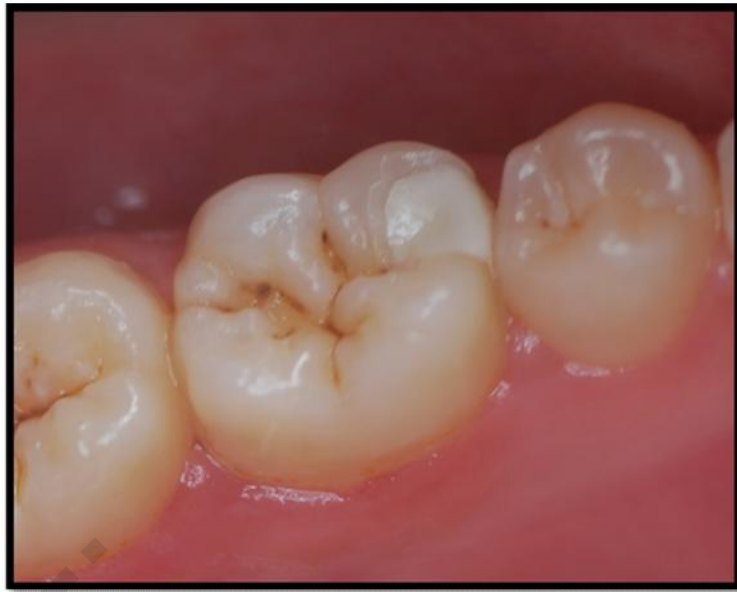
**Figure 33: A representative photograph of a cavity restored with ChemFil Rock HVGIRM at six months evaluation**

At six months evaluation, Figures (33, 38 and 46) show representative photographs and positive replicas for the ChemFil Rock HVGI restorations of both genders with code 0. The only ChemFil Rock HVGI restorations that recorded code 2 was presented in Figure 50. While representative photographs and positive replicas of both genders for Fuji IX HVGI restorations were presented in Figures (43 and 49).

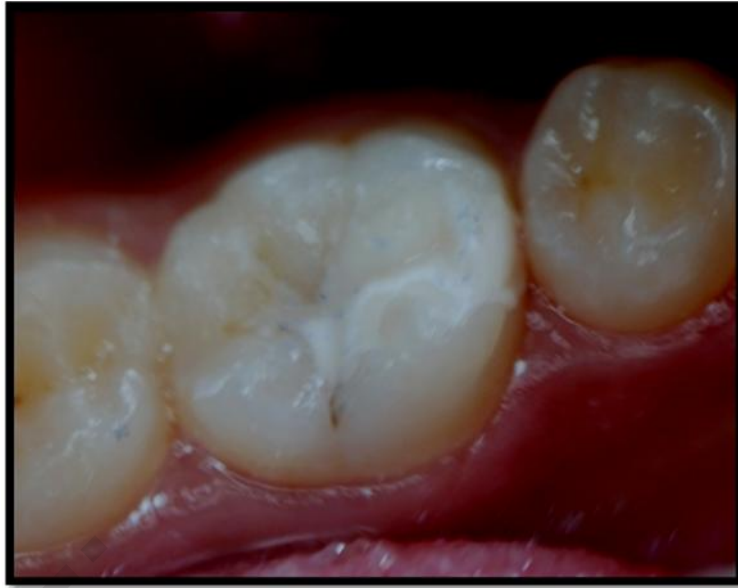
**Figure 41: A representative photograph of a cavity restored with Fuji IX HVGIRM at baseline evaluation**

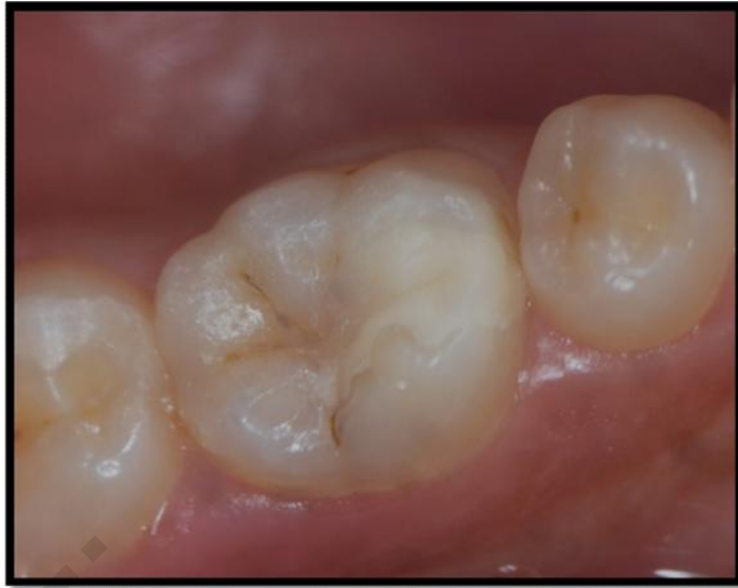
**Figure 43: A representative photograph of a cavity restored with Fuji IX HVGIRM at six months evaluation**

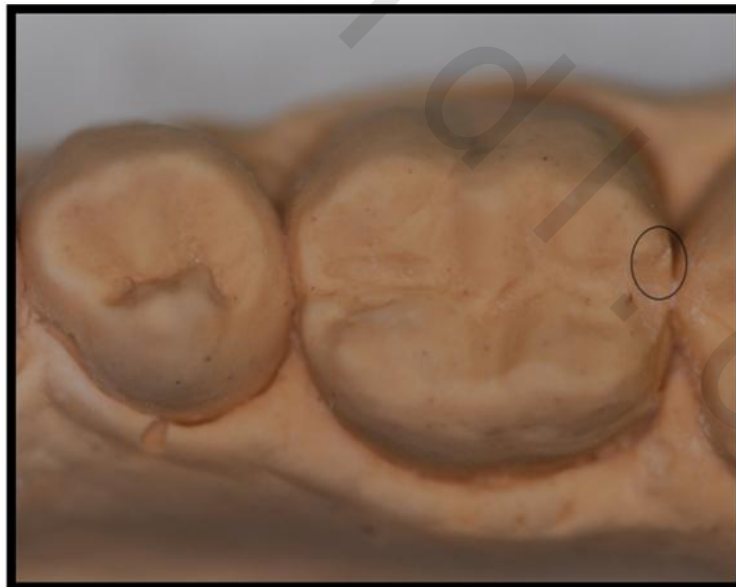
**Figure 50: A representative positive replica of a failed ChemFil Rock HVGI restoration at six months evaluation**

Descriptive statistics for ART evaluation codes of the two tested HVGIRMs for both genders at the six months evaluation period were represented in Table 8, 9 and Figure 29. For female patients, both Fuji IX and ChemFil Rock restorations recorded Code 0. While considering male patients, a single dropout case was recorded for Fuji IX restoration. Besides, twelve Fuji IX restorations and twelve ChemFil Rock restorations showed Code 0. Whereas, only one ChemFil Rock restoration scored slight deficiency at cavity margin that assigned to Code 2.
