CHAPTER 4: TEST RESULTS AND DISCUSSION

4.2 Group 1: Effect of Lap Splice Length

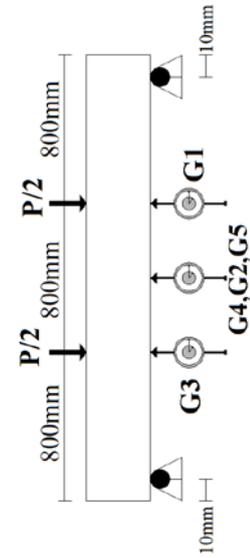
Dial gauges and transducers position.

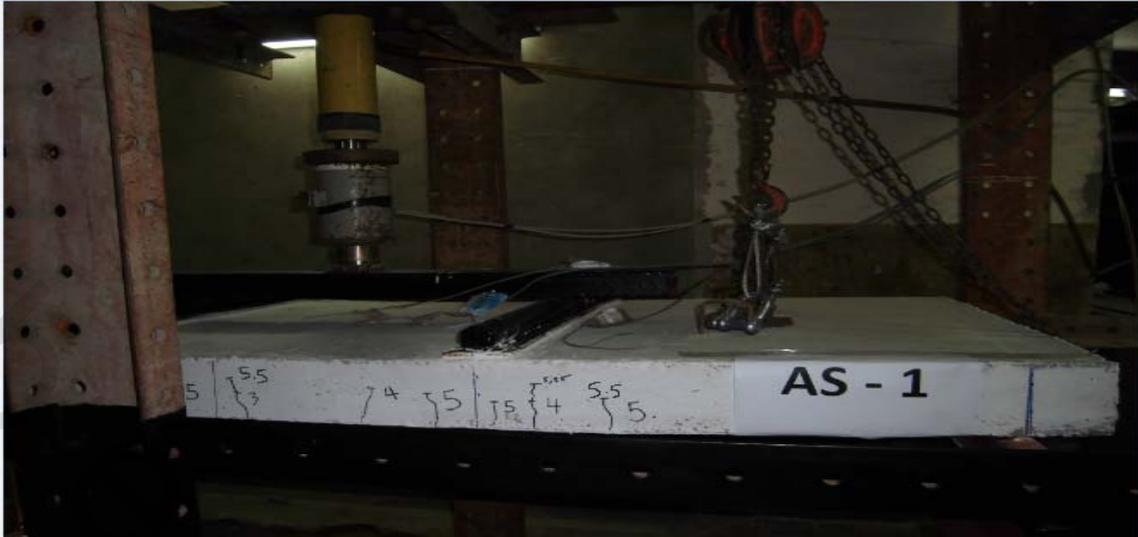
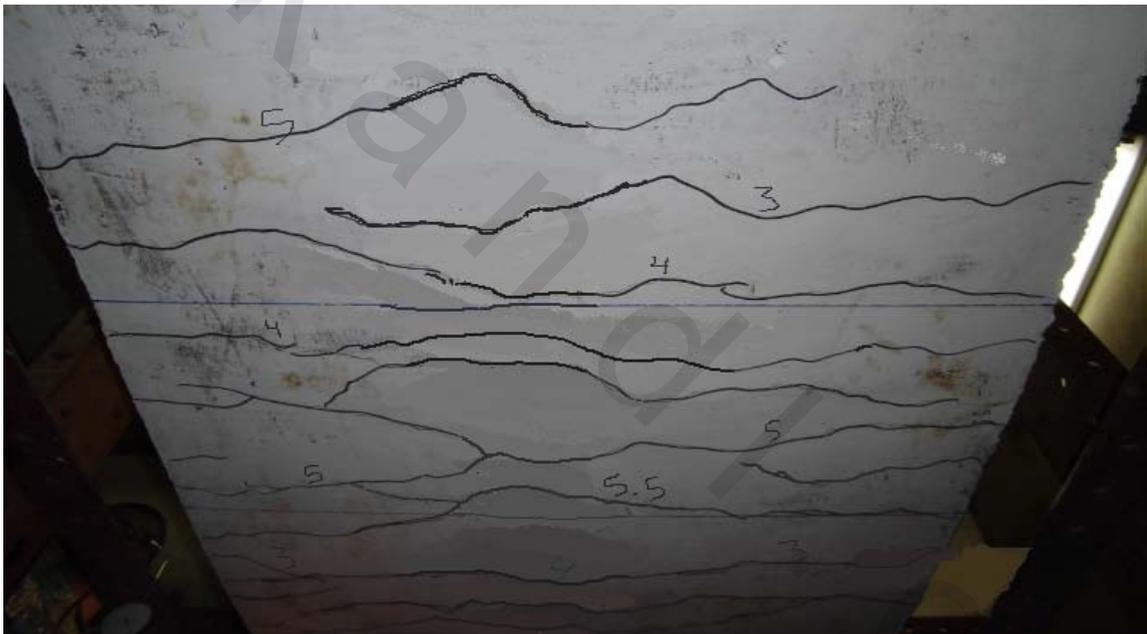
Figure (4-1): Crack patterns of **AS-1**(Reference specimen).

(a): Cracks on the side face at failure.

(b): Cracks on the bottom surface of slab at failure.

For the reference slab **AS-1**, with no splice, flexural cracks appeared at the constant moment zone at a load of 30 kN (about 55% of the ultimate load; P_u). As the load was increased, flexural cracks propagated upward towards the compression zone. Yield of bottom longitudinal steel occurred at a load of 50 kN (about 91% of the ultimate load; P_u), with load increase, cracks became wider and extended upward to about 95% of the slab height and increased along the span to cover the constant moment zone. Failure of the slab occurred by crushing of compression zone at a load of 55 kN, as shown in **Figure (4-1)**.

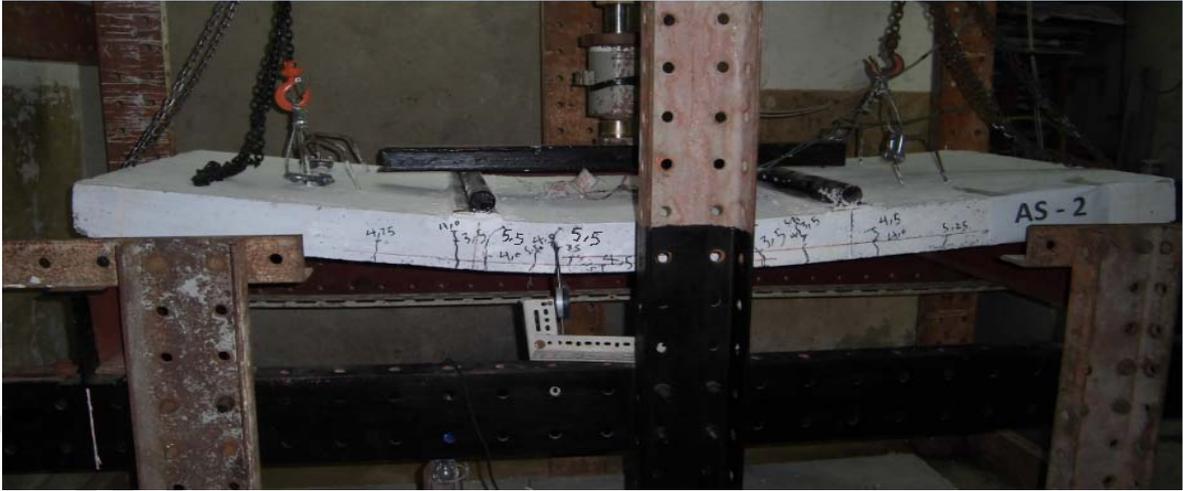
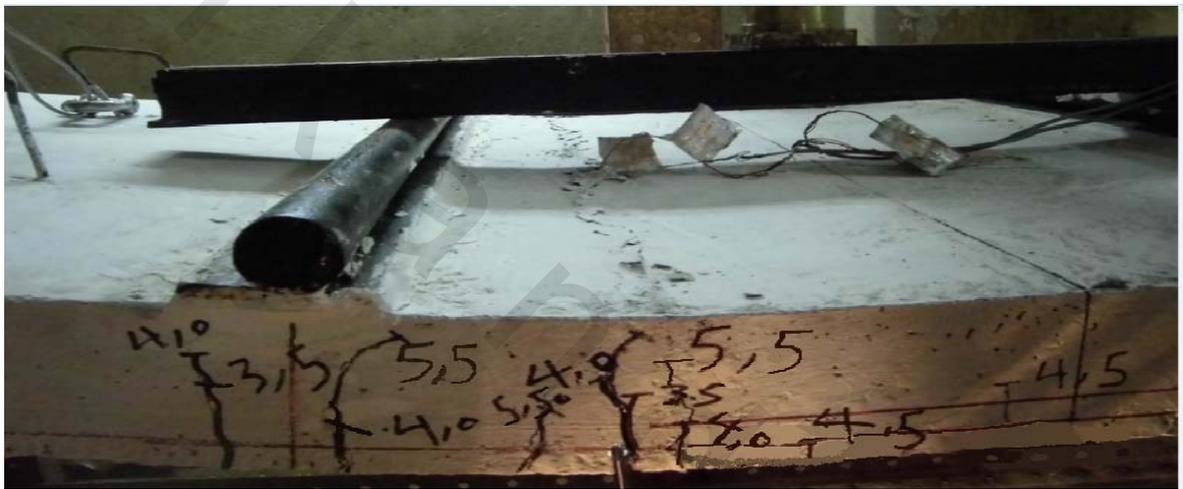
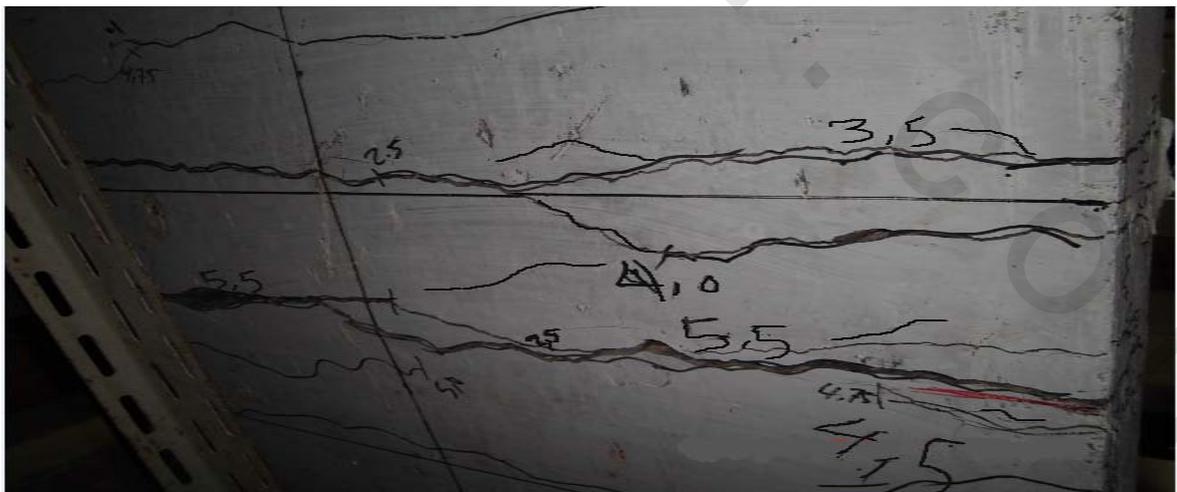
Figure (4-2): Crack patterns **AS-2**.

(a): Cracks on the side face at failure.

(b): Cracks close to the end of the lap zone.

(c): Cracks on the bottom surface of slab inside and outside the lap zone at failure.

For slab **AS-2**, with $45 d_b$ lap splice length (450 mm) and without any special reinforcement at lap splice zone, the spliced bars were without head, flexural cracks initiated at the constant moment zone at a load of 25 kN (about 46% of the ultimate load; P_u). As the load was increased, flexural cracks appeared at the lap-splice zone at a load of 35 kN (about 64% of the ultimate load; P_u). As the load was increased, flexural cracks propagated upward towards the compression zone. With the load increase, cracks became wider and extended upward to about 97% of the slab height and extended along the span to cover all the constant moment zone. Yielding of bottom longitudinal tension steel occurred at a load of 52.5 kN (about 96%

of the ultimate load; P_u). Failure of the slab occurred by crushing of concrete in compression at a load of 55 kN, as shown in **Figure (4-2)**.

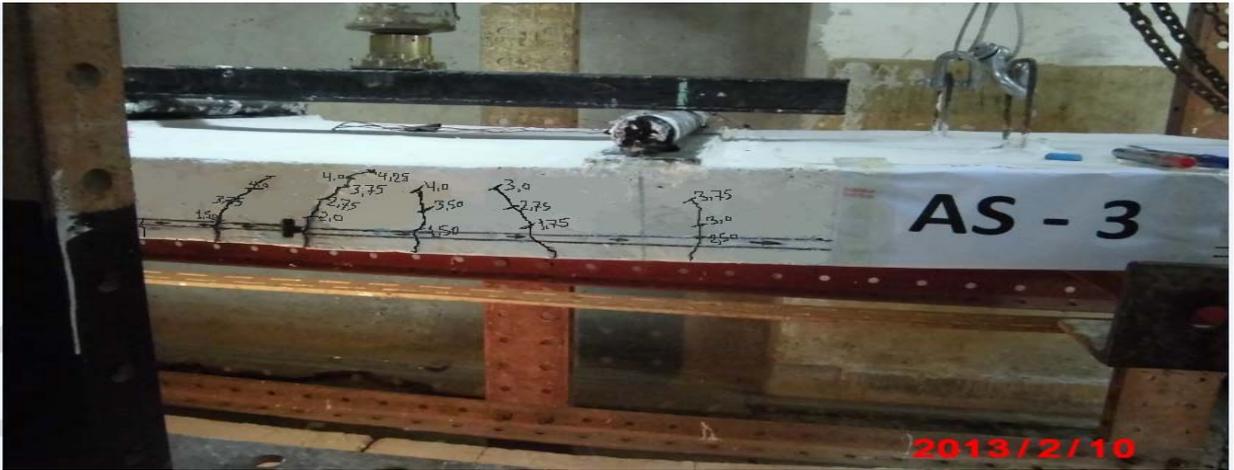
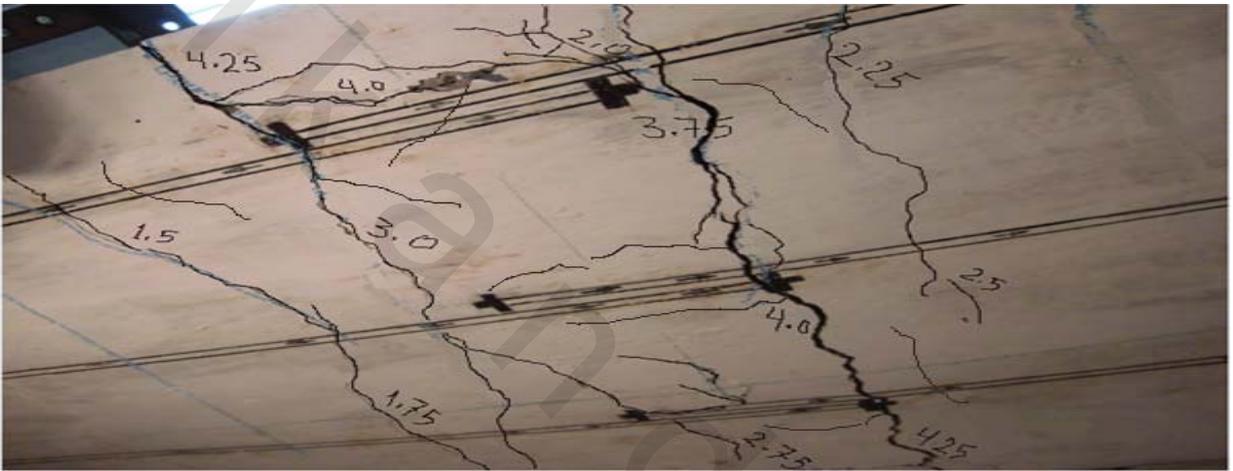
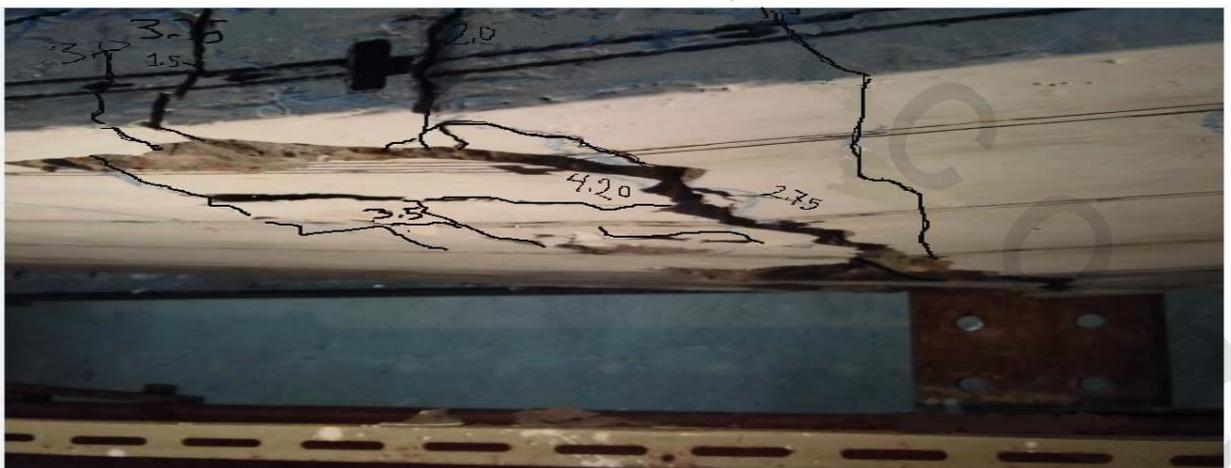
Figure (4-3): The crack pattern of AS-3.

(a): Cracks on the side face.

(b): Extensive cracks on the bottom surface of slab inside and outside the lap zone at failure.

(c): Wide cracks at failure of the slab AS-3.

Slab **AS-3**, with $15 d_b$ lap splice joint provided with headed bars (150 mm) and without any special reinforcement at the splice area, flexural cracks initiated at the constant moment zone at a load of 15 kN (about 35% of the ultimate load; P_u). As the load was increased, flexural cracks formed and appeared along the position of the heads at each end of the lap-spliced bar at a load of 20 kN (about 47% of the ultimate load; P_u). As the load was increased, cracks propagate further across the length of the lap zone and flexural cracks propagated upward towards the compression zone. With load increase, cracks became wider and extended upward to about 97% of the slab thickness and spread along the span to cover the constant moment zone. No yield of steel reinforcement was recorded at the bottom longitudinal steel bars up to failure. Failure of the slab was a brittle one with failure of bond between concrete and the bars with pushing down the bottom cover causing the brittle failure at a load of 42.5 kN. According to ACI 318-14, the calculated development length for spliced bars with head is $15 d_b$ as the length used in slab **AS-3**. The results indicate that this splice length is not sufficient for developing the forces in the bars. **Figures (4-3) and (4-4)** show the crack pattern and failure at the lap splice joint in slab **AS-3**, respectively.

Cracks of slabs were marked at each load increment up to failure. **Figures (4-3) and (4-43)** show the crack patterns of slabs **AS-3** and **AS-4** respectively. Crack patterns for slab **AS-3** was previously discussed in section 4.2.1.

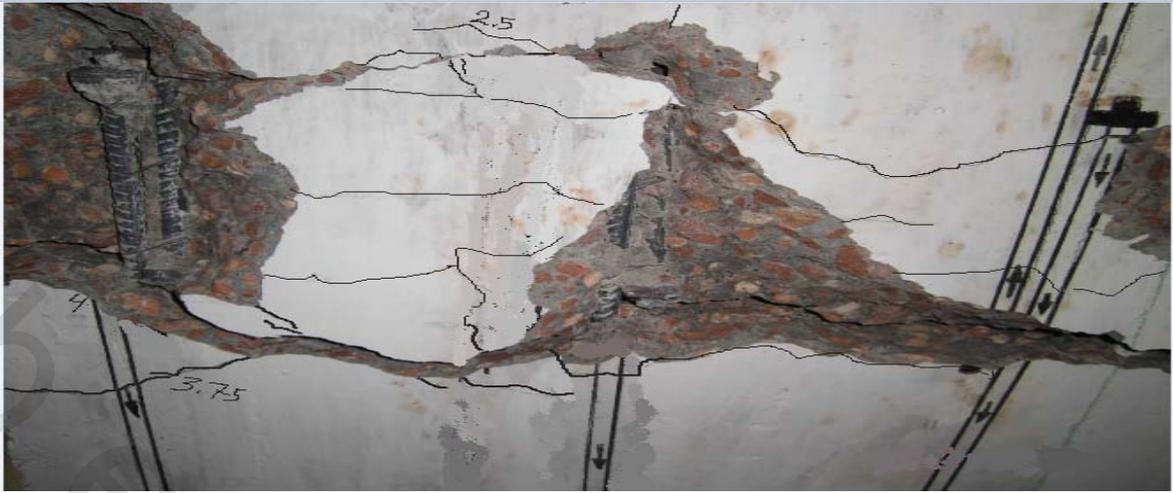
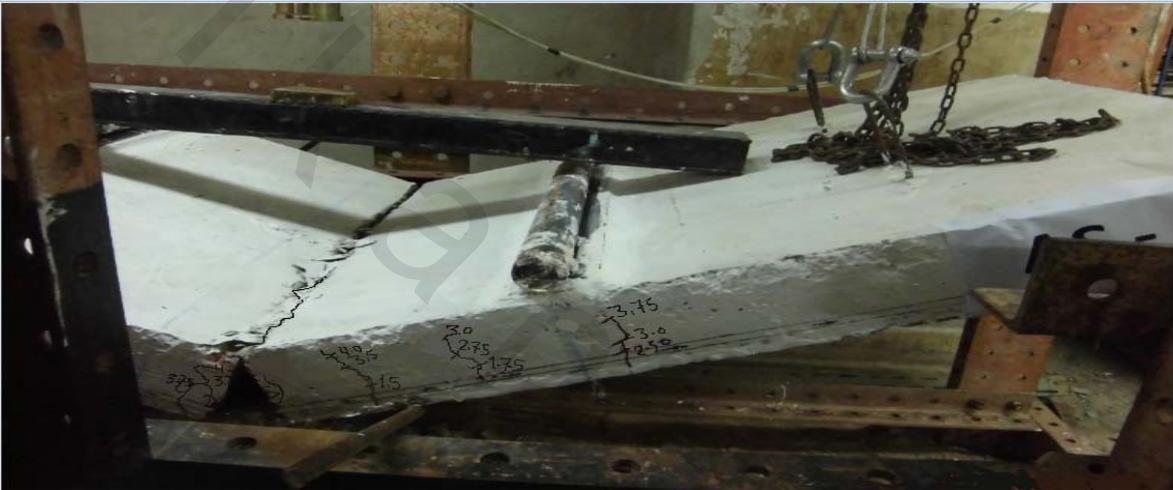
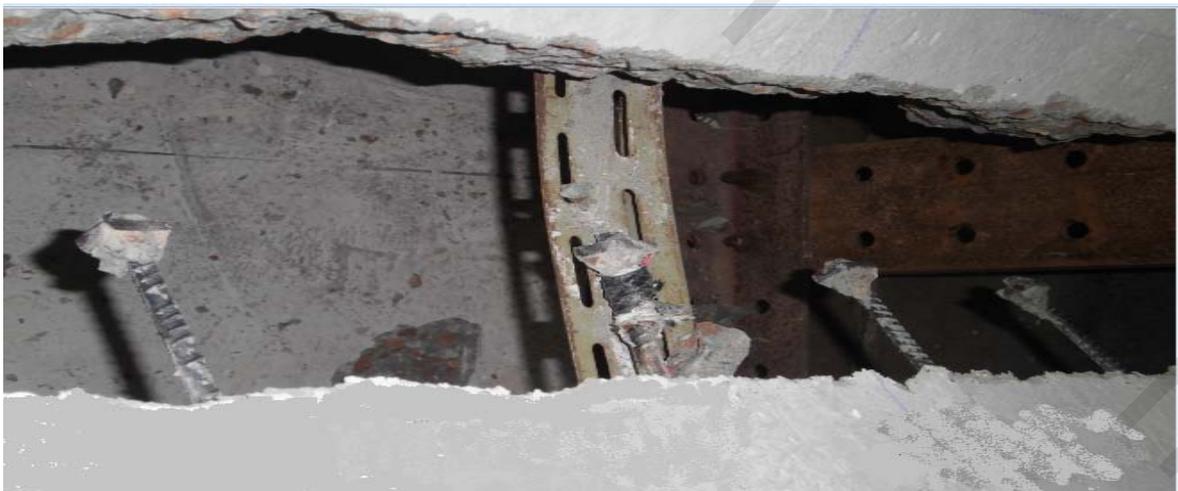
Figure (4-4): Failure of the lap splice in slab **AS-3**.

(a): Bottom cover spalling in lap zone just before failure.

(b): Specimen just after the failure.

(c): The specimen after failure.

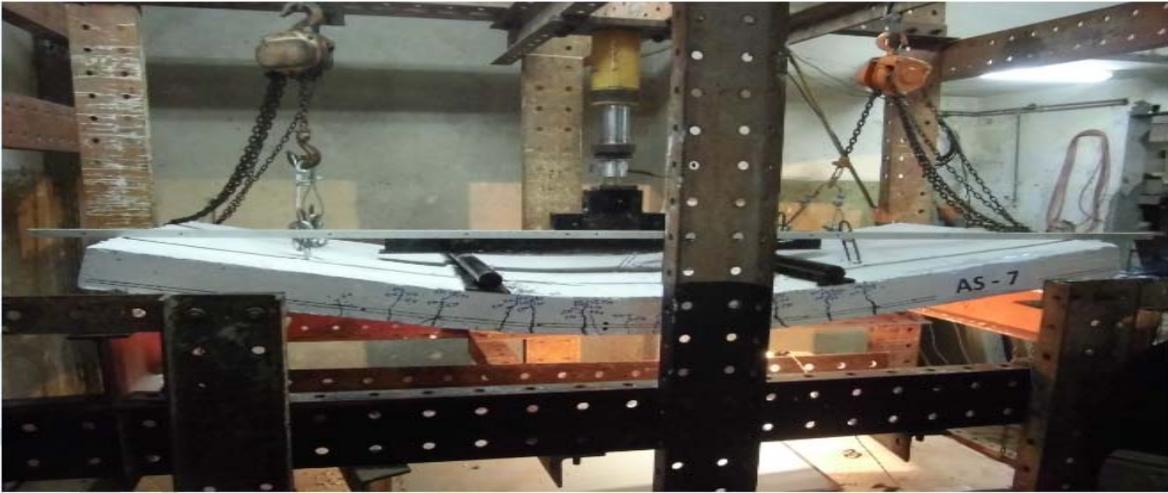
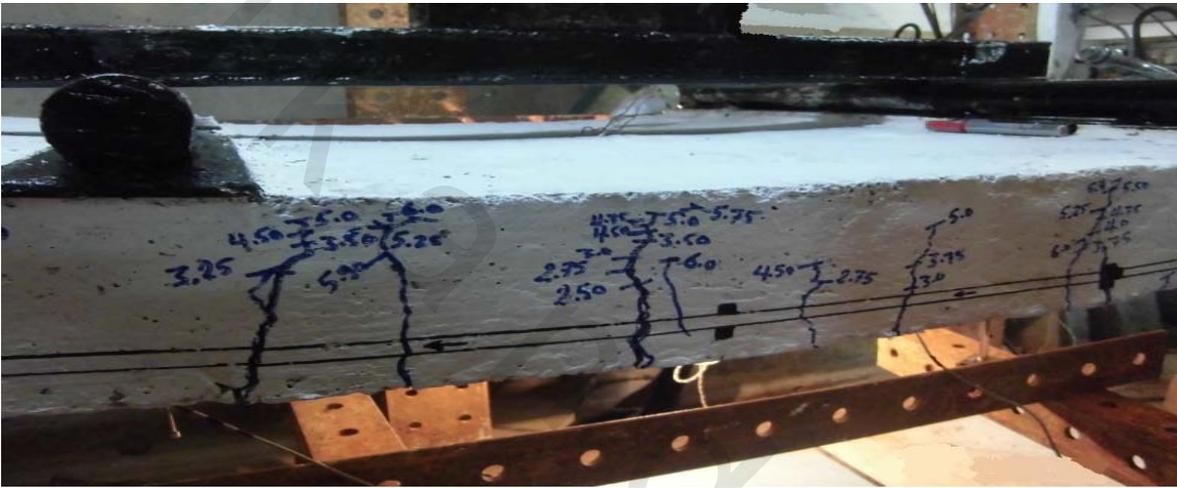
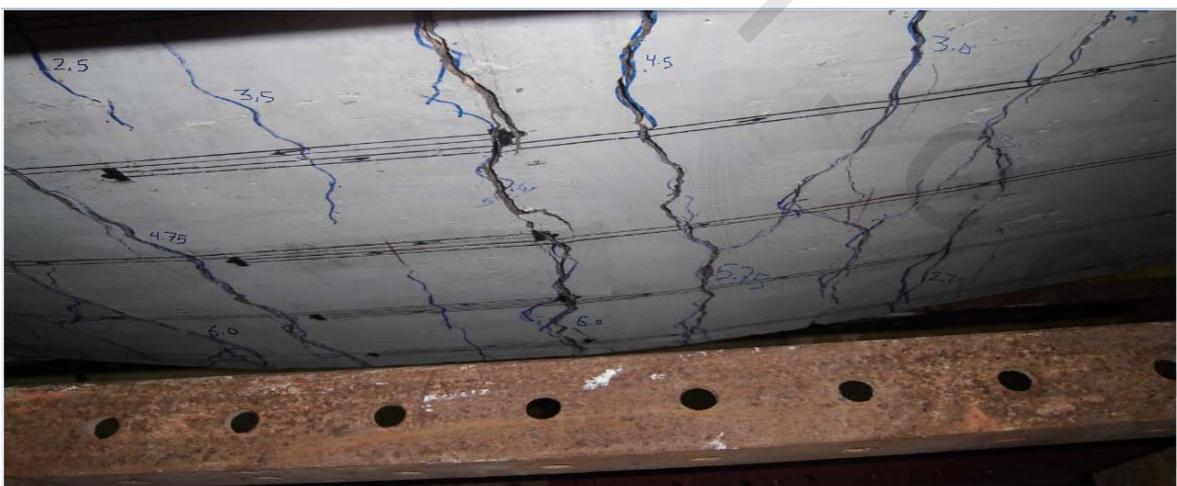
Figure (4-5): The crack pattern of AS-7.

(a): Cracks on the side face at failure.

(b): Cracks close to the end of the lap zone.

(c): Wide cracks on the bottom surface of slab inside and outside the lap zone at failure.

For slab **AS-7**, with $27 d_b$ lap splice length (270 mm) as recommended by Yassin^[28] for headed deformed bar in wide beams. No confinement at lap splice connection zone was introduced. Flexural cracks initiated at the constant moment zone at a load of 25 kN (about 42% of the ultimate load; P_u). As the load was increased, flexural cracks appeared at the lap-splice zone at a load of 27.5 kN (about 46% of the ultimate load; P_u) and appeared close to position of the head of the spliced bar at a load of 37.5 kN (about 63% of the ultimate load; P_u). As the load was increased, flexural cracks propagated upward to the compression zone and cracks became wider extending upward to about 97% of the slab thickness in the constant moment zone. Yielding of bottom longitudinal tension steel occurred at a load of 48 kN (about 80% of the ultimate load; P_u). Failure of the slab occurred by flexure at a load of 60 kN.

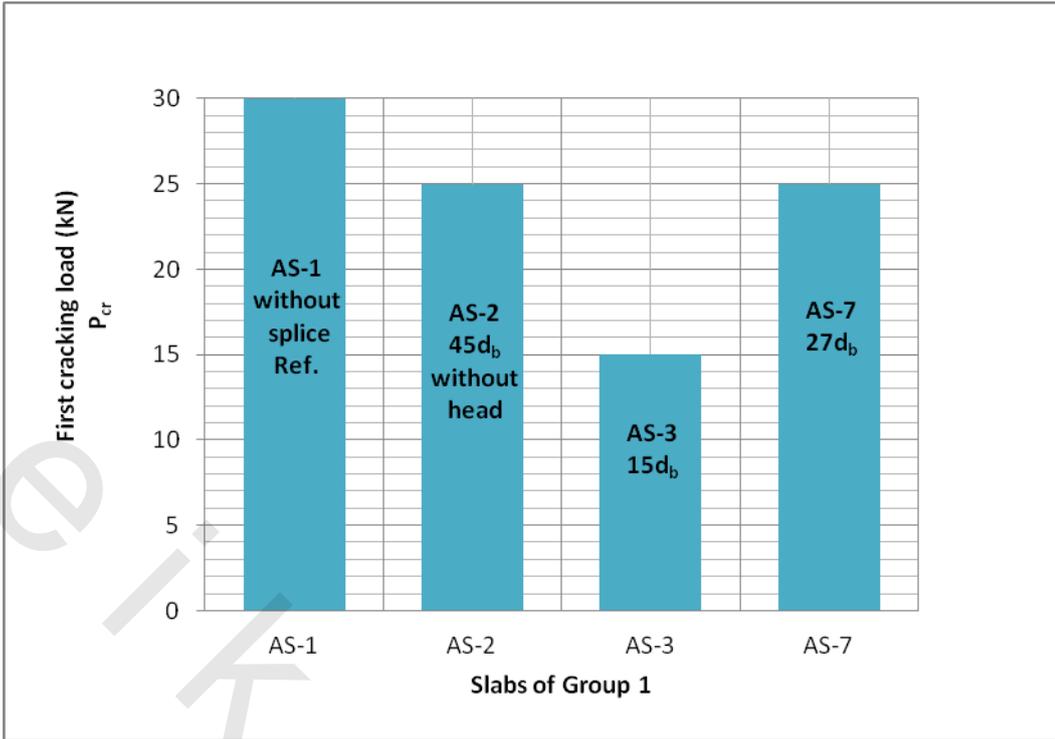
Figure (4-6): First cracking loads for slabs of Group (1).

Figure (4-6) shows the first cracking load and lap splice length for the slabs in Group (1). In slabs, **AS-2** and **AS-7** the first crack appeared at a load 17% less than that of the reference slab without splice. While slab **AS-3**, the first crack appeared at a load 50% of reference slab **AS-1** due to small length of the splice.

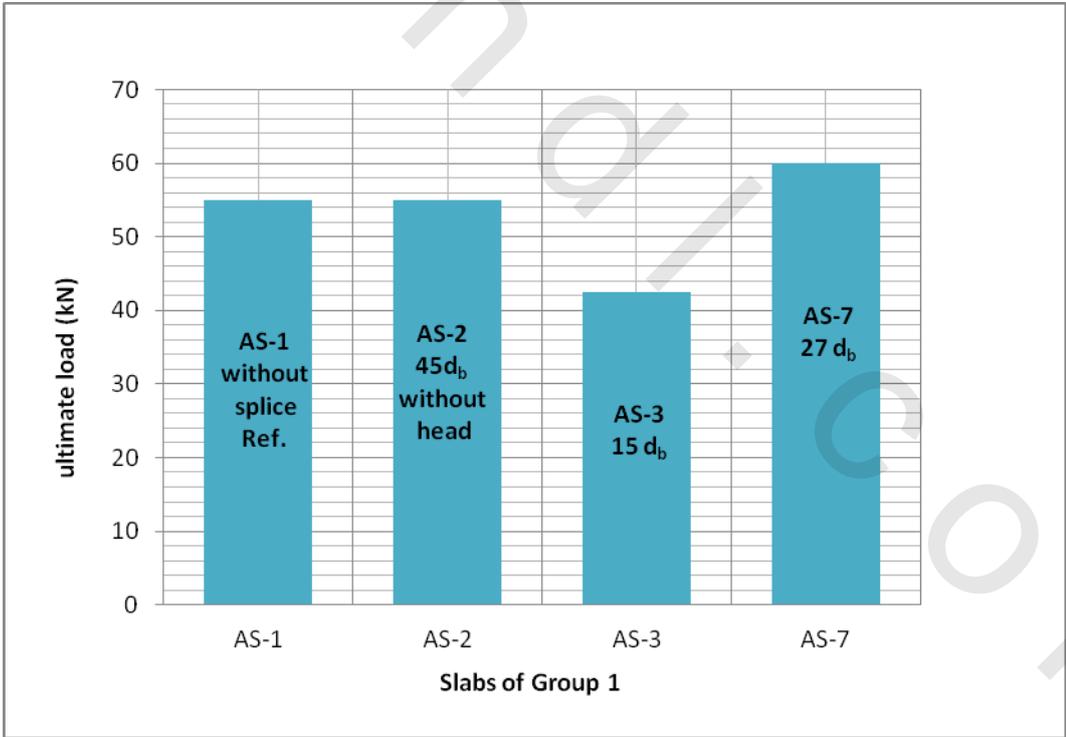
Figure (4-7): Failure loads for slabs of Group (1).

Figure (4-7) shows the failure load and lap splice length of the tested slabs **AS-1**, **AS-2**, **AS-3**, and **AS-7**. The failure loads were 55, 55, 42.5, and 60 kN respectively. Slabs **AS-2**, **AS-3**, and **AS-7** achieved ultimate load of 100%, 77%, and 109%, of that of slab **AS-1** respectively. The results indicate that the failure load of slab **AS-7** (with headed bar and lap splice length = $27 d_b$) increased by 9% of that of the reference specimen **AS-1** (without splice). Using lap length of $45 d_b$ in slab **AS-2** (without headed bars) did not cause a reduction in the failure load comparing with the reference specimen **AS-1**. With a further reduction in lap splice length to $15 d_b$ (slab **AS-3**) the failure load reduced to 23% the failure load of the reference specimen **AS-1**. The theoretical ultimate load was calculated according to the Egyptian code ECP (203-2007), considering the actual material properties; f_y , f_{cu} and taking the reduction factors as unity, and it is equal to 41.5 kN. **Figure (4-8)** shows the relation between the ratio of experimental ultimate (failure) load to the calculated ultimate load and lap splice length.

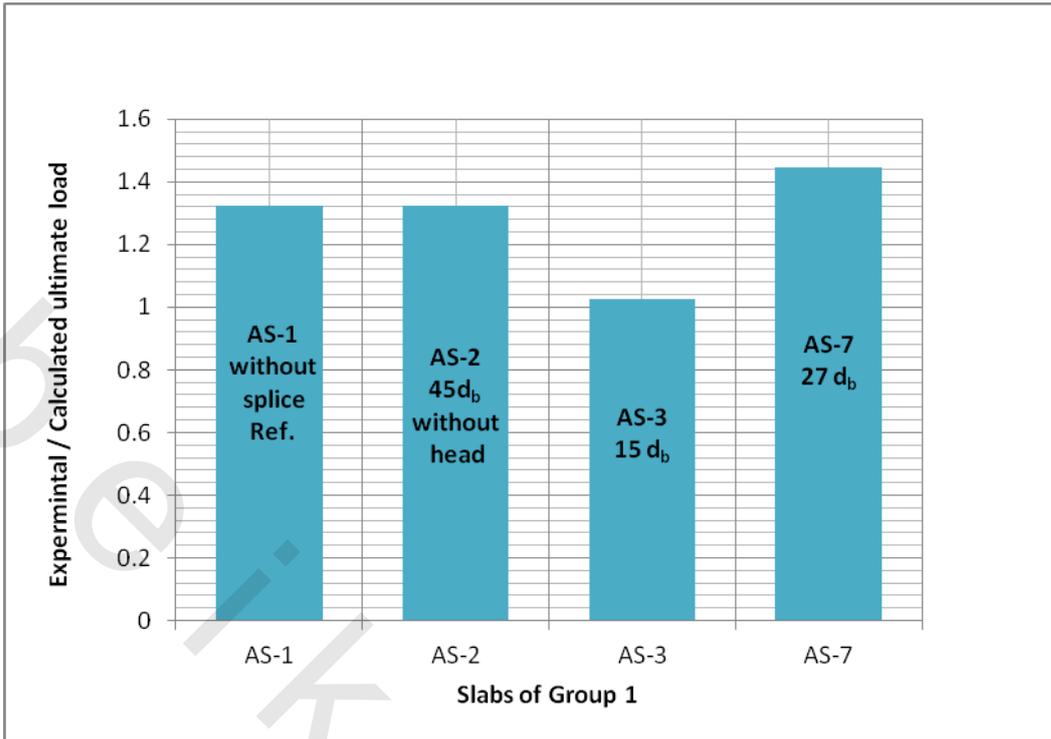
Figure (4-8): (Experimental / Calculated) ultimate loads for slabs of Group (1).

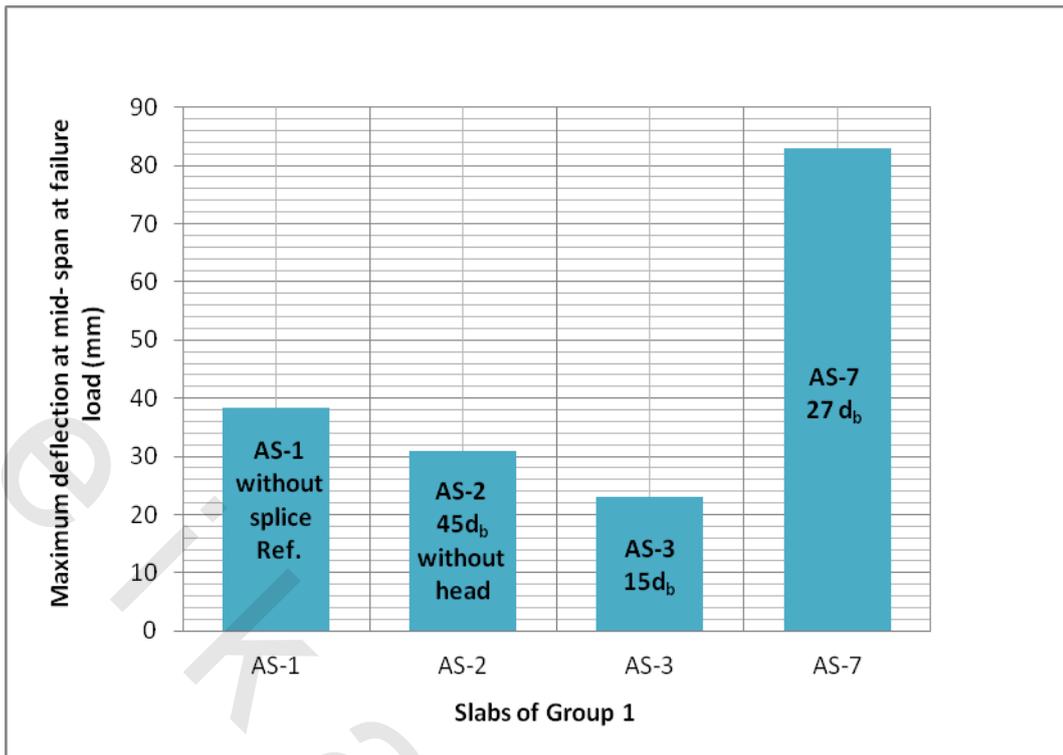
Figure (4-12): Maximum deflection at mid-span at failure load for slabs of Group (1).

Most researches used maximum deflection at mid- span as a measure for ductility. **Figure (4-12)** shows the maximum deflection at failure load and lap splice length for the slabs in this group. Slabs **AS-2**, **AS-3**, and **AS-7** achieved maximum deflection at failure load of 81%, 60%, and 217% of that of the reference slab **AS-1** respectively. The area under the load-deflection curve is termed strain energy or toughness. It was calculated and plotted to measure the maximum energy absorbed by the tested slabs. **Figure (4-13)** shows the relation between strain energy and lap splice length. The strain energy achieved by the tested slabs was 1.748, 1.423, 0.696, and 4.255 kN.m for slabs **AS-1**, **AS-2**, **AS-3**, and **AS-7** respectively. One can conclude that the use of lap splices without headed bars and with length of $45 d_b$ (slab **AS-2**) gave close results to those of the reference slab **AS-1**, but slab **AS-3** (with $15 d_b$ lap splice) showed reduction in strain energy while slab **AS-7** (with $27 d_b$ lap splice) showed higher strain energy than the reference slab **AS-1**.

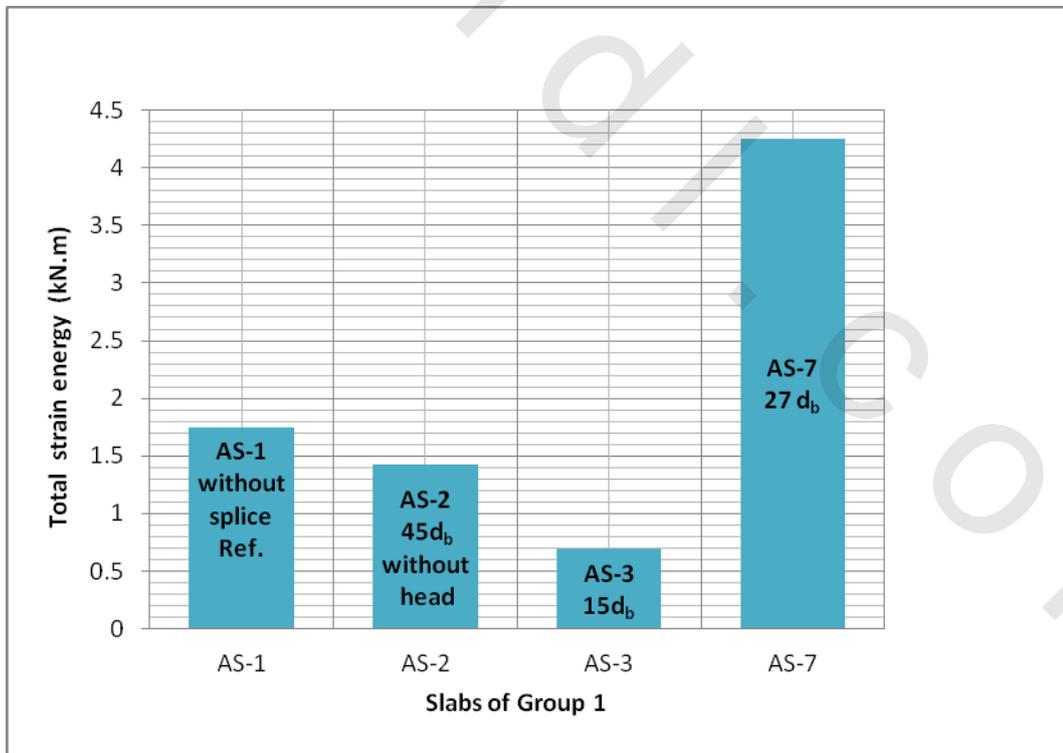
Figure (4-13): Total strain energy for slabs of Group (1).

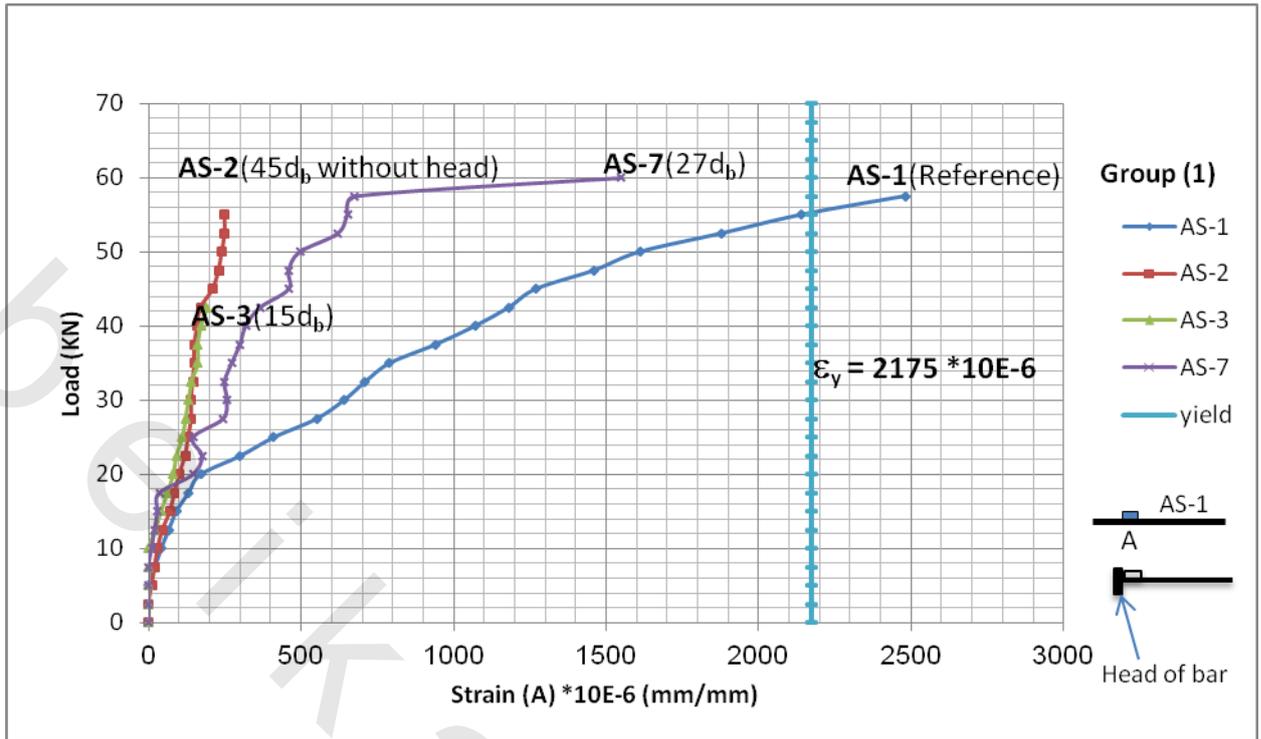
Figure (4-18): Relation between Strain (A) and load for slabs of Group (1).

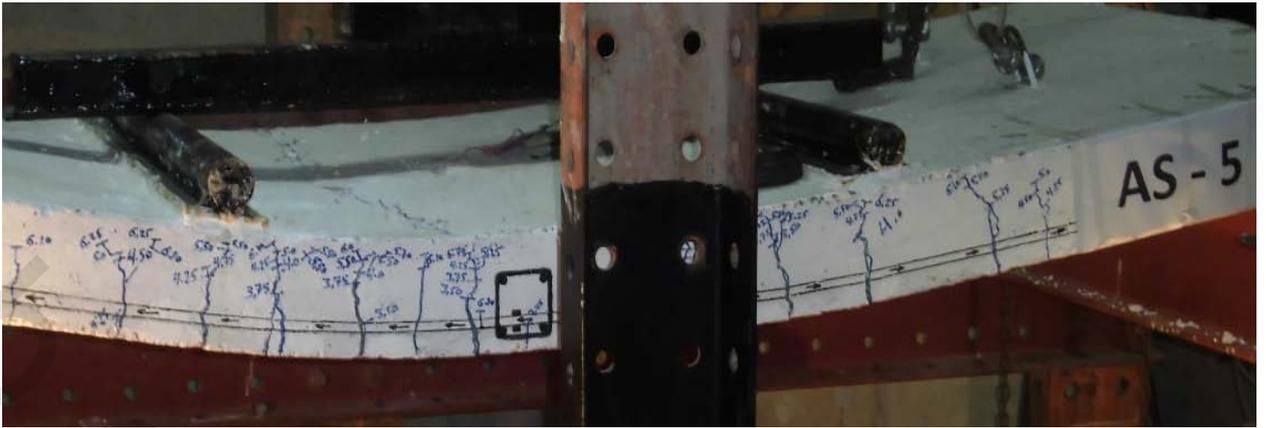
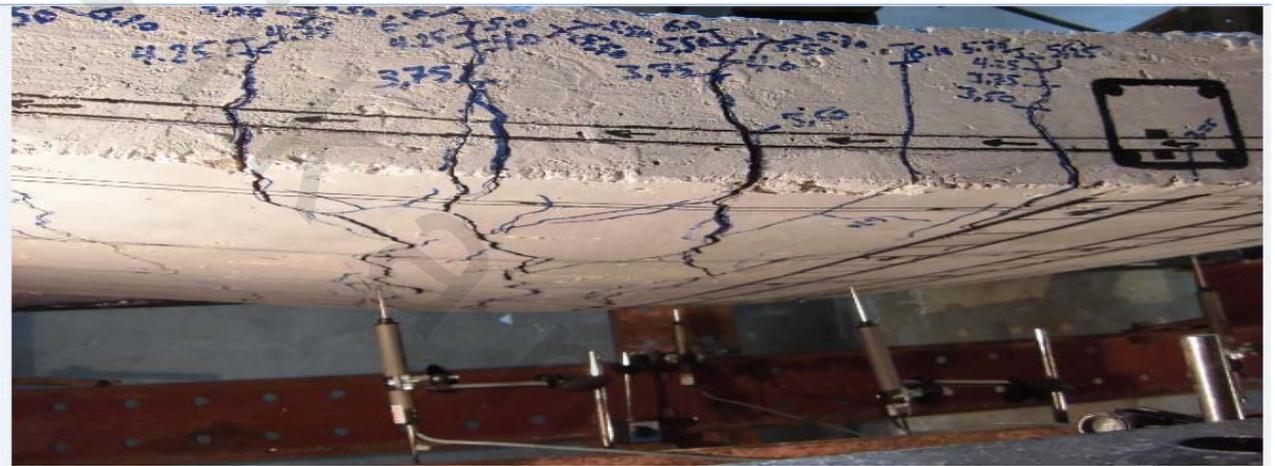
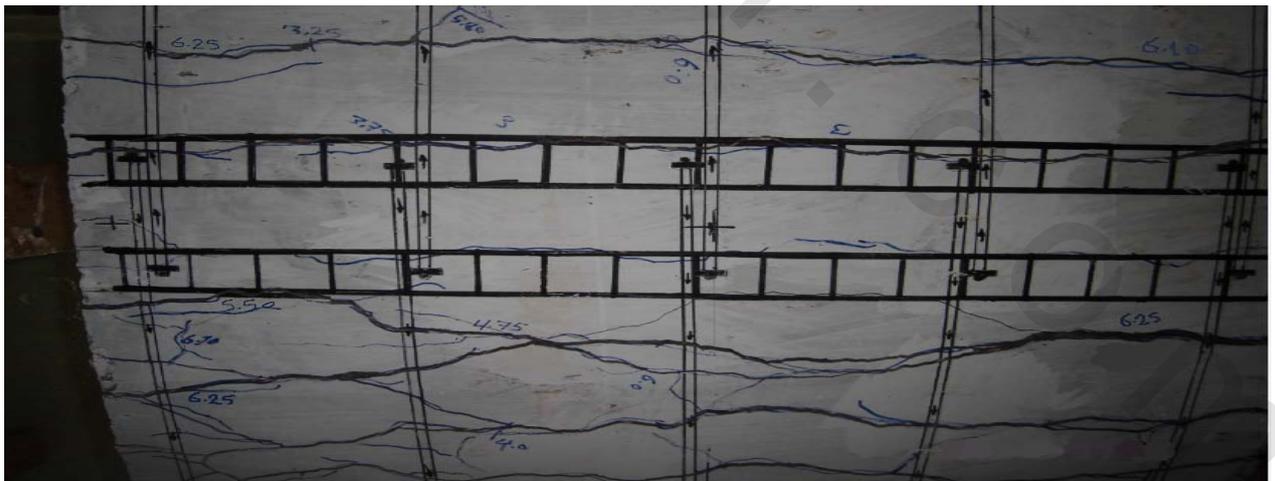
Figure (4-24): The crack pattern of AS-5.

(a): Cracks on the side of slab confined with embedded beams in lap zone at failure.

(b): Cracks formation at the edge of the transverse embedded beams confined and outside lap zone.

(c): Cracks on the bottom surface of slab confined with embedded beams in lap zone at failure.

Slab **AS-5**, confined with two transverse embedded beams at splice zone, first flexural crack appeared at the constant moment zone outside edge of the embedded beams, and extend to the head of the spliced bar at a load of 32.5 kN (about 52% of the ultimate load; P_u). As the load was increased, cracks initiated outside of the lap zone at a location close to transverse embedded beams, and flexural cracks propagated toward the compression zone. First crack inside the lap zone initiated near from the heads and at the bottom of the transverse embedded beams at a load of 47.5 kN (about 76% of the ultimate load; P_u). **Figure (4-24)** shows the crack patterns of slab **AS-5**. With load increase, the longitudinal cracks formed outside the end of the lap zone. This type of cracks did not propagate between transverses embedded beams in the lap zone, as cracks propagated and formed just outside of the lap zone. These cracks became wider and extended to cover the constant moment zone. Yield of bottom longitudinal steel occurred at a load of 48 kN (about 77% of the ultimate load; P_u). Failure of the slab occurred by crushing of concrete in compression zone at load of 62.5 kN. **Figure (4-25-a)** shows crushing of compression zone just after this load and **Fig (4-25-c)** shows the shape of slab **AS-5**, after testing and removal of the concrete cover around the embedded beam in lap zone.

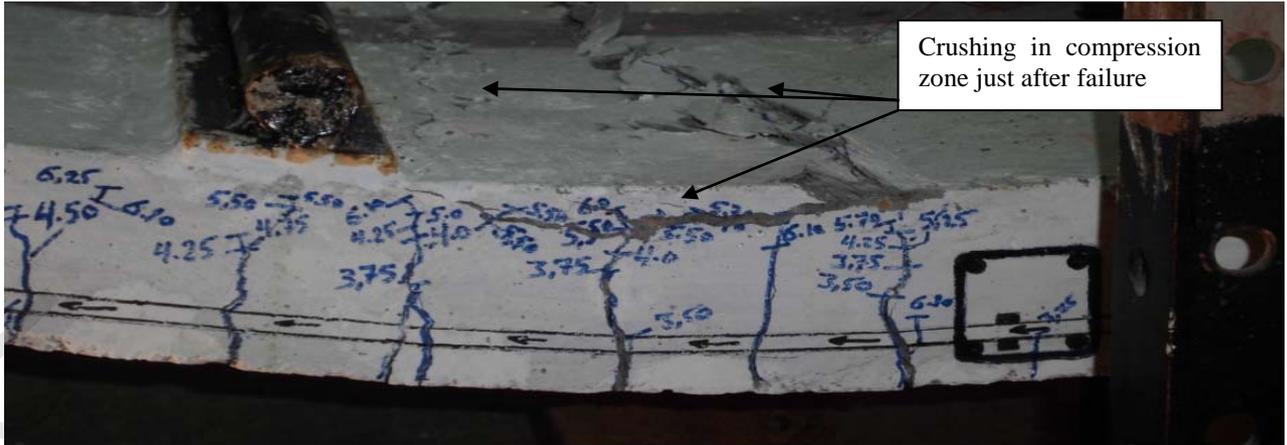
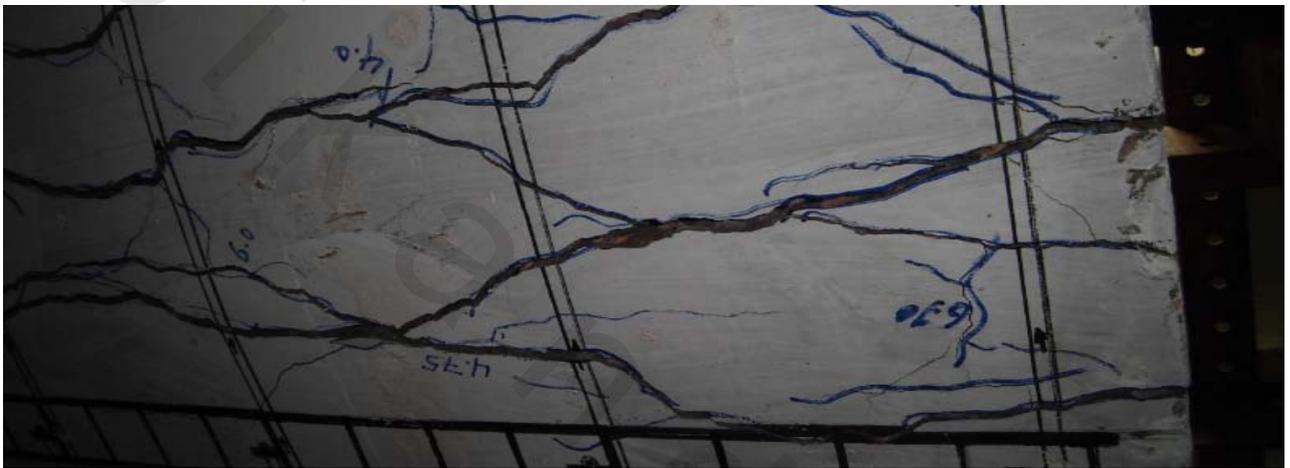
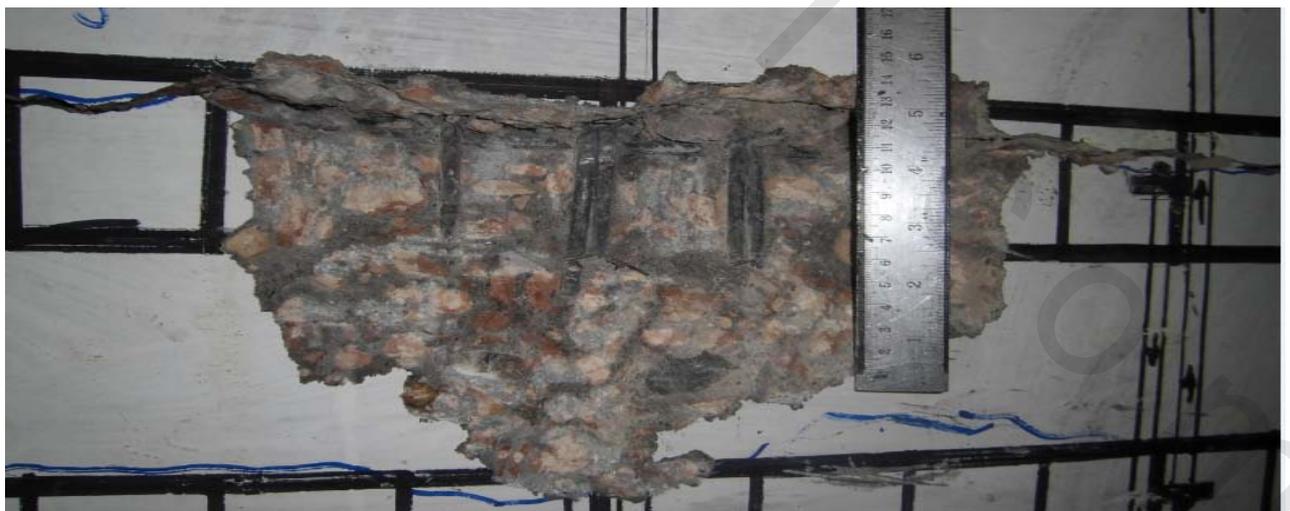
Figure (4-25): Cracks at failure stage of the confined splice slab **AS-5**.

(a): Splitting and crushing compression zone just after failure.

(b) :Cracks became wider and extensive outside the confined lap zone.

(c): The concrete around confined zone after bottom cover removed from the confined lap zone.

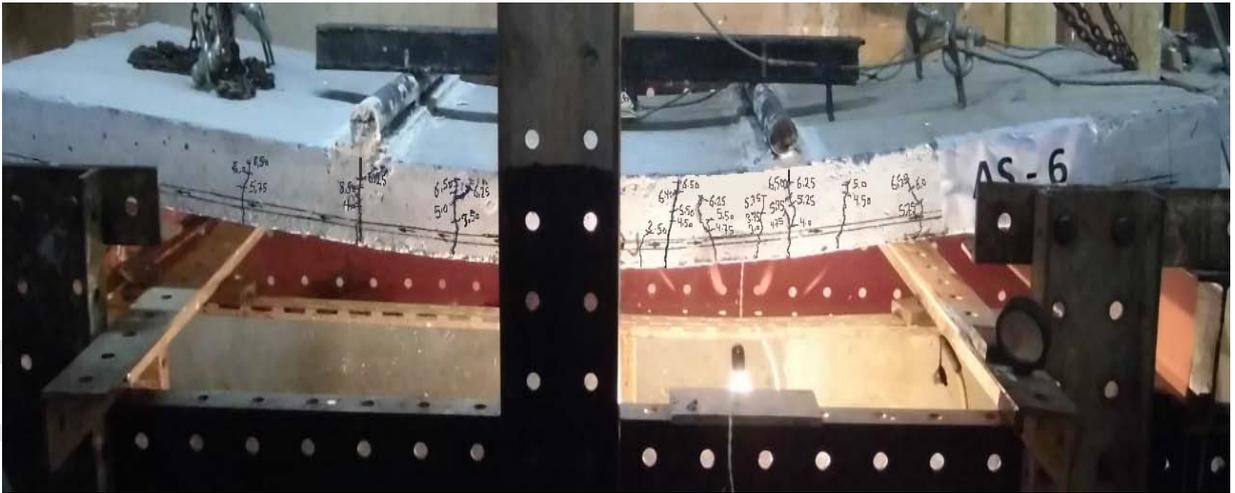
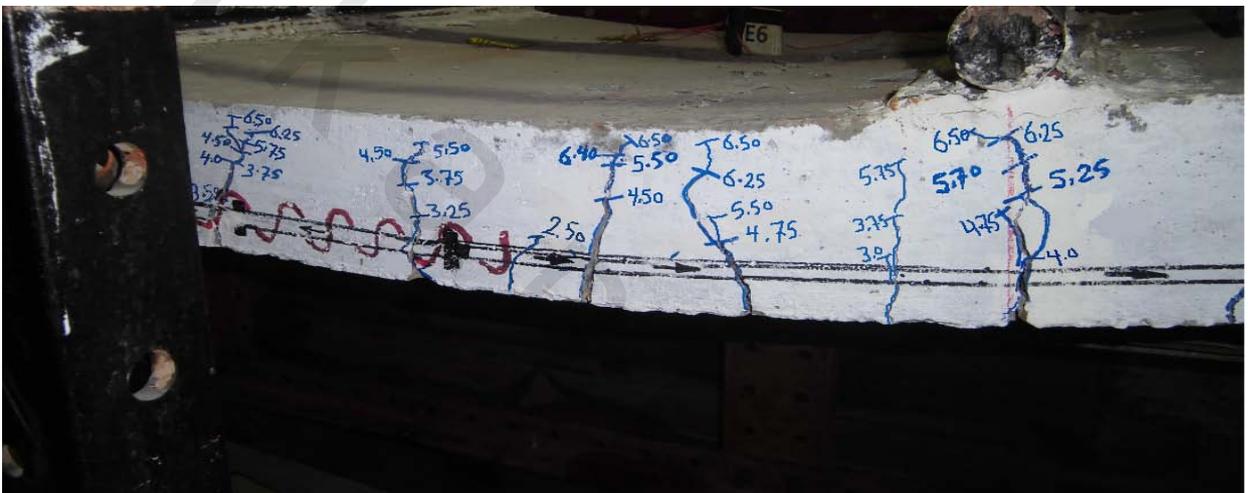
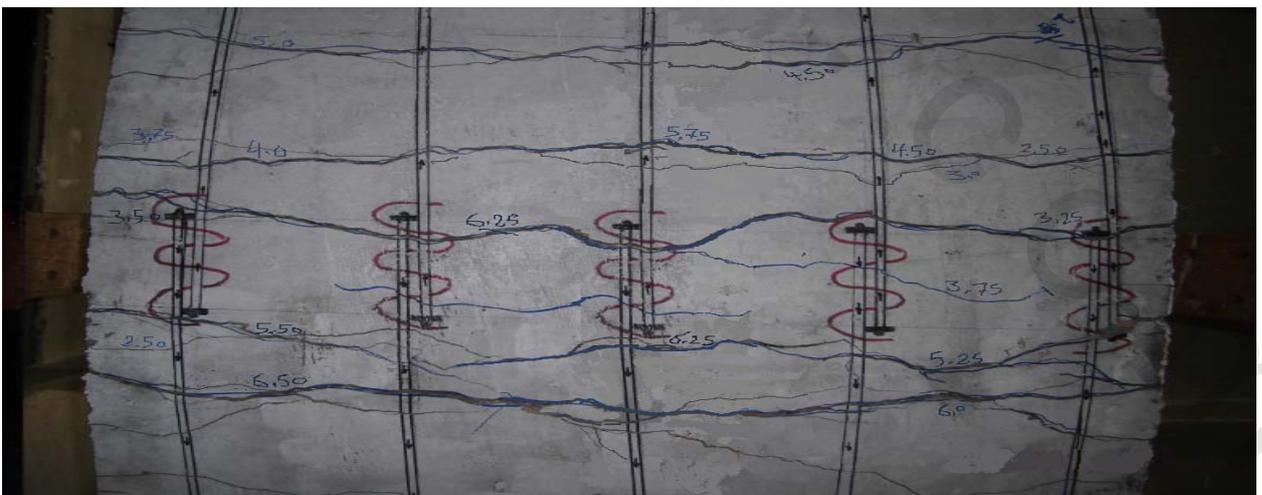
Figure (4-26): The crack pattern of AS-6.

(a): Cracks on side of slab confined with circular spiral stirrups around lap splice at failure.

(b): Cracks formation at the lap zone and extensive outside of confined lap zone.

(c): Cracks on the bottom surface of slab after excessive deflection.

For slab **AS-6**, confined with circular spiral stirrup around the lap splice joint, flexural cracks appeared in the constant moment zone and near the head of the spliced bar at a load of 32.5 kN (about 50% of the ultimate load; P_u). As the load was increased, the first cracking in the lap zone initiated near the heads and close to the edge of the spiral stirrup around lap splice. This behavior was observed in slab **AS-5** in this group; and flexural cracks propagated upward to the compression zone. Then with the gradual increased of load, additional transverse cracks outside of the lap zone were formed. Only one crack appeared between opposing headed bars in lap zone. Just before failure, some cracks formed within the lap zone. These cracks became wider and extended in the lap zone. Yield of bottom longitudinal steel occurred at a load of 57.5 kN (about 88% of the ultimate load; P_u). Failure of the slab occurred by crushing of concrete in compression zone at load of 65 kN. **Figure (4-26)** shows the crack patterns of slab **AS-6**, and **Fig (4-27)** shows the photos of slab **AS-6**, after testing and removing the bottom cover over circular spiral stirrup in the lap zone. **Figure (4-26-c)** shows the cracks in the lap zone with no splitting after the occurrence of excessive deflection.
