CHAPTER 4: TEST RESULTS AND DISCUSSION

4.2 Group 1: Effect of Lap Splice Length

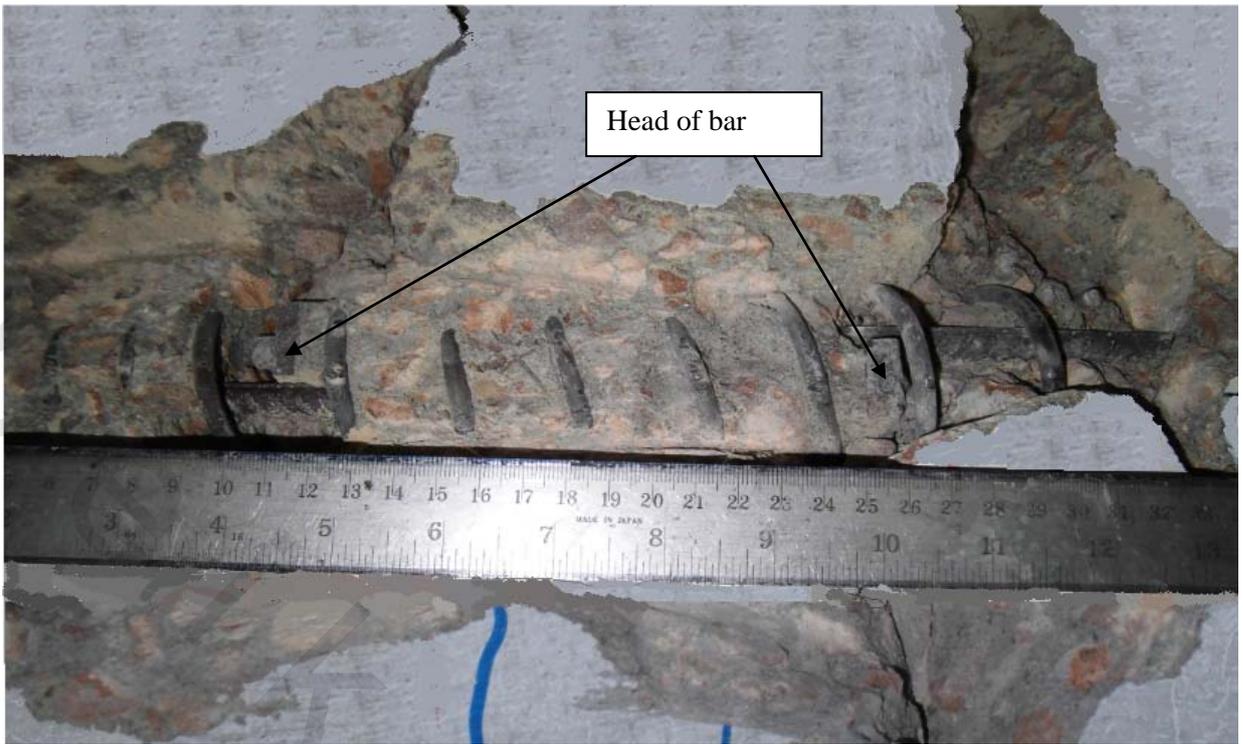
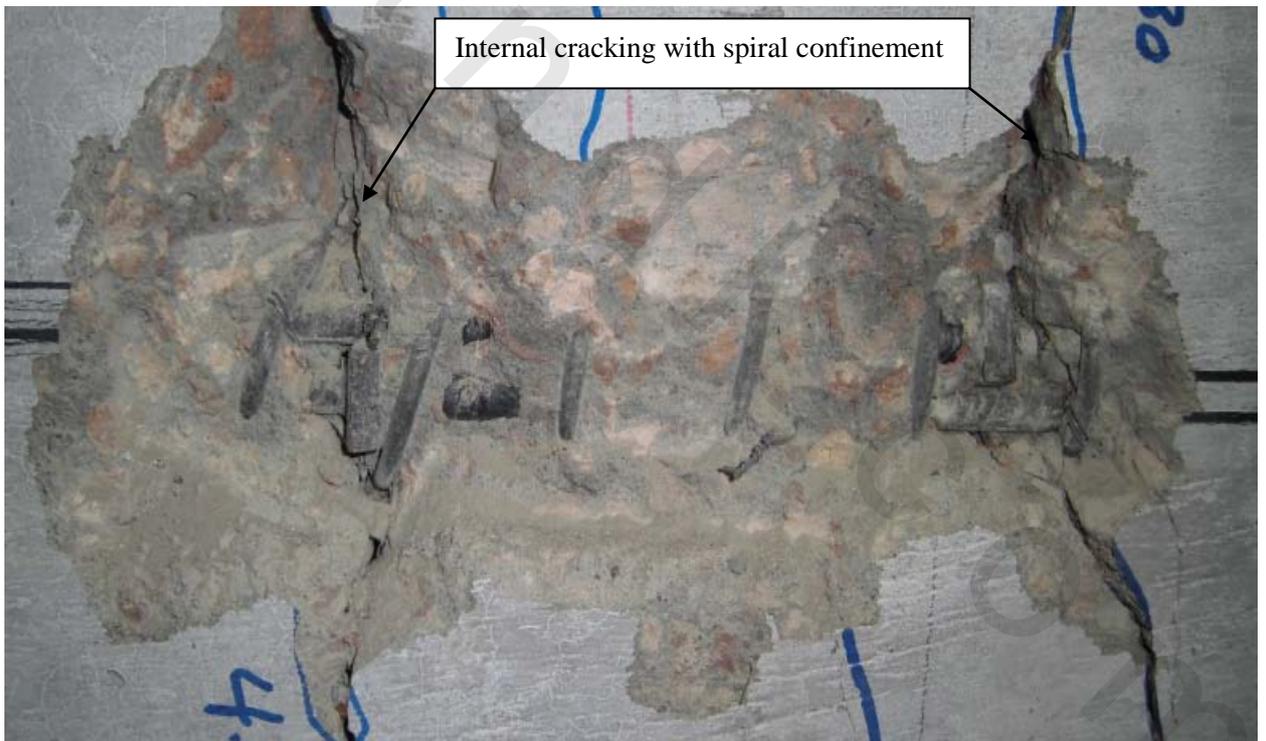
(a): The concrete around spiral stirrups after bottom cover was removed from the lap zone.

(b): Cracking in the lap zone occurred along the heads.

Figure (4-27): Failure of the confined splice slab **AS-6**, confined with spiral stirrup around the lap joint.

For slab **AS-6**, confined with circular spiral stirrup around the lap splice joint, flexural cracks appeared in the constant moment zone and near the head of the spliced bar at a load of 32.5 kN (about 50% of the ultimate load; P_u). As the load was increased, the first cracking in the lap zone initiated near the heads and close to the edge of the spiral stirrup around lap splice. This behavior was observed in slab **AS-5** in this group; and flexural cracks propagated upward to the compression zone. Then with the gradual increased of load, additional transverse cracks outside of the lap zone were formed. Only one crack appeared between opposing headed bars in lap zone. Just before failure, some cracks formed within the lap zone. These cracks became wider and extended in the lap zone. Yield of bottom longitudinal steel occurred at a load of 57.5 kN (about 88% of the ultimate load; P_u). Failure of the slab occurred by crushing of concrete in compression zone at load of 65 kN. **Figure (4-26)** shows the crack patterns of slab **AS-6**, and **Fig (4-27)** shows the photos of slab **AS-6**, after testing and removing the bottom cover over circular spiral stirrup in the lap zone. **Figure (4-26-c)** shows the cracks in the lap zone with no splitting after the occurrence of excessive deflection.

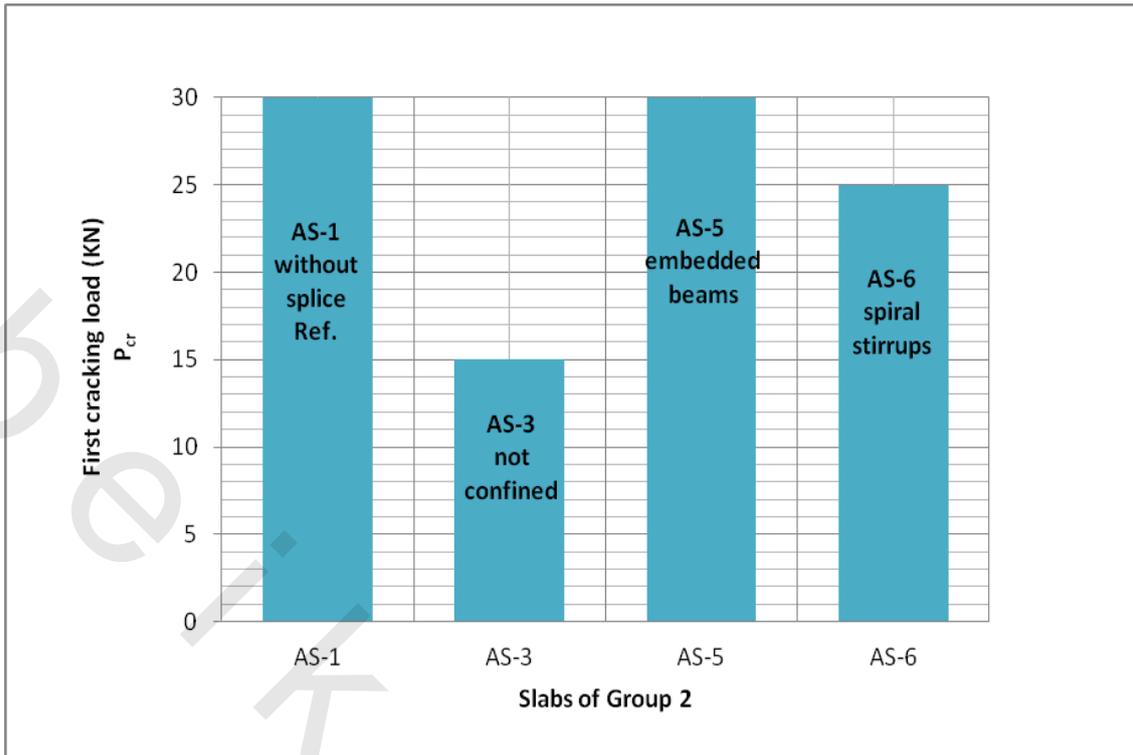
Figure (4-28): First cracking loads for slabs of Group (2).

Figure (4-28) shows the cracking load of this group. Slab **AS-1**, reference specimen without splice, had first flexural cracking load at 30 kN. Slab **AS-3**, without confinement in lap splice zone, had first cracking load at 15 kN. For slabs, **AS-5**, and **AS-6** had first cracking load at 30 kN, and 25 kN respectively. This indicates that confinement of the lap splice delayed the cracking of the slabs.

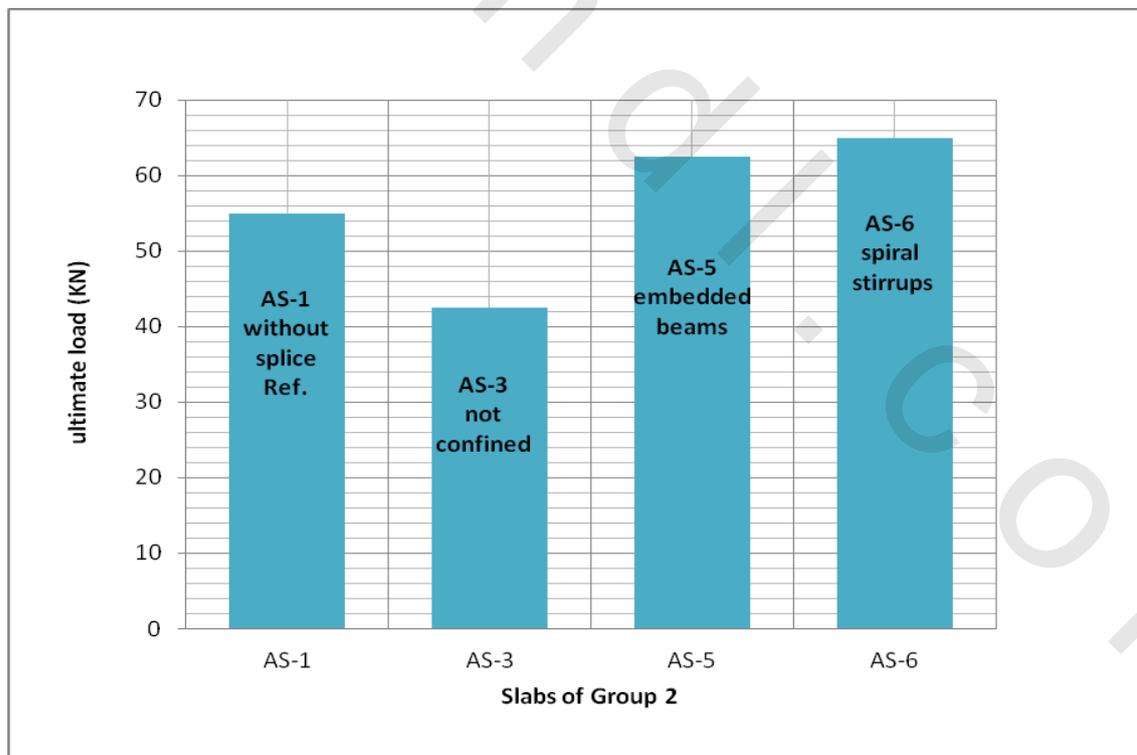
Figure (4-29): Failure loads for slabs of Group (2).

Figure (4-29) shows the failure load and effect of confinement in lap splice zone of the tested slabs in this group. The failure loads of slabs **AS-3**, **AS-5**, and **AS-6** were 42.5, 62.5, and 65 kN respectively. These slabs achieved ultimate load of 77%, 114%, and 118%, respectively, of that of slab **AS-1** (reference slab). These results indicate that the failure load of slab **AS-3** (without confinement) was reduced by only 23% of that of the reference slab **AS-1**. Using confinement with embedded beams around the bar heads for slab **AS-5**, and spiral stirrups around lap splice for slab **AS-6**, respectively increased the failure load by 14%, and 18% than that of the reference slab **AS-1**, respectively. Figure (4-30) shows the relation between the ratios of experimental ultimate (failure) load to the calculated ultimate load (calculated as 41.5kN). Slab **AS-3**, without confinement at lap splice zone, showed 2.4% increase in its ultimate load than the calculated value, while for slab **AS-5** confined with embedded beams around the bar heads, the ultimate load was higher than the calculated value by 51%. For slab **AS-6** confined with spiral stirrups around lap splice zone, the ultimate load was higher than the calculated value by 57%. This indicates that confinement of the lap splice improved the load capacity of the slabs.

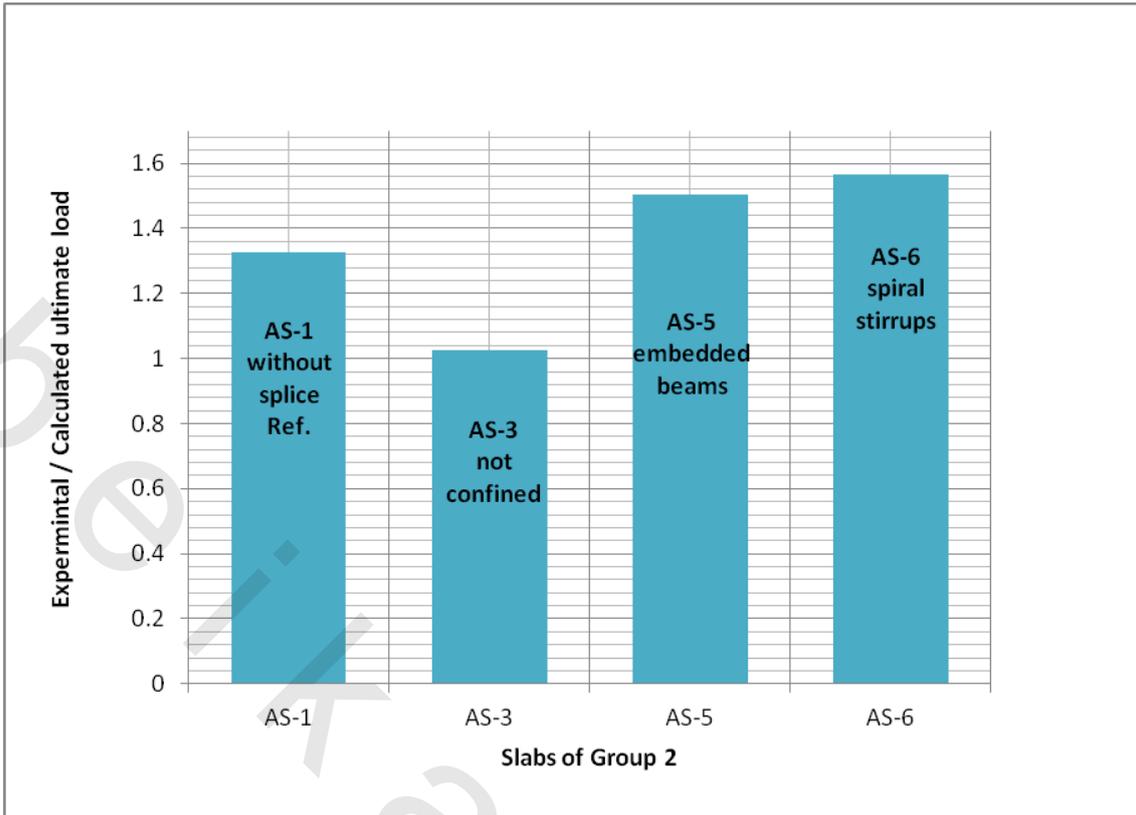
Figure (4-30): (Experimental / Calculated) ultimate loads for slabs of Group (2).

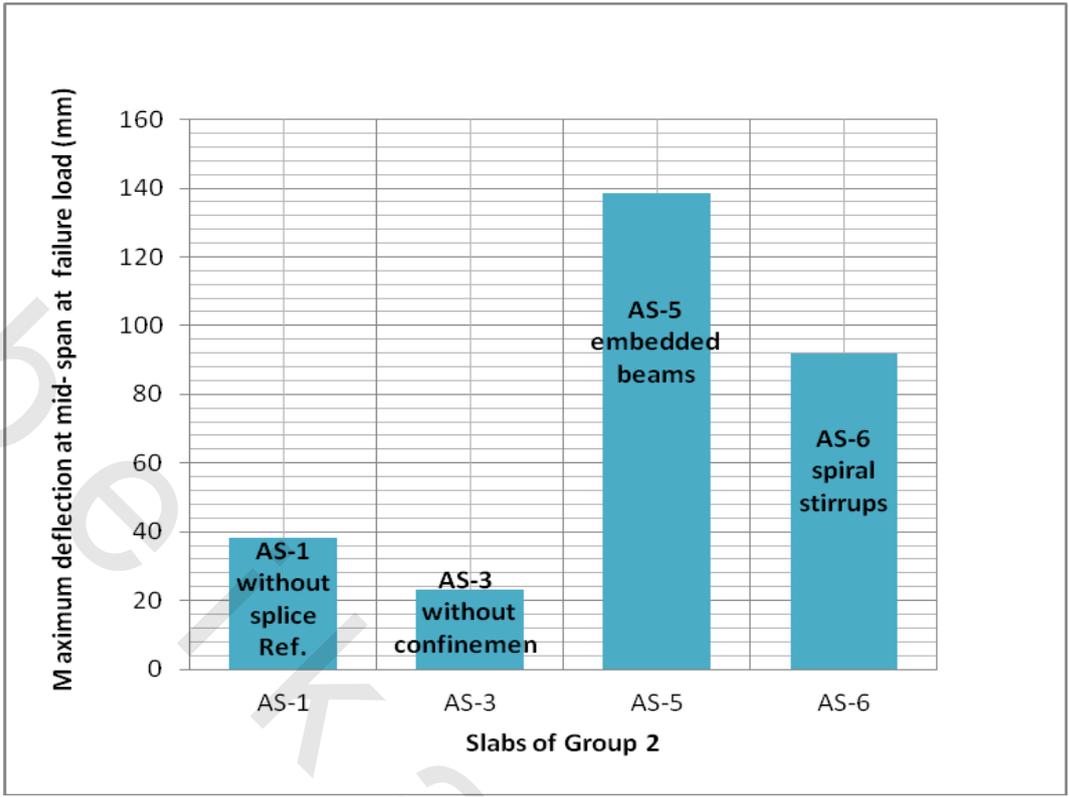
Figure (4-34): Maximum deflection at mid-span at failure load for slabs of Group (2).

Figure (4-34) shows the maximum deflection at mid-span at failure load and effect of confinement in the lap splice zone. Slabs **AS-3**, **AS-5**, and **AS-6** achieved maximum deflection at failure load of 60%, 362%, and 241% respectively of that of slab **AS-1** (reference slab). The area under the load-deflection curve is calculated and plotted to measure the maximum energy absorbed by these slabs. Figure (4-35) shows the values of the calculated strain energy. Strain energy achieved by the tested slabs was 1.748, 0.696, 7.229, and 4.956 kN.m for slabs **AS-1**(reference slab), **AS-3**, **AS-5**, and **AS-6** respectively. One can conclude that strain energy absorbed by the slab, increased when the confinement in the splice zone was provided.

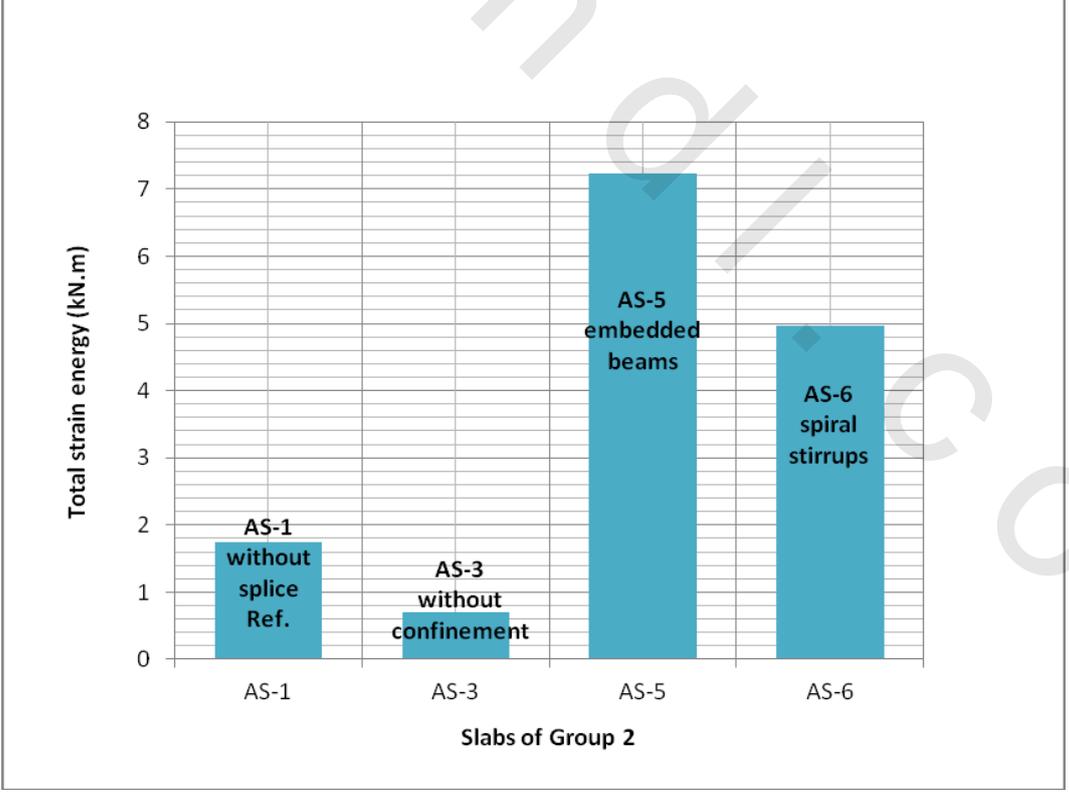
Figure (4-35): Total strain energy for slabs of Group (2).

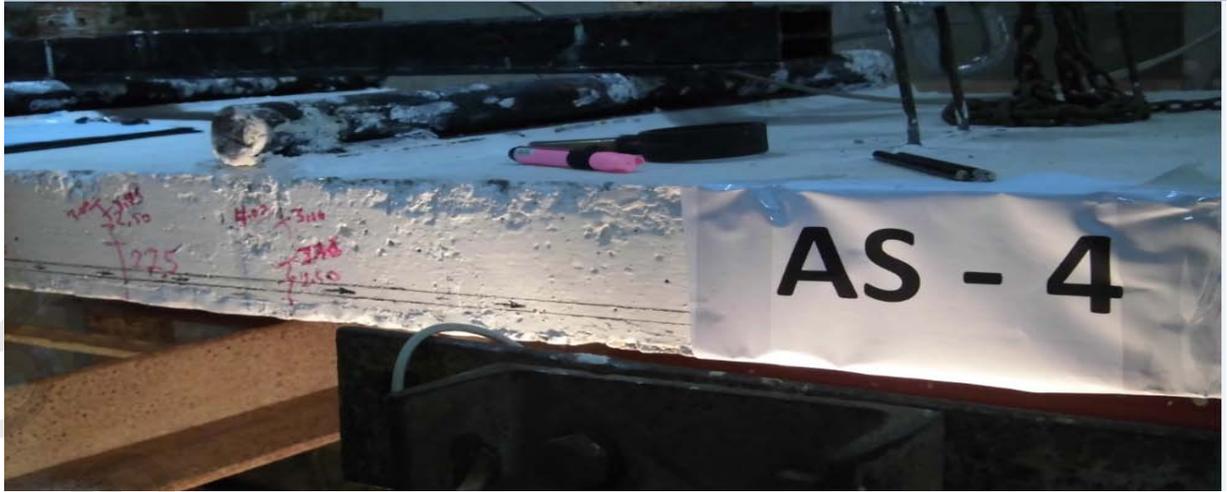
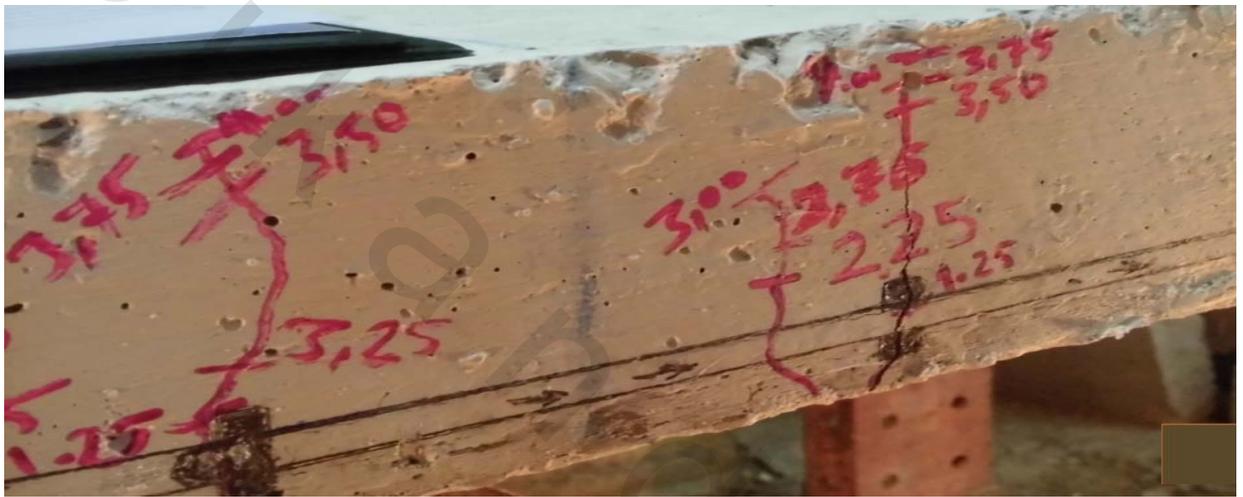
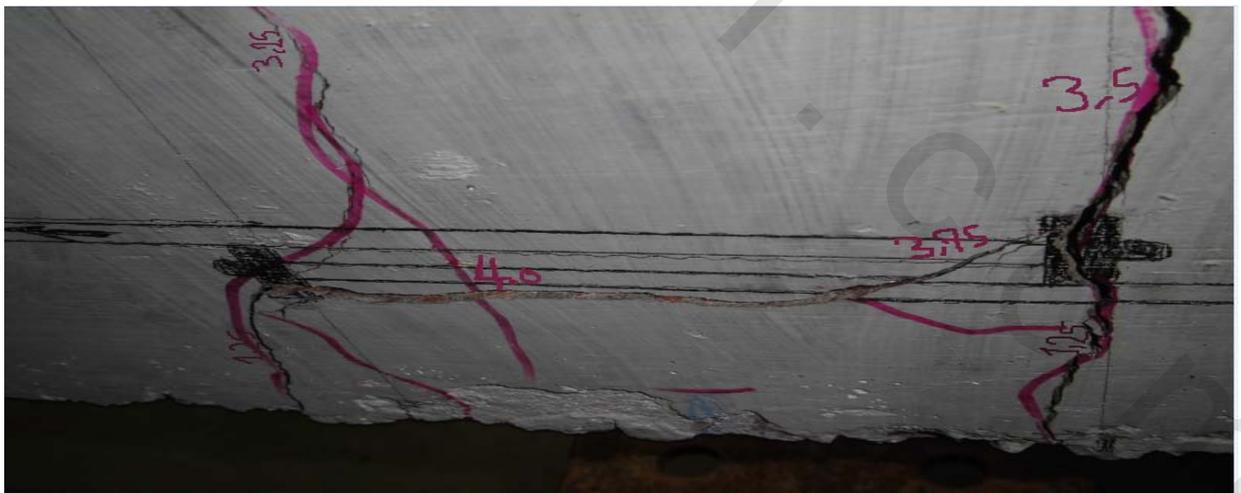
Figure (4-42): The crack pattern of AS-4.

(a): Cracks on the side face.

(b): Cracks close to the end of the lap zone.

(c): Cracks on the bottom surface close to lap zone before failure.

For slab **AS-4**, with debonded headed bars in the splice zone, $15 d_b$ lap splice length (150 mm) and with no confinement at lap zone, flexural cracks appeared at the constant moment zone near the head of the spliced bar at a load of 12.5 kN (about 31% of the ultimate load; P_u). This value was less than that recorded in the bonded specimen **AS-3**. The width of cracks was much wider than the bonded specimen (**AS-3**). Transverse cracking in the slab (**AS-4**) occurred close to the position of the bar head. Distinct longitudinal cracks formed between two sets of opposing heads. These cracks appeared at a load of 37.5 kN (about 94% of the ultimate load; P_u). Cracking around the heads of bonded slabs was more propagation at the lap zone with indications of bond stress between headed bars and the surrounding concrete. This behavior was not evident in the debonded slab (**AS-4**) because there was no contribution from bond. As the load was increased, flexural cracks propagated upward towards the compression zone. With the load increase, cracks along the line of heads at each end of the lap became wider and extended upward to about 97% of the slab height and covered the lap zone. No yield was recorded in the tension steel up to failure. Failure of the slab was a brittle (pushed down the bottom cover by the heads of bars and cover separated from the slab) at a load of 40 kN, as shown in **Fig (4-43)**. **Figure (4-44)** shows the first cracking load for the slabs in Group (3).

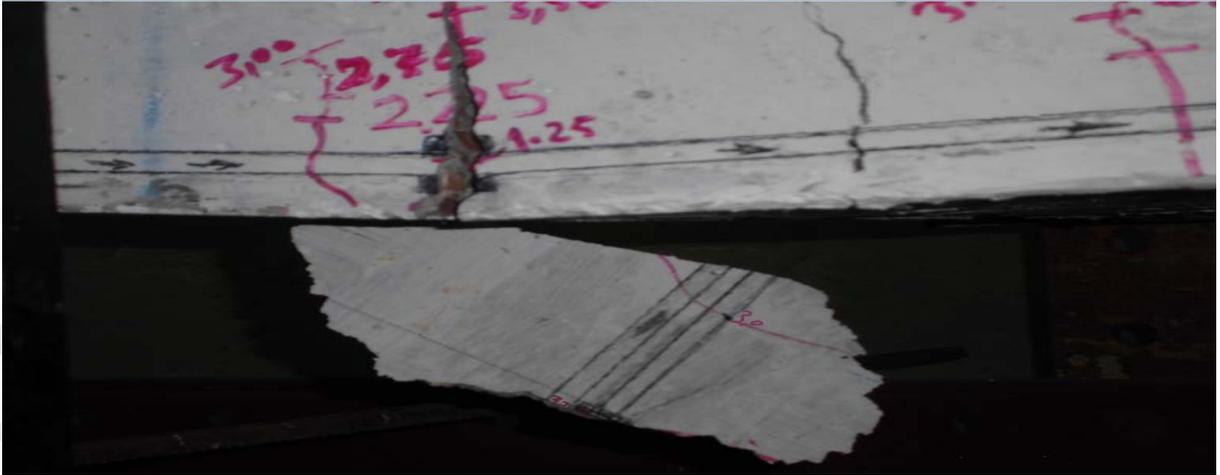
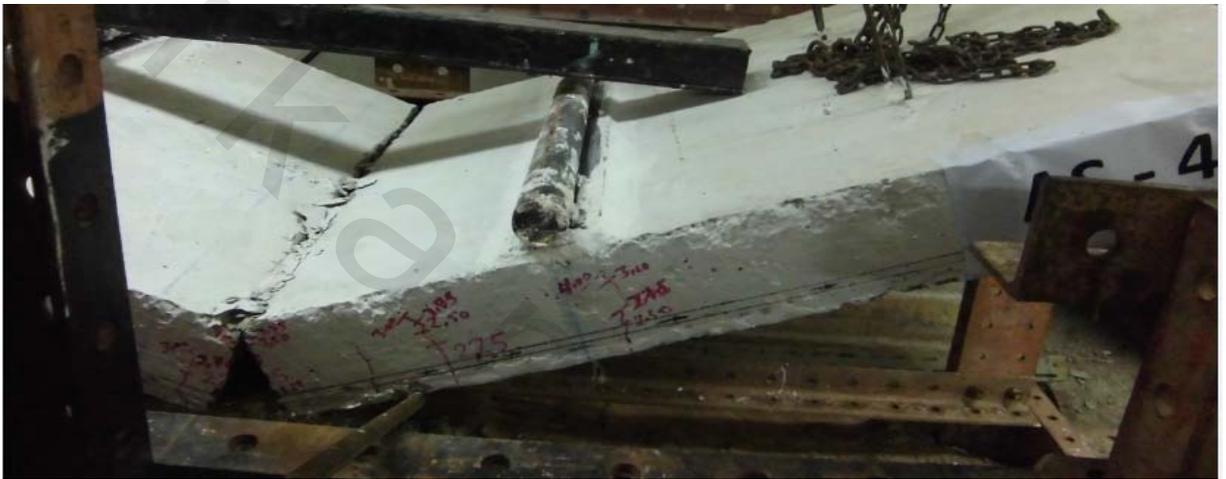
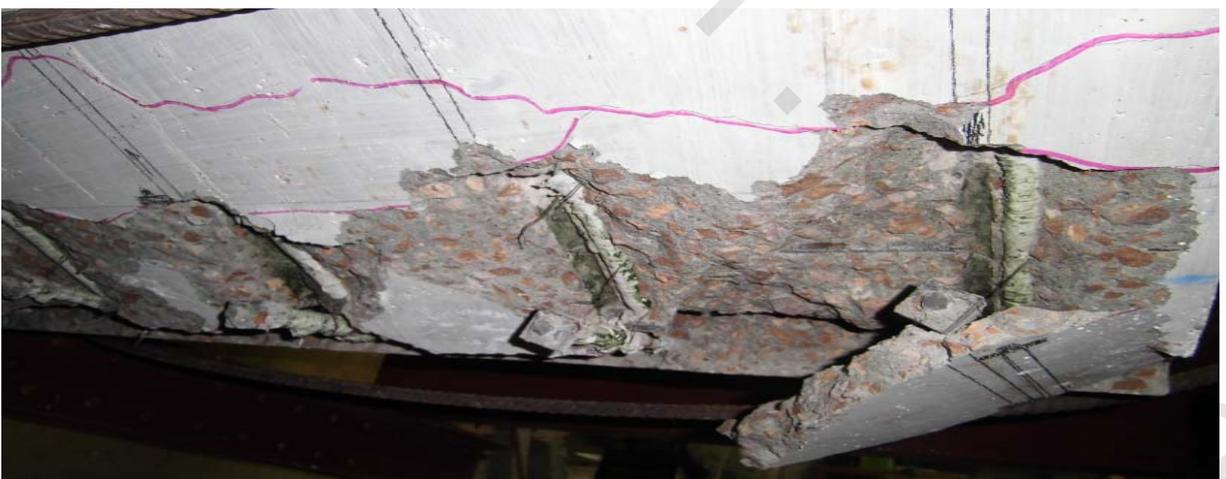
Figure (4-43): Failure of the lap splice of slab **AS-4**.

(a): Bottom cover spalling in lap zone just before failure.

(b): Specimen just after the failure.

(c): The concrete around the debonded lap zone just after failure.

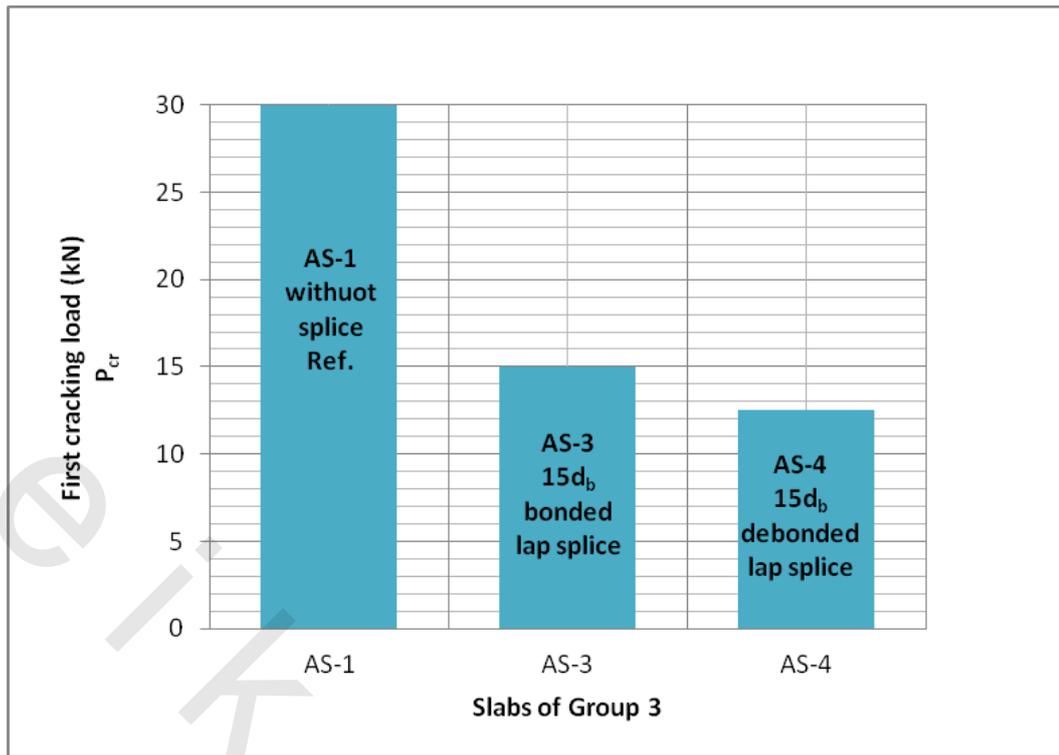
Figure (4-44): First cracking loads for slabs of Group (3).

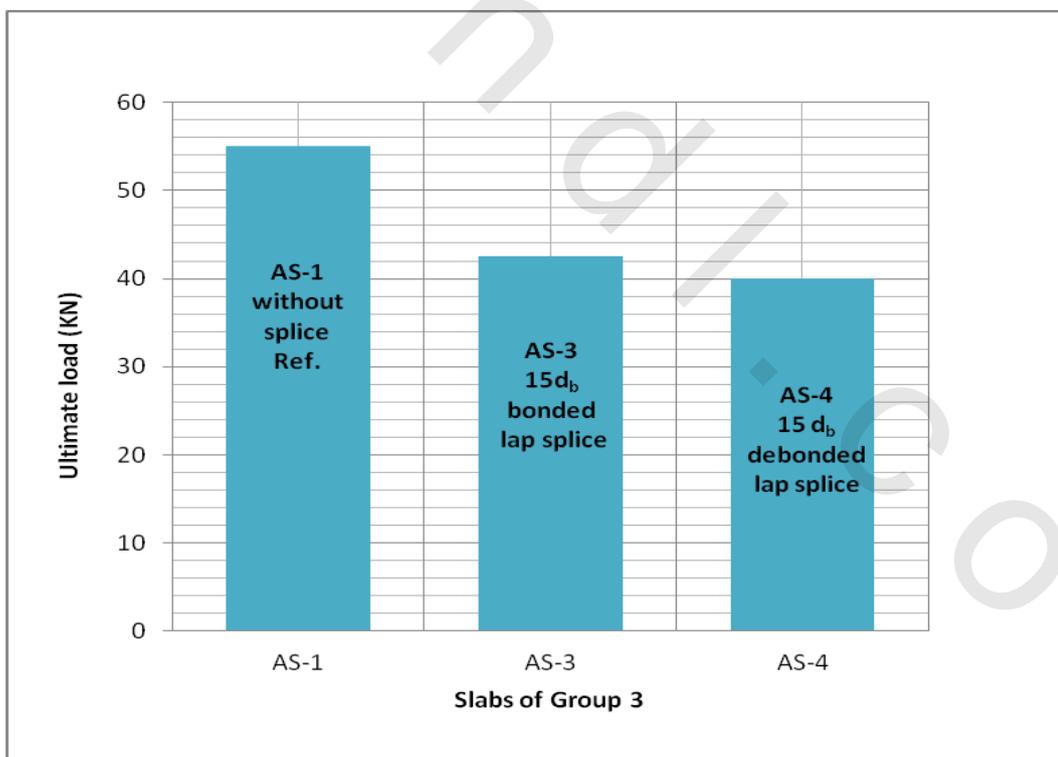
Figure (4-45): Failure loads for slabs of Group (3).

Figure (4-45) shows the failure load for bonded and debonded lap splice zone of the tested slabs **AS-1**, **AS-3**, and **AS-4**, respectively. The failure loads of these slabs were 55.0, 42.5, and 40.0 kN respectively. Slabs **AS-3**, and **AS-4** achieved a load of 77%, and 73%, respectively, of that of slab **AS-1**(reference slab). **Figure (4-46)** shows the ratio of

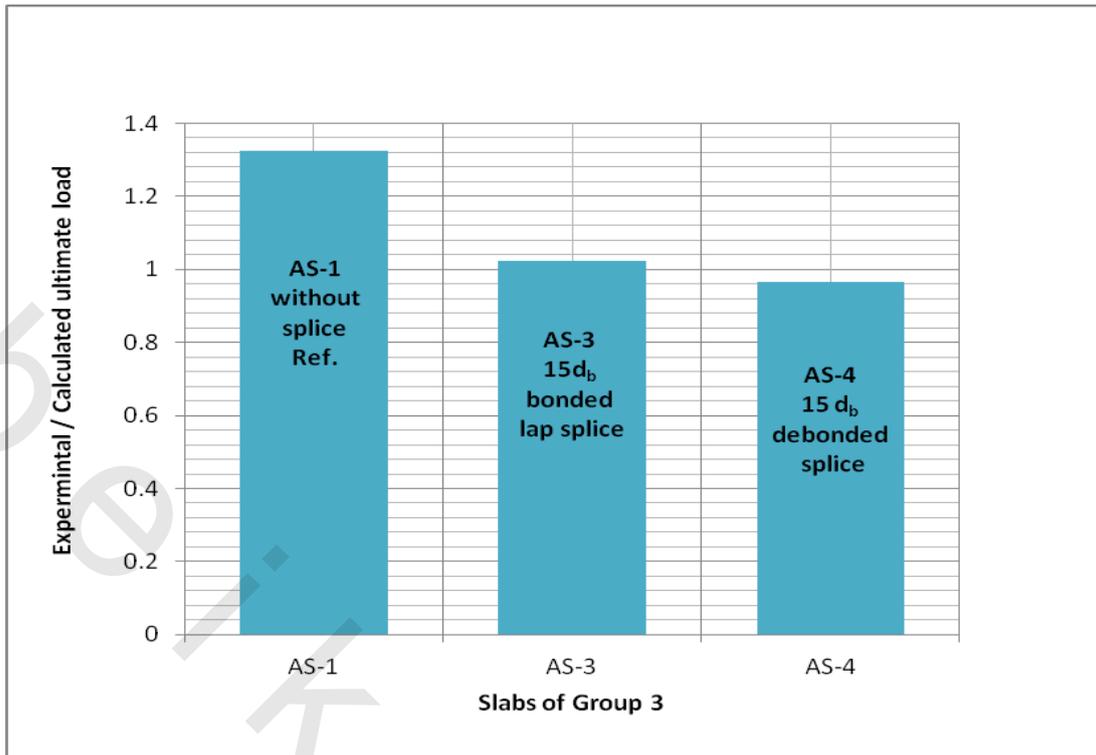
Figure (4-46): (Experimental / Calculated) ultimate loads for slabs of Group (3)

experimental ultimate (failure) load to the calculated ultimate load for bonded, debonded splice bar in slabs in this group. Slab **AS-3**, showed 2.4% increase in its ultimate load above the calculated value, while for slab **AS-4** with debonding in the lap splice zone, a 3.6% reduction in its ultimate load below the calculated value was obtained. This indicates the role of head in transferring the bar force in the spliced bars.

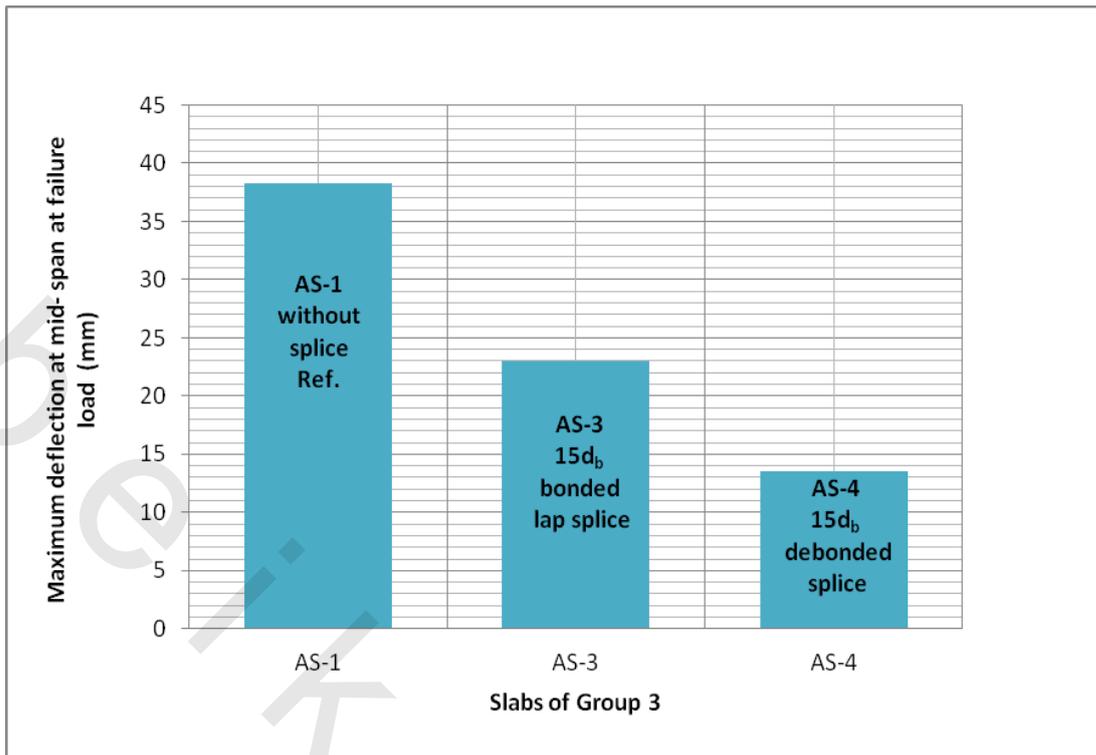
Figure (4-50): Maximum deflection at mid-span at failure load for slabs of Group (3).

Figure (4-50) shows the maximum deflections at mid-span at failure load of the slabs of this group. Slabs **AS-3**, and **AS-4** achieved maximum deflection at failure load equal to 60%, and 35% respectively of that of slab **AS-1** (reference slab). The area under the load-deflection curve is calculated and plotted to measure the maximum energy absorbed by these slabs.

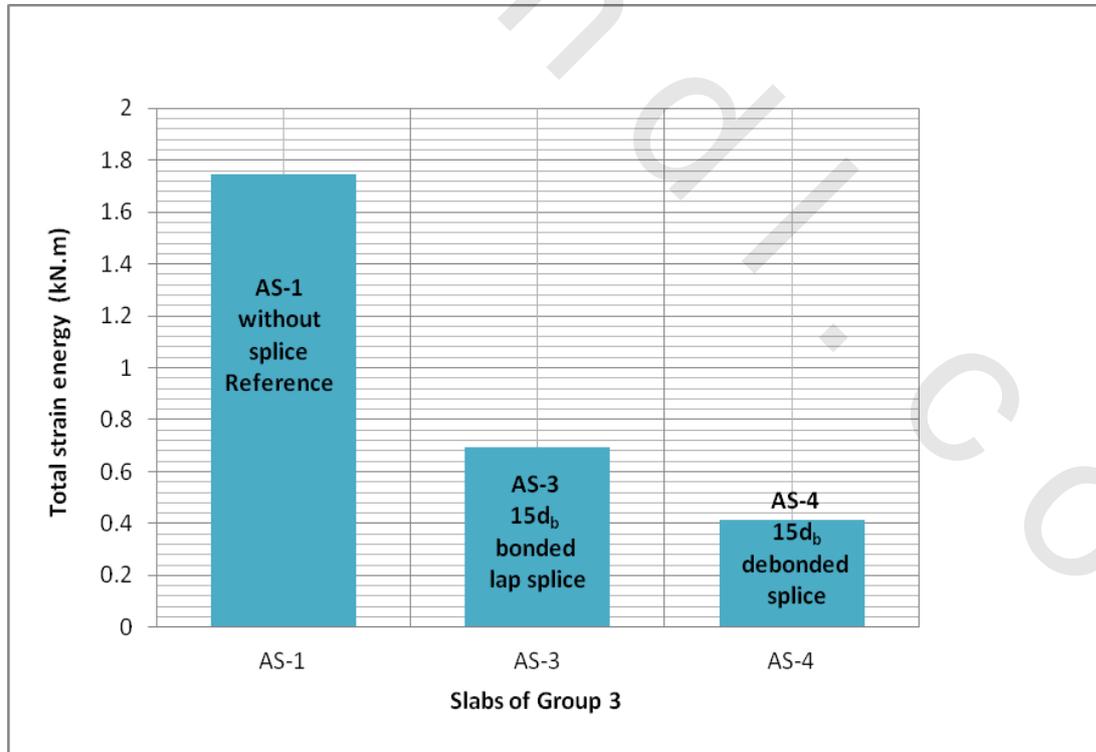
Figure (4-51): Total strain energy for slabs of Group (3).

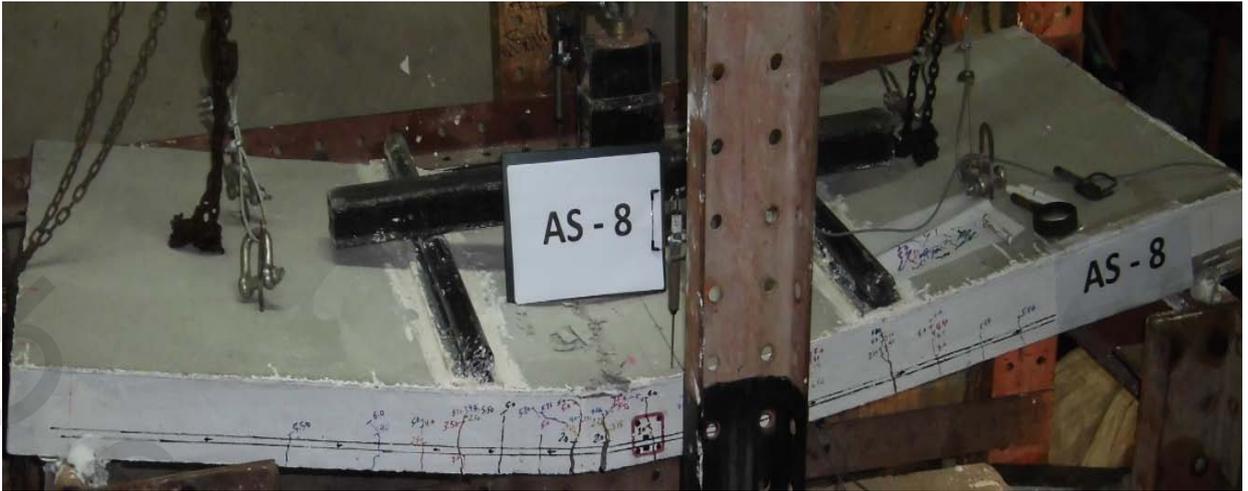
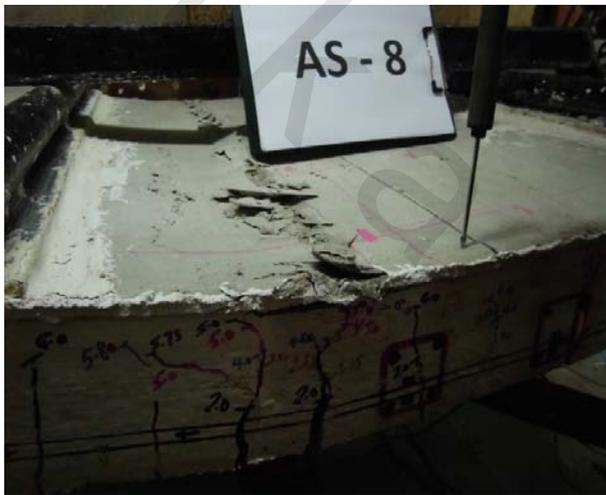
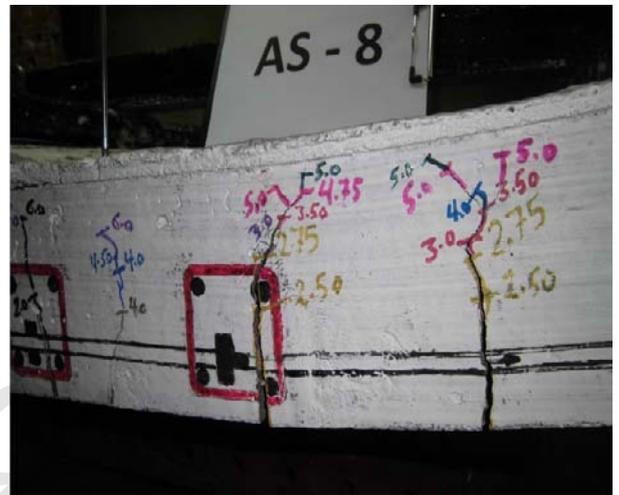
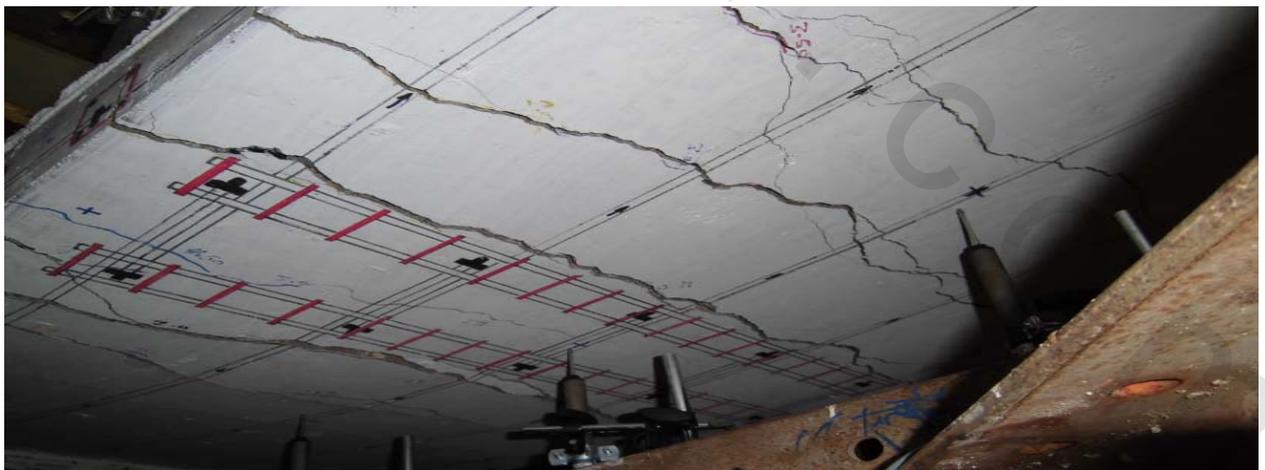
Figure (4-58): The crack pattern of AS-8.

(a): Cracks on the side face at failure.

(b): Cracks close to confined lap zone.

(c): Cracks on the bottom surface of slab AS-8 confined with embedded beams around bar heads at failure.

Cracks of slabs were marked with different colors at each load increment up to failure. Figures (4-58) and (4-60) show the crack patterns of slabs AS-8, and AS-9 in all cycles respectively.

Slab AS-8 confined with embedded beams around the bar heads, with the same details of slab AS-5 and the applied loads were repeated up to failure. Flexural crack appeared in the first cycle at a load of 20 kN (about 33% of the ultimate load; P_u) at the constant moment zone, near the leg of the transverse stirrups cage of the embedded beam located at the head. In the second cycle, the crack occurred near at the other head in the lap zone at a load of 25 kN (about 42% of the ultimate load; P_u) and began to extend transversely near the edge of the embedded beam. In the third cycle, the cracks were extended outside the embedded beams at a load of 30 kN (about 50% of the ultimate load; P_u). With increase the applied repeated cycles, the cracks initiated outside the lap zone at a location close to embedded beams. At the seventh cycle, cracks were extensive and adjacent to the right and left of the embedded beam. Also, at the seventh cycle, yield of longitudinal headed bars occurred at a load of 42.5 kN (about 71% of the ultimate load; P_u). During removing the applied load, width of some cracks decreased. In the eighth cycle, the cracks parallel to the embedded beams also became wider with load increase, after this cycle, flexural cracks propagated upward to the compression zone. Failure of the slab occurred in the tenth cycle by crushing of concrete in compression zone at load of 60 kN. Figure (4-58) shows crack patterns of slab AS-8, and Fig. (4-59) shows the shape of slab AS-8 after testing and removing the cover over the embedded beams.

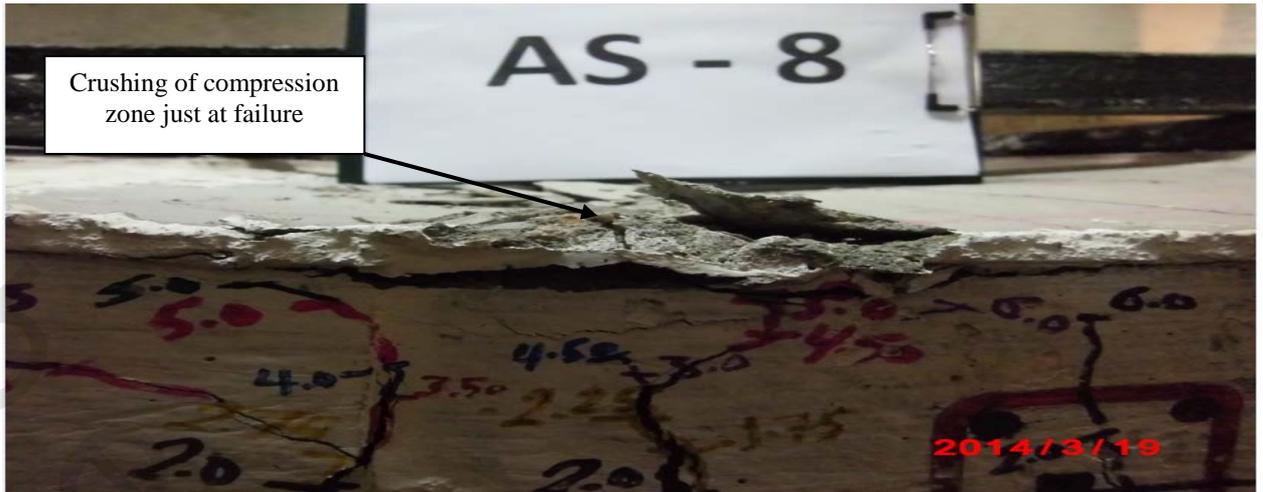
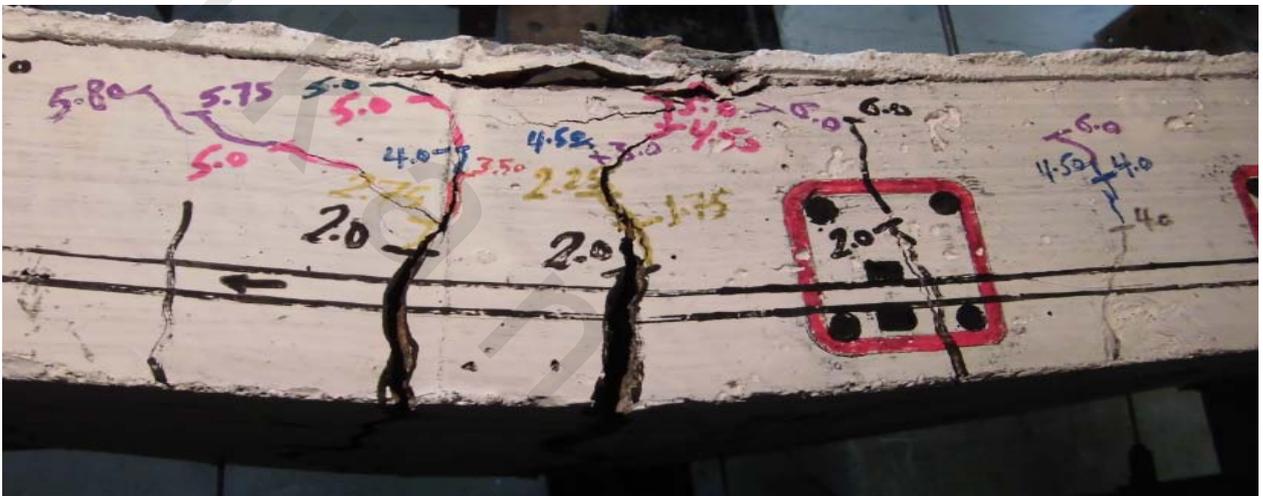
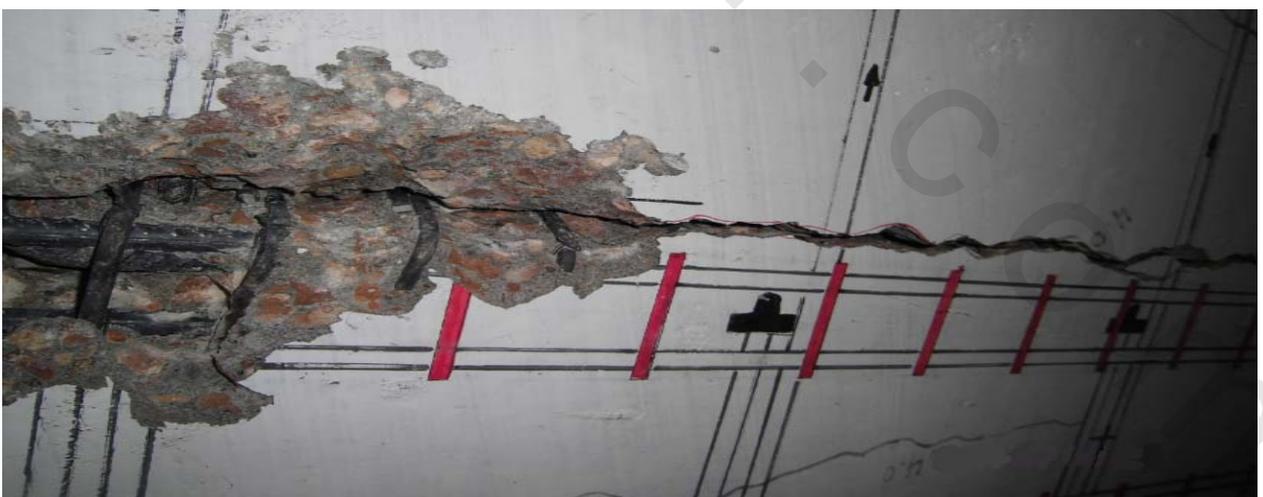
Figure (4-59): Failure of the confined splice slab AS-8.

(a): Splitting and crushing compression zone just at failure.

(b) :Cracks became wider and extensive outside of confined lap zone just at failure.

(c): The concrete around confined zone after cover removed over confined lap zone.

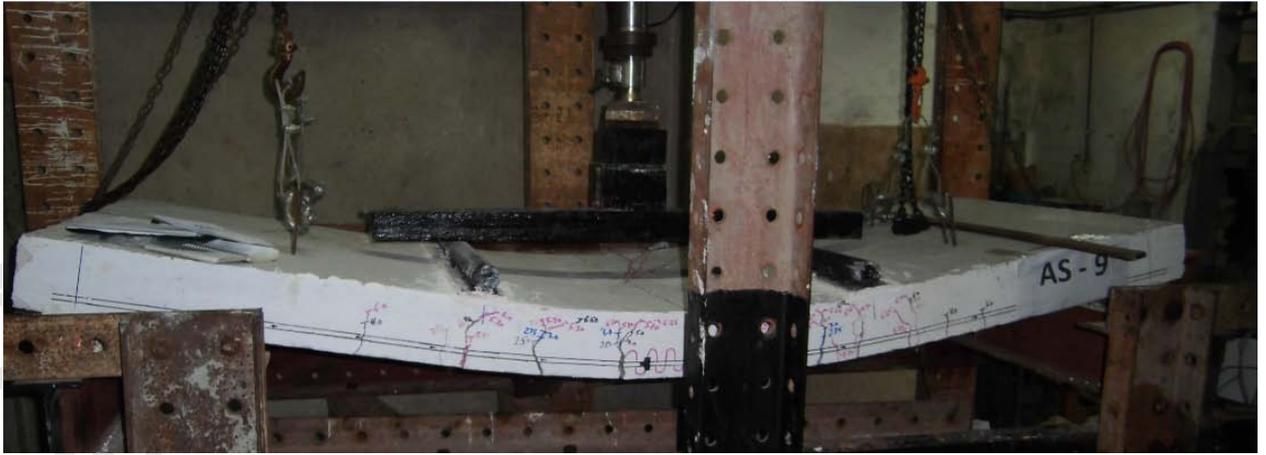
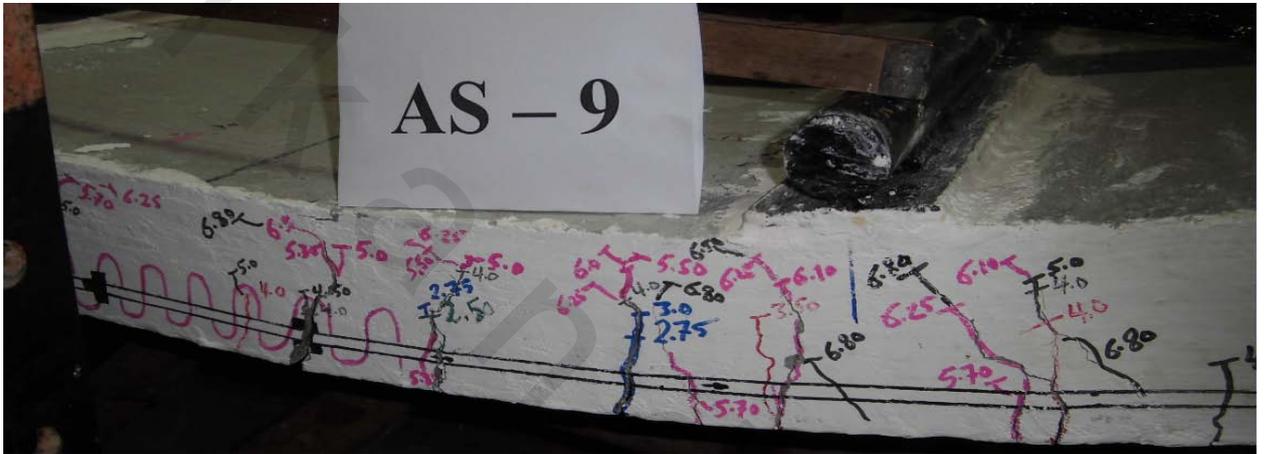
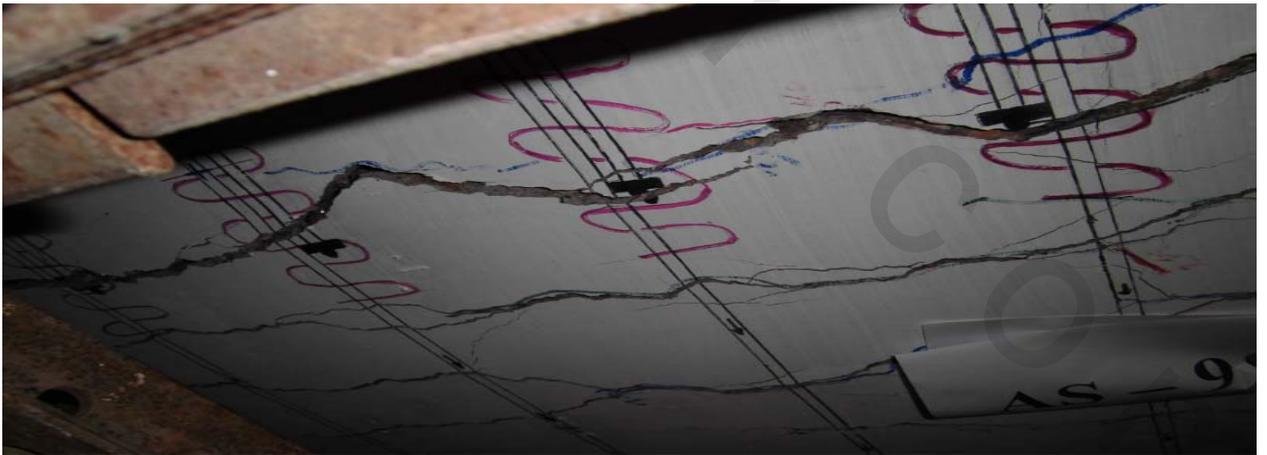
Figure (4-60): The crack pattern of AS-9.

(a): Cracks on the side face.

(b): Cracks close to the bar head.

(c): Cracks on the bottom surface of the slab confined by circular spiral stirrups in lap zone at failure.

For slab AS-9, provided with circular spiral stirrups around the lap splice, with the same reinforcement details of slab AS-6 but with repeated loading up to failure. Flexural crack appeared at the constant moment zone adjacent of the end of circular spiral stirrup in the first cycle at a load of 25 kN (about 37% of the ultimate load; P_u). In the second cycle, the cracks occurred outside the confined zone and extended up ward at a load of 27.5 kN (about 40% of the ultimate load; P_u). In the third cycle, cracks began to form near the head of bars at the bottom of the specimen at a load of 30 kN (about 44% of the ultimate load; P_u). In the fourth cycle, cracks appeared and extended within the lap zone on the side face of the specimen at a load of 40 kN (about 59% of the ultimate load; P_u). With applying repeated cycles, the cracks formed and initiated outside of the lap zone close to the end of the spiral stirrups. Also, some cracks started near the head of the bar. In the fifth cycle, yield in longitudinal headed bars occurred at a load of 50.7 kN (about 75% of the ultimate load; P_u). The behavior of this specimen was similar to that of slab AS-8 provided with embedded beams around the bar heads. In the sixth cycle, flexural cracks propagated upward to the compression zone. Failure of this slab occurred by crushing of concrete in compression zone at load of 68 kN. Figure (4-60) shows the crack patterns of slab AS-9, and Fig. (4-61) shows the shape of slab AS-9, after testing and removing the concrete cover of the spiral stirrups around the lap zone. It is clear that concrete inside the spiral stirrups zone was not damaged and concrete cover did not spilt off. Figure (4-62) shows the first cracking load for slabs in this group.
