CHAPTER 4: TEST RESULTS AND DISCUSSION

4.2 Group 1: Effect of Lap Splice Length

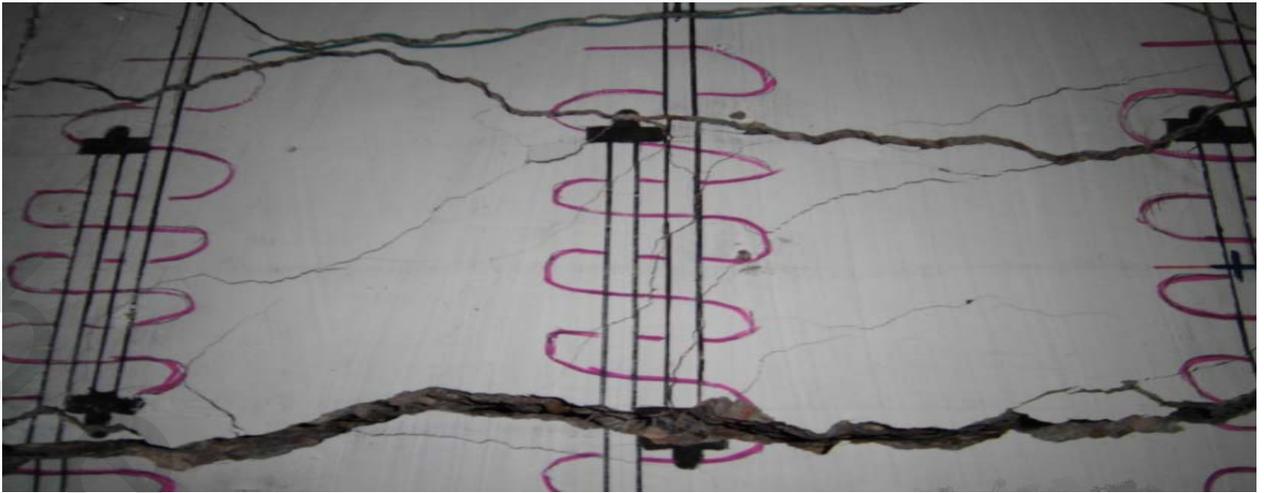
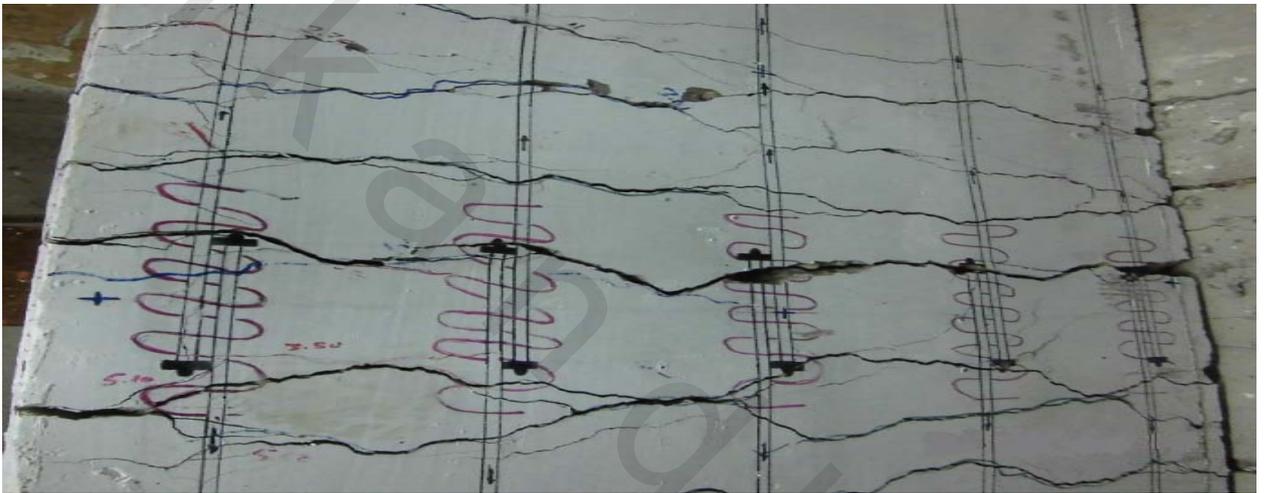
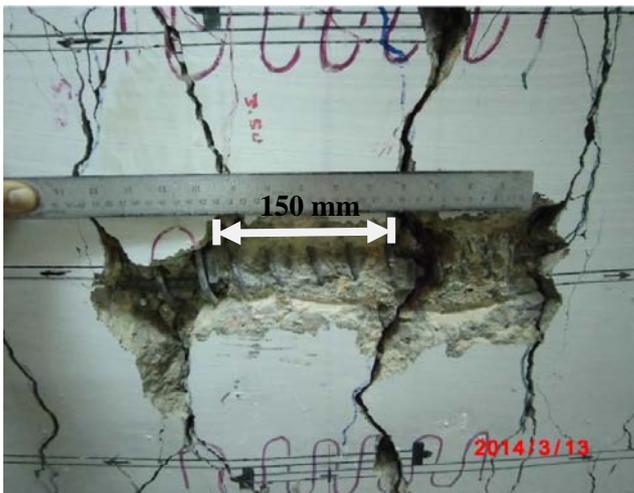
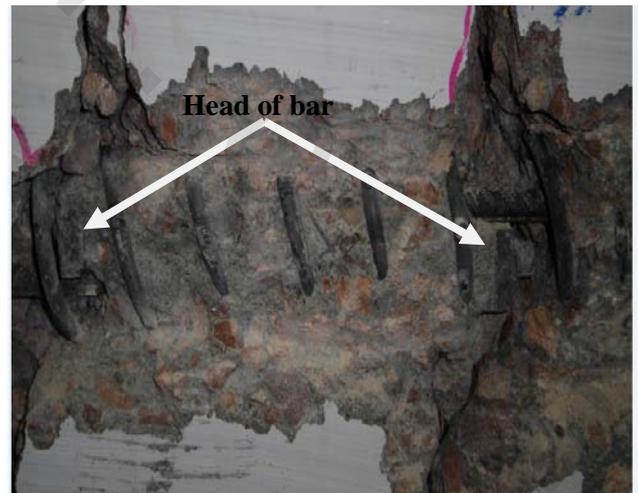
Figure (4-61): Failure of the confined splice slab **AS-9**.

(a) :Cracks became wider and extensive around of confined lap zone at failure.

(b) :Lap zone after finished test and before removed cover.

(c): The concrete around confined zone after removal cover in confined lap zone.

For slab AS-9, provided with circular spiral stirrups around the lap splice, with the same reinforcement details of slab AS-6 but with repeated loading up to failure. Flexural crack appeared at the constant moment zone adjacent of the end of circular spiral stirrup in the first cycle at a load of 25 kN (about 37% of the ultimate load; P_u). In the second cycle, the cracks occurred outside the confined zone and extended up ward at a load of 27.5 kN (about 40% of the ultimate load; P_u). In the third cycle, cracks began to form near the head of bars at the bottom of the specimen at a load of 30 kN (about 44% of the ultimate load; P_u). In the fourth cycle, cracks appeared and extended within the lap zone on the side face of the specimen at a load of 40 kN (about 59% of the ultimate load; P_u). With applying repeated cycles, the cracks formed and initiated outside of the lap zone close to the end of the spiral stirrups. Also, some cracks started near the head of the bar. In the fifth cycle, yield in longitudinal headed bars occurred at a load of 50.7 kN (about 75% of the ultimate load; P_u). The behavior of this specimen was similar to that of slab AS-8 provided with embedded beams around the bar heads. In the sixth cycle, flexural cracks propagated upward to the compression zone. Failure of this slab occurred by crushing of concrete in compression zone at load of 68 kN. Figure (4-60) shows the crack patterns of slab AS-9, and Fig. (4-61) shows the shape of slab AS-9, after testing and removing the concrete cover of the spiral stirrups around the lap zone. It is clear that concrete inside the spiral stirrups zone was not damaged and concrete cover did not spilt off. Figure (4-62) shows the first cracking load for slabs in this group.

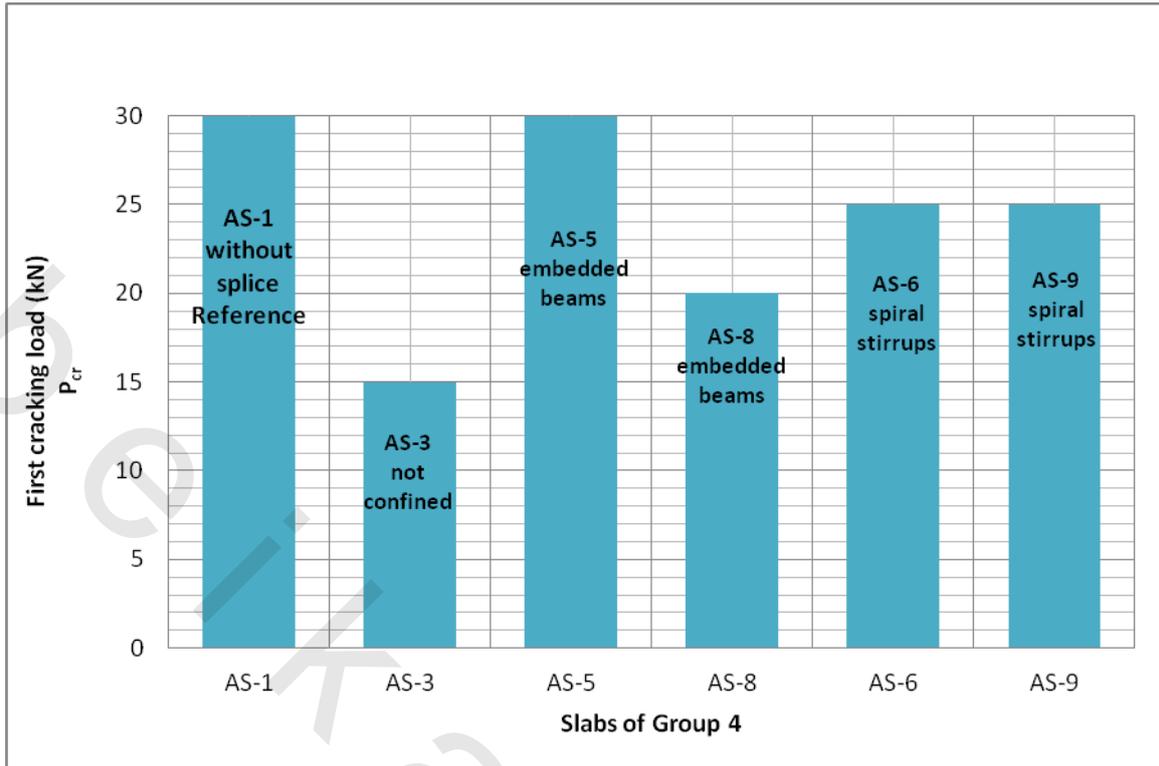
Figure (4-62): First cracking loads for slabs of Group (4).

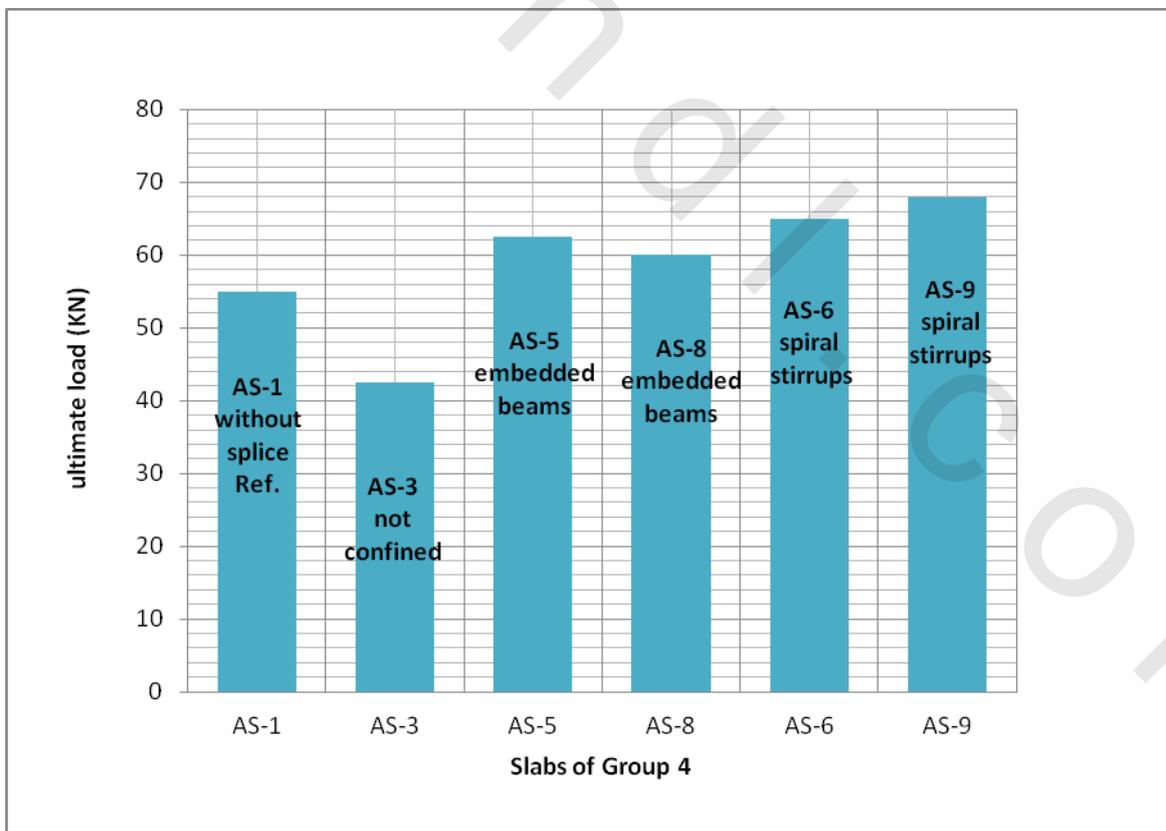
Figure (4-63): Failure loads for slabs of Group (4).

Figure (4-63) shows the failure load for the slabs in this group with confinement in lap splice zone. The failure loads of slabs AS-1 (reference slab), AS-3 (without confinement), AS-5, AS-6, AS-8 and AS-9 were 55.0, 42.5, 62.5, 65.0, 60.0, and 68.0 kN respectively. These slabs

achieved ultimate load of 77%, 114%, 118%, 109%, and 124%, respectively, of that of slab **AS-1** (reference slab). The results indicate that the failure load of slab **AS-3** (without confinement and monotonic loading) reduced by only 23% of that of the reference slab **AS-1**. While using the confinement in the lap splice joint for the specimens, **AS-5**, **AS-6** (with monotonic loading), and **AS-8**, **AS-9** (with repeated loading) increased the ultimate load but the cracks became wider and extensive outside of the confinement lap zone in the specimens **AS-8** and **AS-9** with applying repeated loading. Even though, when repeated loading was applied to slabs **AS-8** and **AS-9**, the ultimate load for these two slabs was higher by 9% and 24% than that of slab **AS-1** (reference slab) respectively. **Figure (4-64)** shows the ratio of experimental ultimate (failure) load to the calculated ultimate load (calculated as 41.5 kN) for the slabs in this group. Slab **AS-3**, without confinement in lap splice zone and monotonic loading, showed 2.4% increase in its ultimate load above the calculated value, while for slab **AS-5** confined with embedded beams around the bar heads and monotonic loading, the ultimate load was higher than the calculated value by 51%. While specimen **AS-8** with the same reinforcement details of slab **AS-5**, but with the application of repeated load, showed 45% increase in its ultimate load above the calculated value. For slab **AS-6** confined with the spiral stirrups around lap splice zone and monotonic loading, the ultimate load was higher than the calculated value by 57%. While specimen **AS-9** similar to slab **AS-6**, but with the application of repeated load, showed 64% increase in its ultimate load above the calculated value.

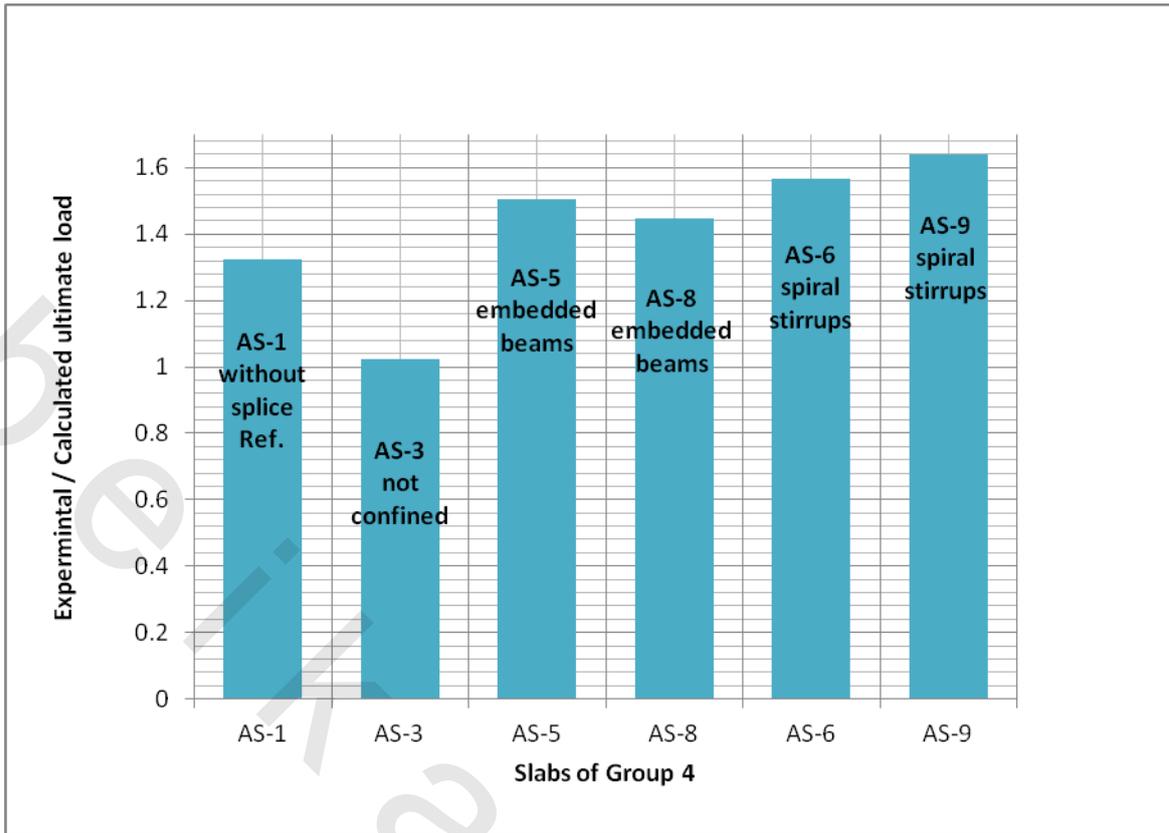
Figure (4-64): (Experimental / Calculated) ultimate loads for slabs of Group (4).

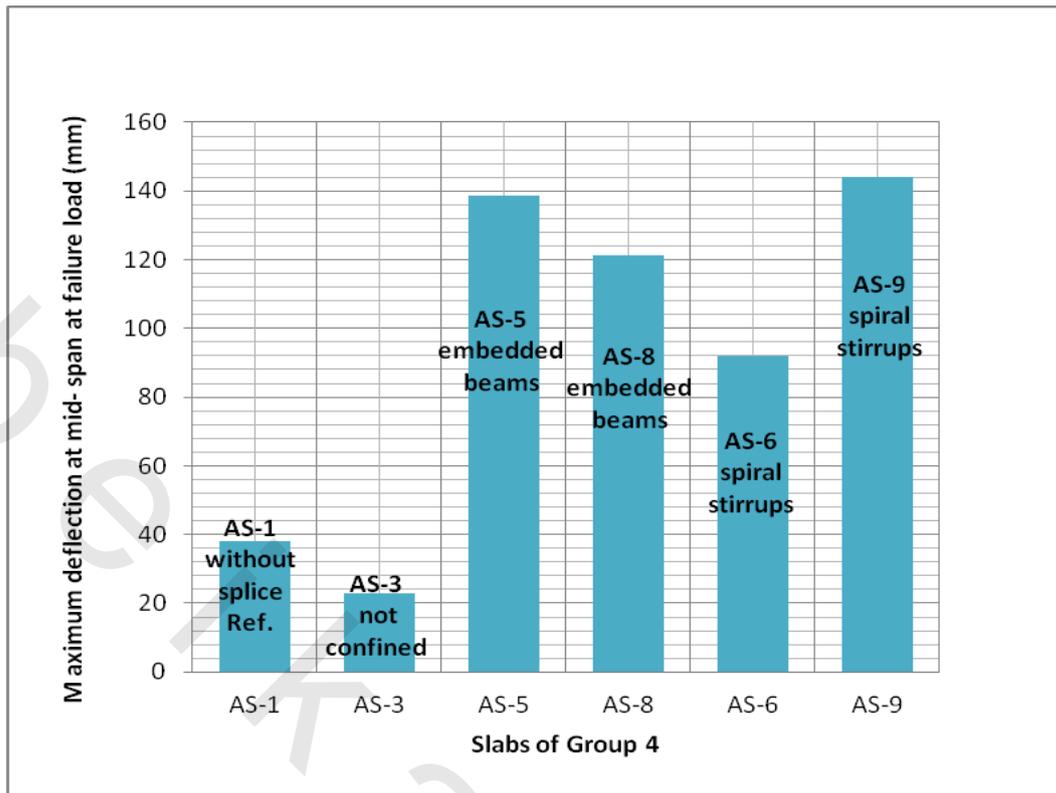
Figure (4-70): Maximum deflection at mid-span at failure load for slabs of Group (4).

Figure (4-70) shows the maximum deflections at mid-span at failure load of the slabs of this group. Slabs **AS-3**, **AS-5**, **AS-6**, **AS-8**, and **AS-9** achieved maximum deflection at failure load equal to 60%, 362%, 241%, 318%, and 377% respectively of that of slab **AS-1** (reference slab). The area under the load-deflection curve is calculated and plotted to measure the maximum energy absorbed by these slabs. **Figure (4-71)** shows the relation between strain energy and confinement. Strain energy achieved by the tested slabs was 1.748, 0.696, 7.229, 4.956, 7.394, and 8.173 kN.m for slabs **AS-1** (reference slab), **AS-3** (without confinement), **AS-5**, **AS-6**, **AS-8**, and **AS-9** respectively. Specimens **AS-8** and **AS-9** were able to dissipate energy, exhibited good ductility, and showed almost stable hysteric loops. Even though the loading was cyclic one, but it can be concluded that strain energy by the slabs increased when using the confinement in the lap zone.

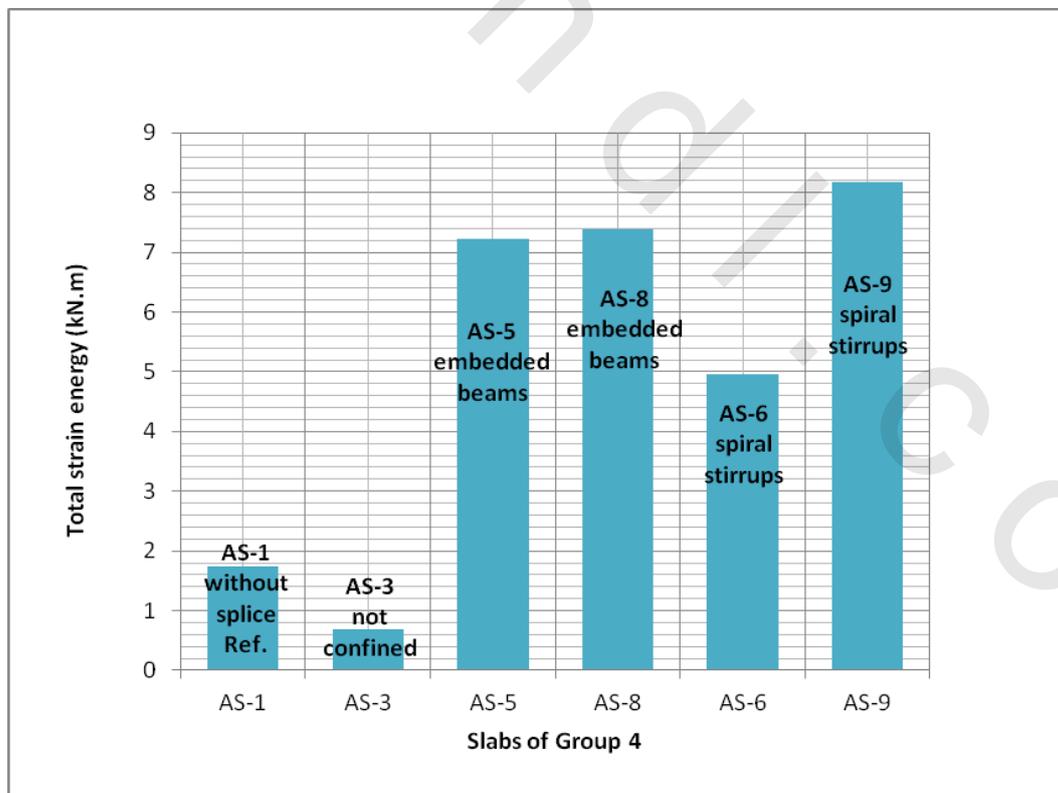
Figure (4-71): Total strain energy for slabs of Group (4).

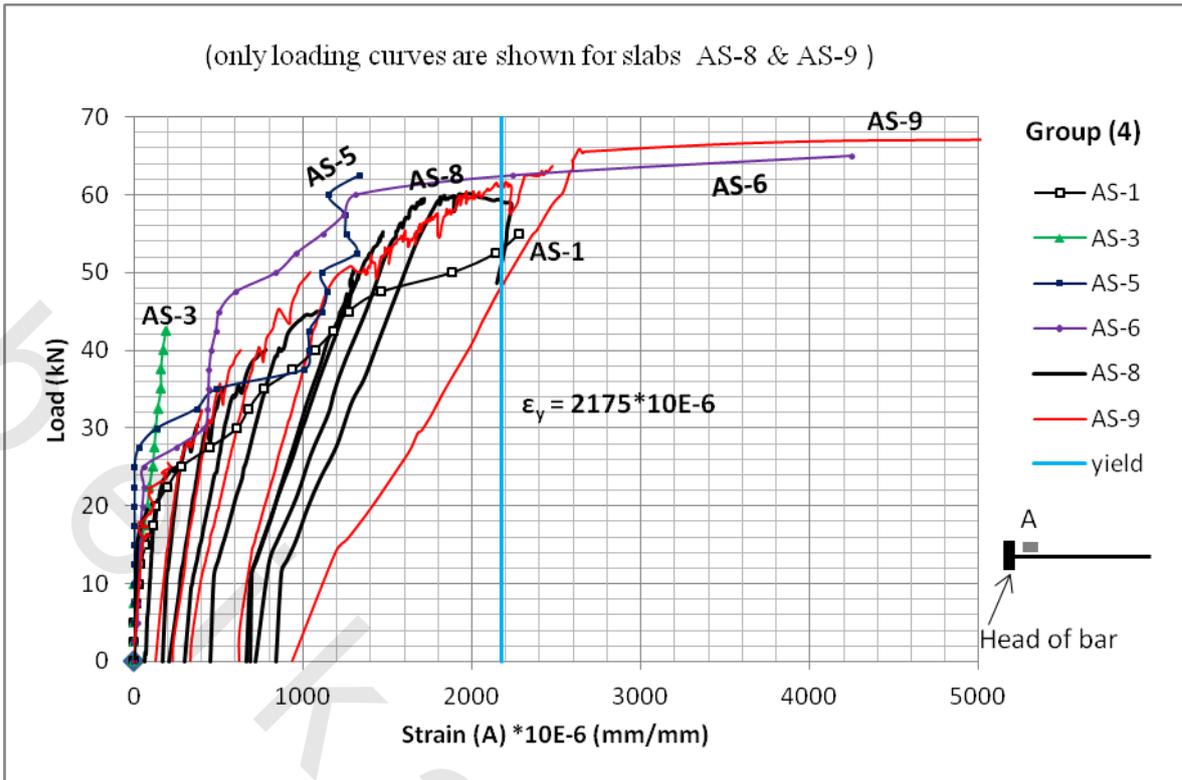
Figure (4-74): Relation between Strain (A) and load for slabs of Group (4).

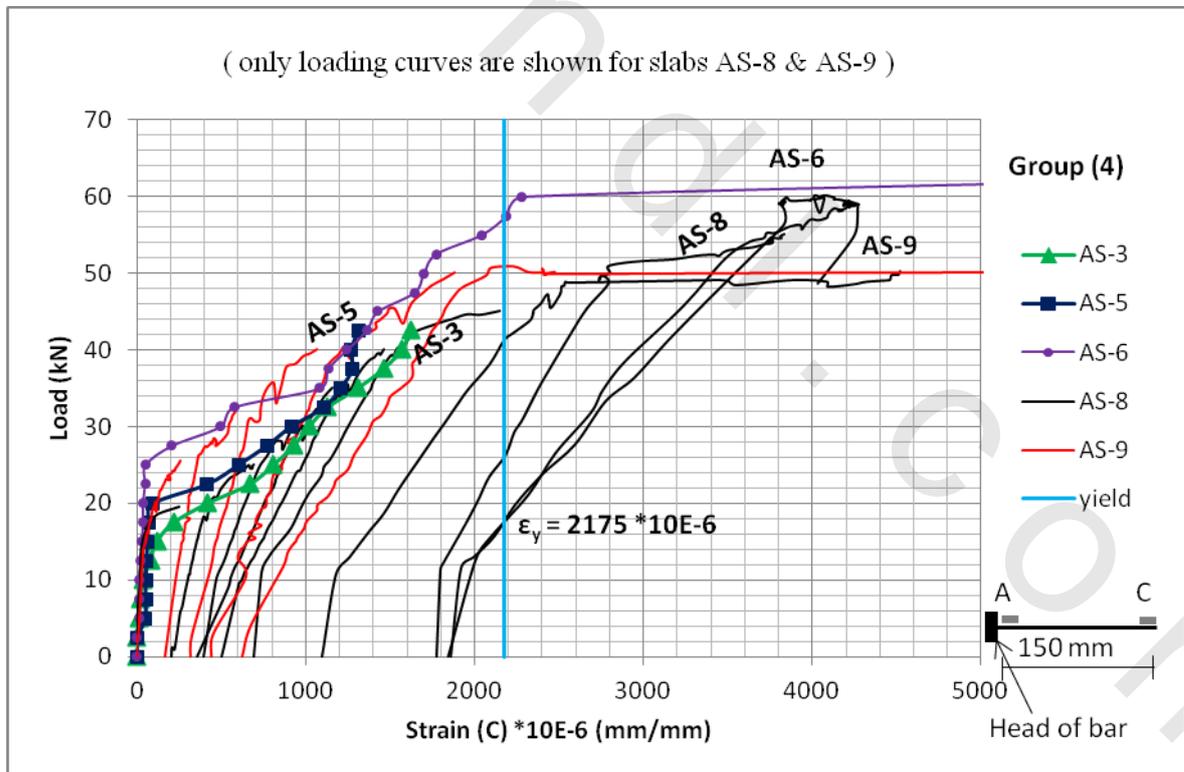
Figure (4-75): Relation between Strain (C) and load for slabs of Group (4).
