AIM OF THE WORK

The aim of this work will be directed to study the role of Multi-Detector Computed Tomography (MDCT) over Conventional Radiography in evaluation and clearing the diagnosis of osseous injuries of the pelvis.

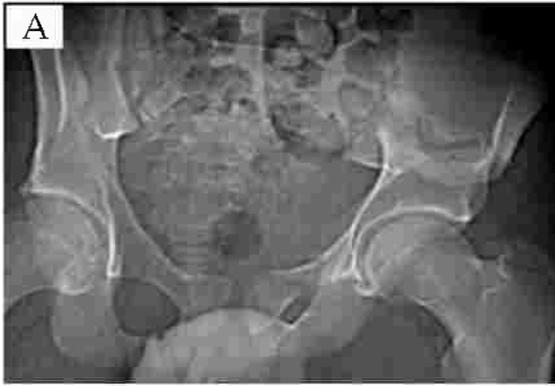
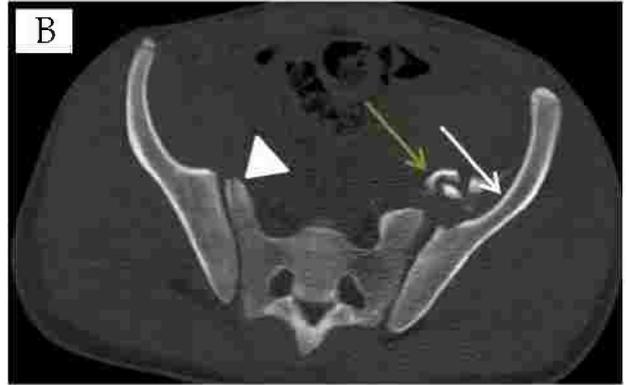
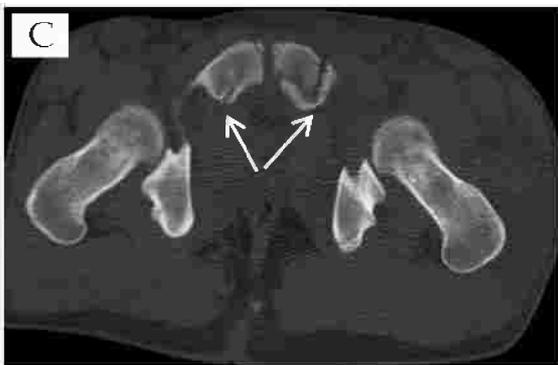
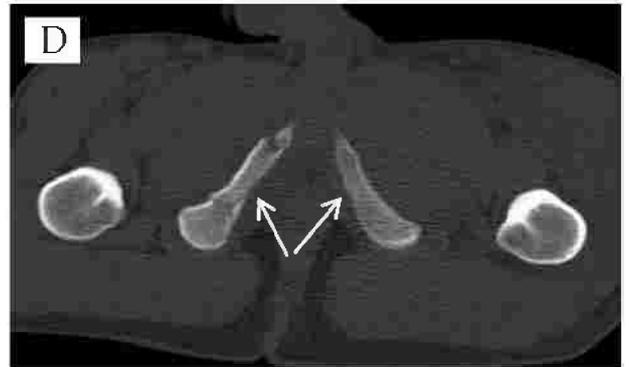
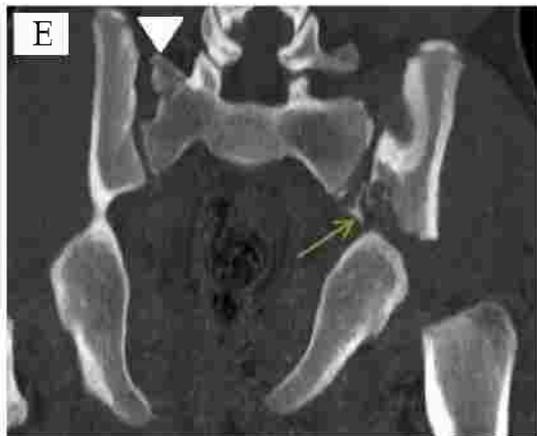
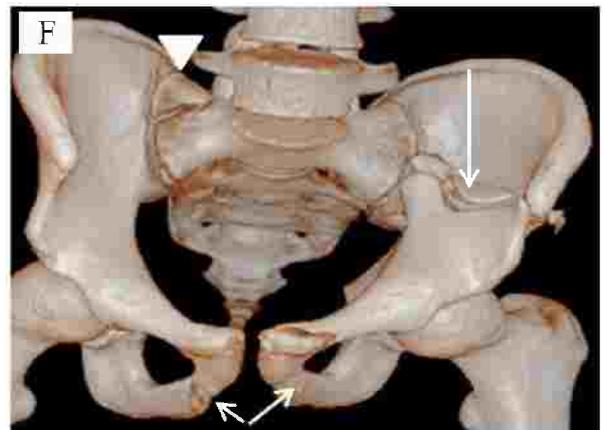
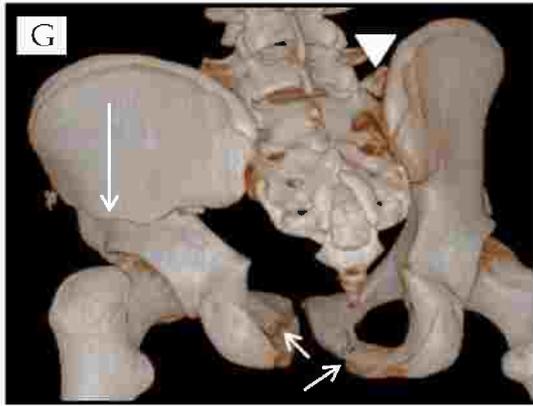
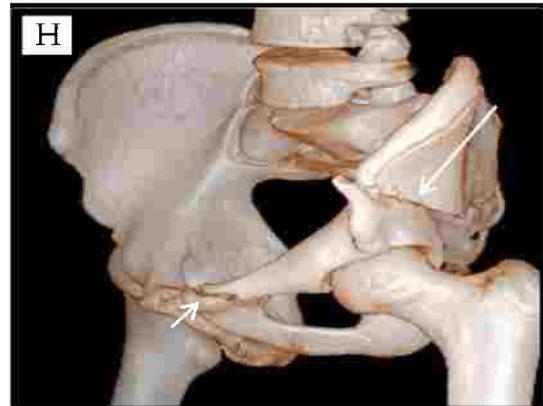
Case (1)

Fig. (30): 16 years old male with history of Falling from height, (A) plain x ray anteriorposterior view, (B, C, D) axial, (E) coronal CT bone windows and (F,G,H) VR images they are showing left iliac wing bone fracture reach the SI joint (long arrows in B,F,G,H) with diastasis anterior of the left SI joint, and sacral fracture (arrow head in B,E,F). Fragment is noted in B and E (Green arrow). There is fracture in both right and left inferior pubic rami (short arrows in C,D,F,G,H).
Conclusion: Lateral compression pelvic fracture (Young classification), Type B2 (Tile classification).

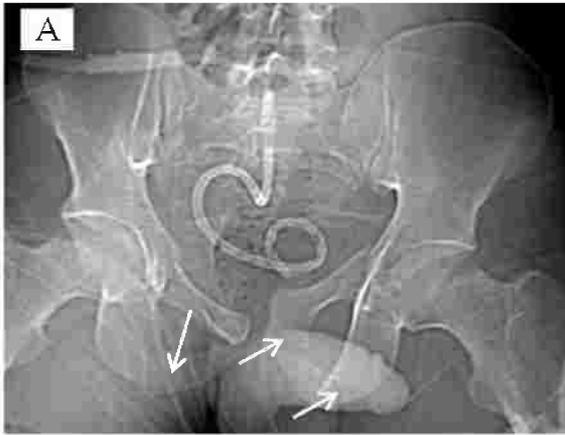
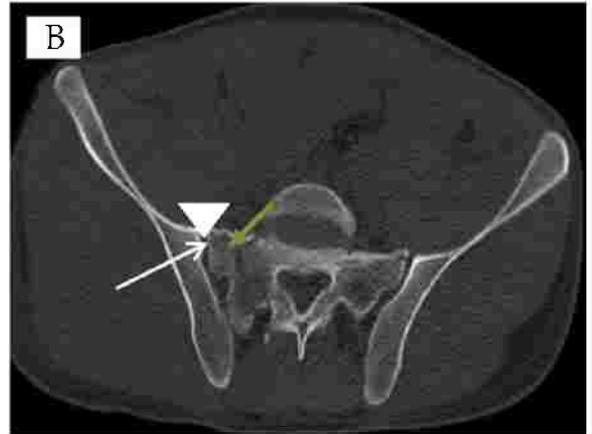
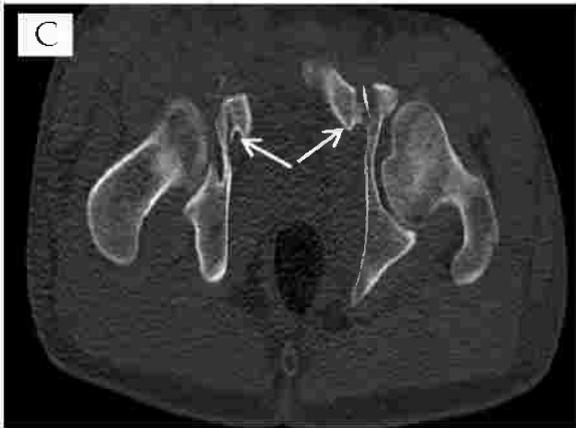
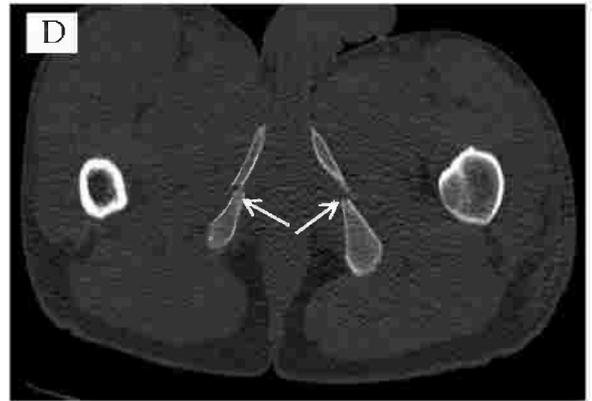
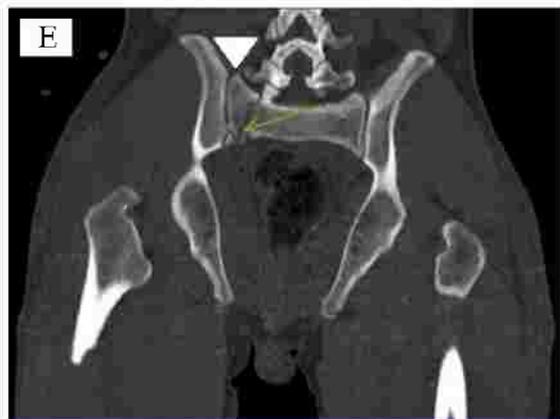
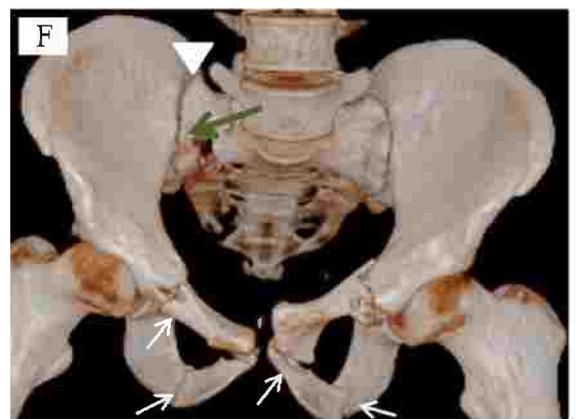
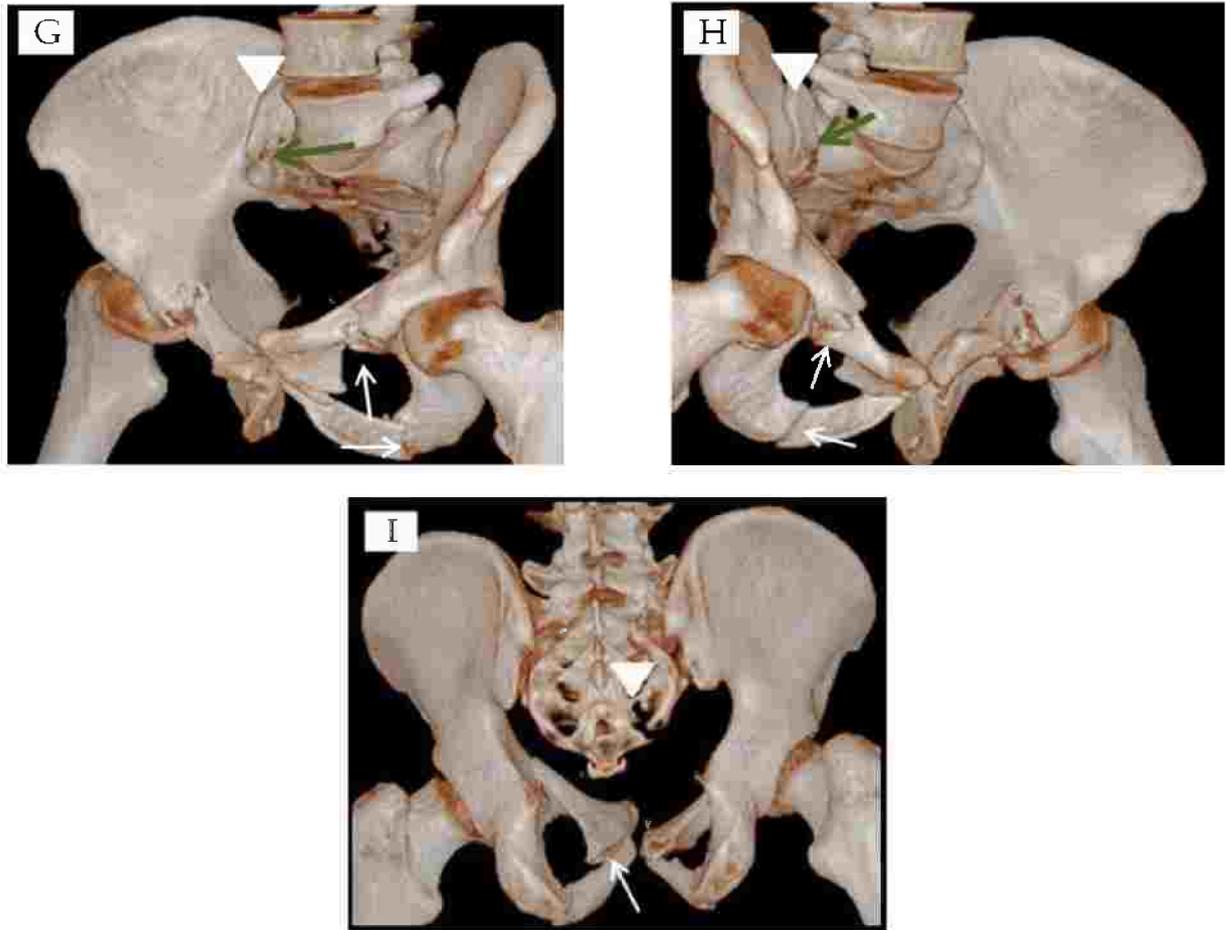
Case (2)

Fig. (31): 23 years old male with history of road traffic accident, (A) plain x ray anteriorposterior view, (B, C, D) axial CT, (E) coronal CT bone windows and (F,G,H, I) VR images they are showing right anterior SI joint diastasis (long arrow in B) with sacral fracture (arrow heads in A,B,E,F,G,H,I) .Both right and left superior and inferior pubic rami are fractured (short arrows in A,C,D,F,G,H,I) , with fragment (Green arrow in B,E,F,G,H). **Conclusion:** lateral compression pelvic fracture (Young classification), Type C1 (Tile classification).

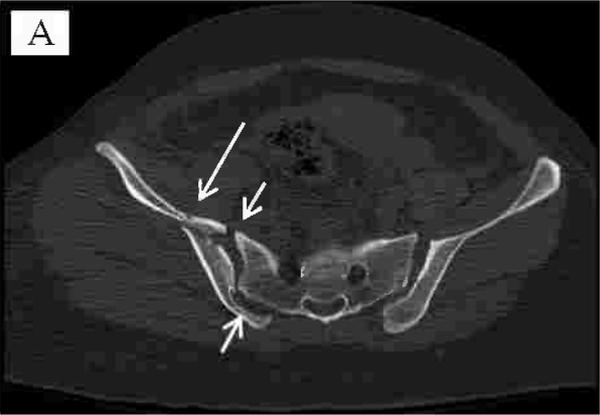
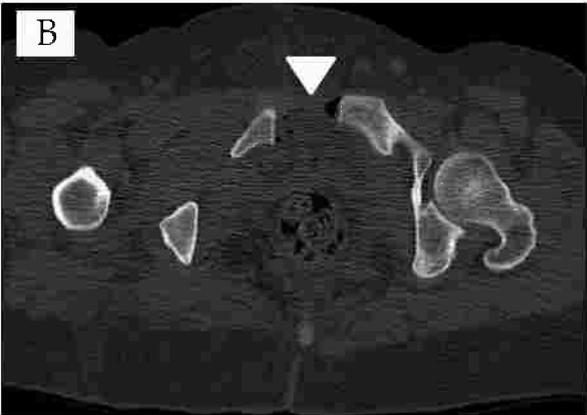
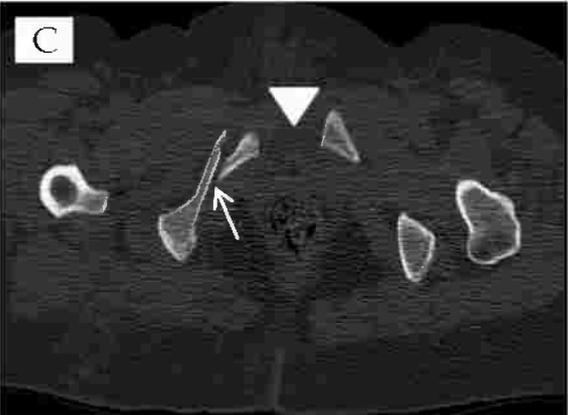
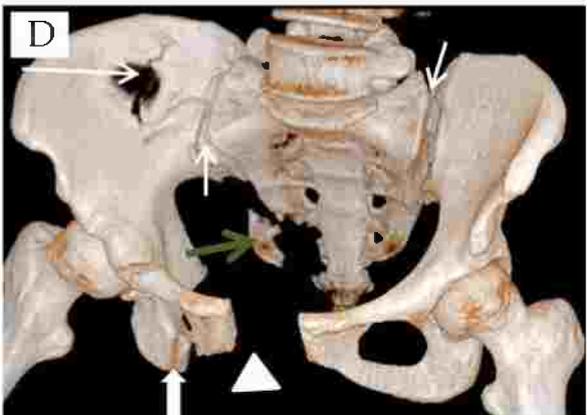
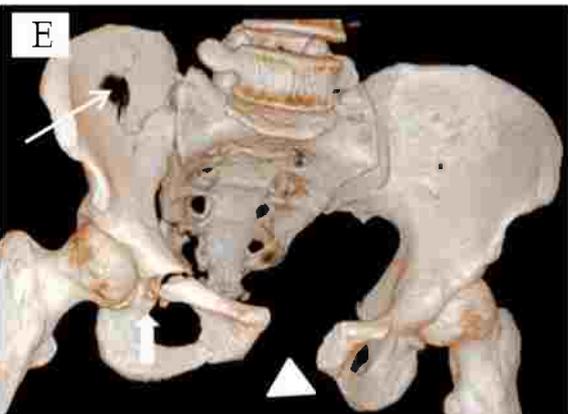
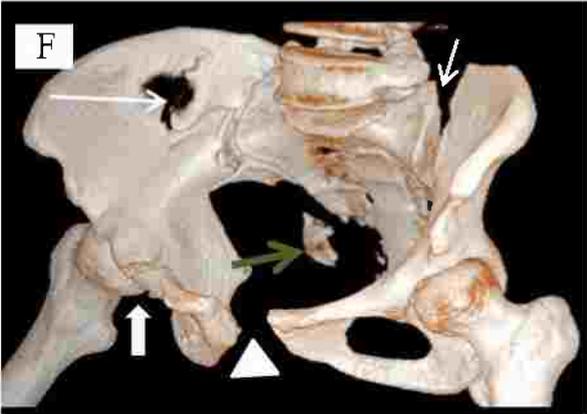
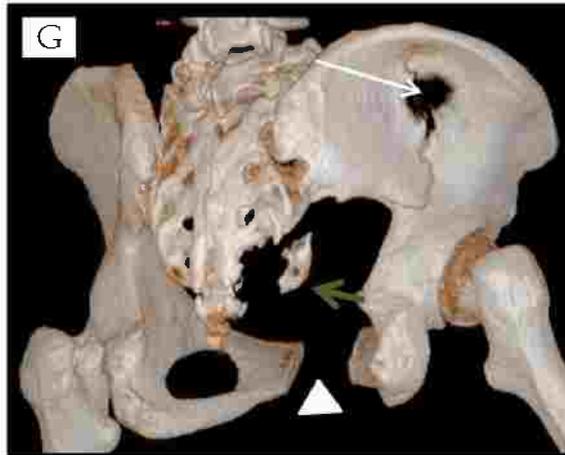
Case (3)

Fig. (32): 35 years old female with history of road traffic accident, axial bone window CT in (A,B,C) and VR in (D,E,F,G) show widening of the symphysis pubis (arrow head in B,C,D) , right iliac wing fracture (long arrow in A,) reach to right SI joint that showed diastasis (small arrow in A,D). There is fracture in both inferior and superior right pubic rami (arrow in C and thick arrow in D,E,F). Fragment is seen in D (Green arrow).
Conclusion: anteroposterior compression pelvic fracture (Young classification), Type B3 (Tile classification).

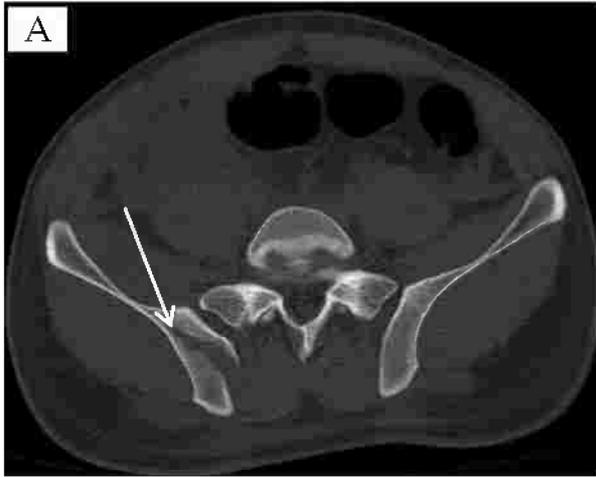
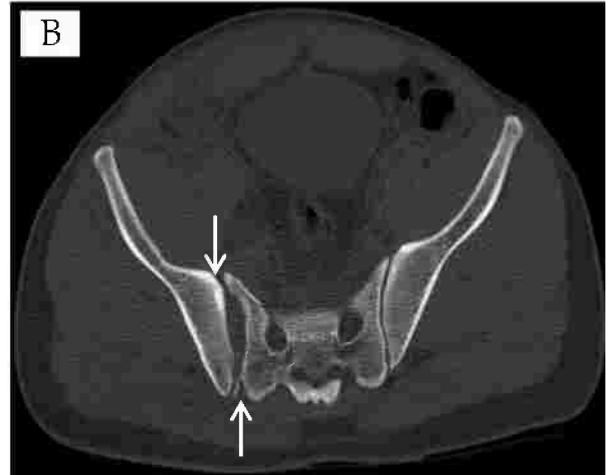
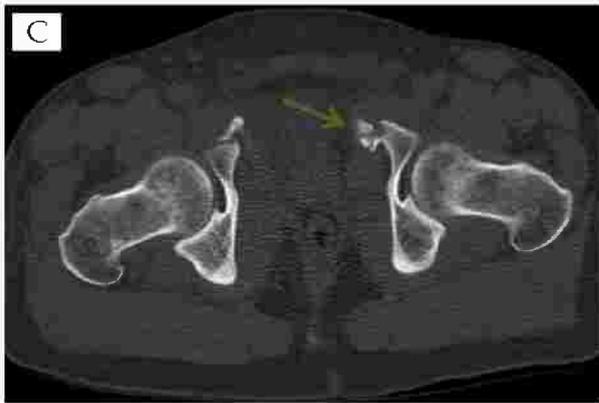
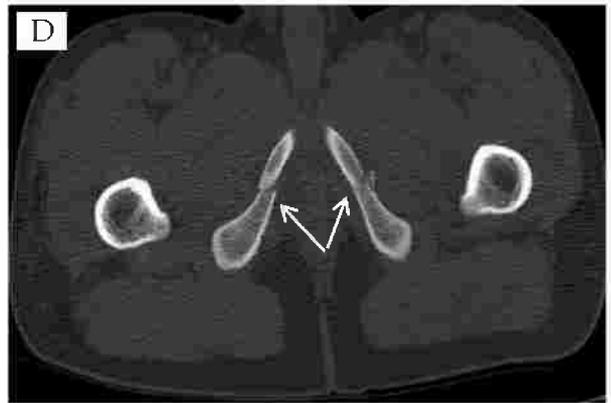
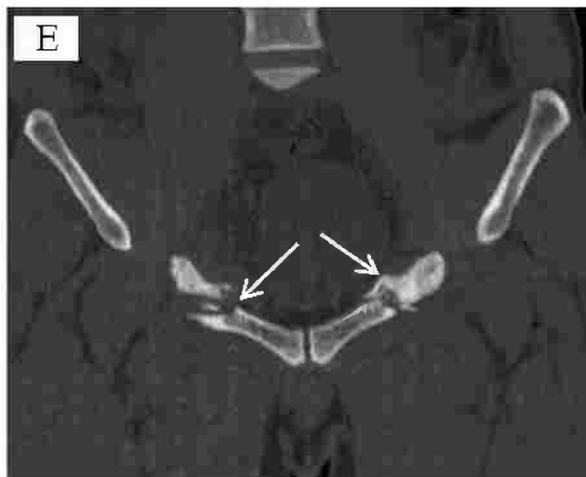
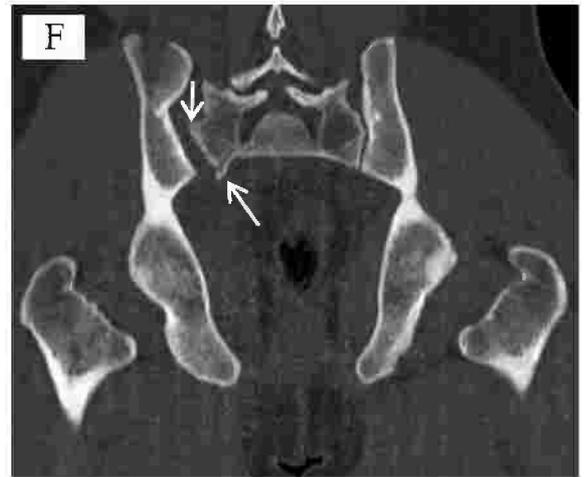
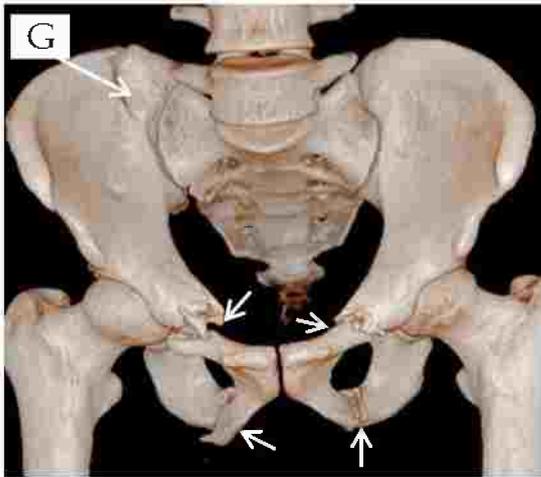
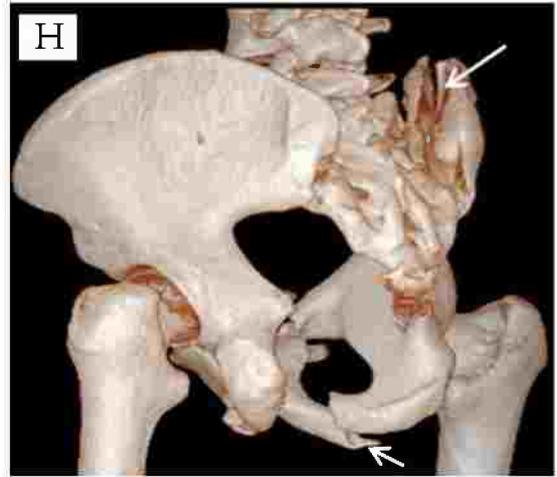
Case (4)

Fig. (33): 23 years old male with history of road traffic accident, (A, B, C, D) axial CT, (E, F) coronal CT bone windows and (G,H) VR images (anterior view in H and posterior oblique view in G) they are showing right iliac bone fracture reaches to the right SI joint (long arrow in A,G,H), the right SI joint diastasis in both anterior and posterior with (short arrows in B). Both right and left superior and inferior pubic rami are fractured (short arrows in D, E,G,H), with fragment (Green arrow in C).
Conclusion: lateral compression pelvic fracture (Young classification), Type C1 (Tile classification).

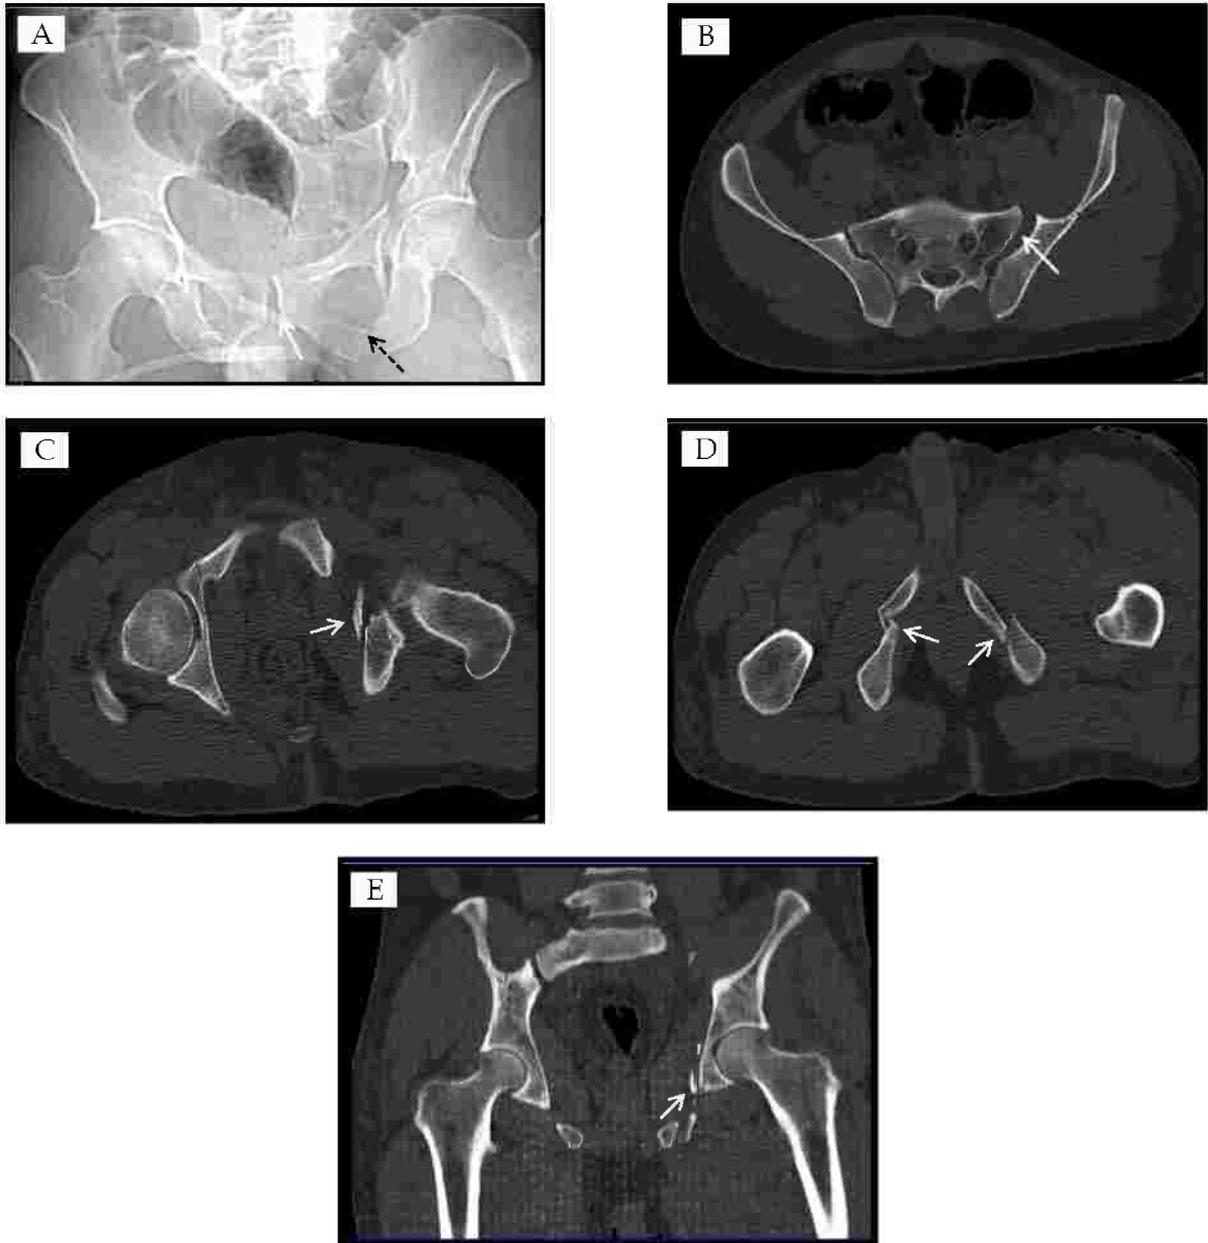
Case (5)

Fig. (34): 30 years old male with history of falling from height, plain x-ray anteriorposterior view in (A) show pubic symphysis diastasis (short white arrow), and a fracture of the left inferior pubic rami (black arrow), (B,C,D) Axial bone window CT of the pelvis showing left sacroiliac diastasis which didn't seen in plain radiography in (B) and both inferior pubic rami in (C,D) , (E) Coronal CT of the pelvis show the fragments.
Conclusion: Vertical shear pelvic fracture (Young classification), Type B2 (Tile classification)
