AIM OF THE WORK

The aim of this work will be directed to study the role of Multi-Detector Computed Tomography (MDCT) over Conventional Radiography in evaluation and clearing the diagnosis of osseous injuries of the pelvis.

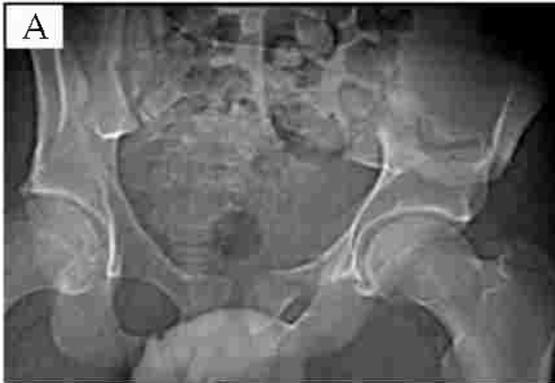
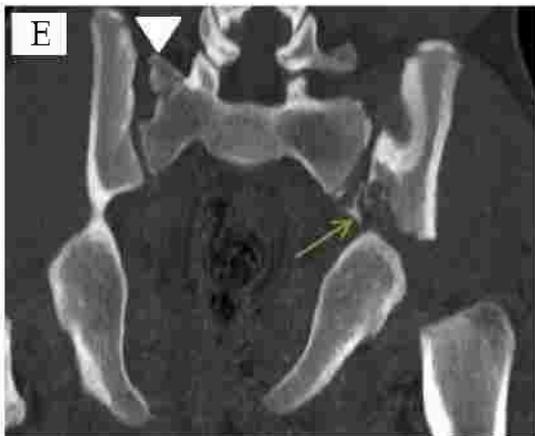
Case (1)

Fig. (30): 16 years old male with history of Falling from height, (A) plain x ray anteriorposterior view, (B, C, D) axial, (E) coronal CT bone windows and (F,G,H) VR images they are showing left iliac wing bone fracture reach the SI joint (long arrows in B,F,G,H) with diastasis anterior of the left SI joint, and sacral fracture (arrow head in B,E,F). Fragment is noted in B and E (Green arrow). There is fracture in both right and left inferior pubic rami (short arrows in C,D,F,G,H).
Conclusion: Lateral compression pelvic fracture (Young classification), Type B2 (Tile classification).

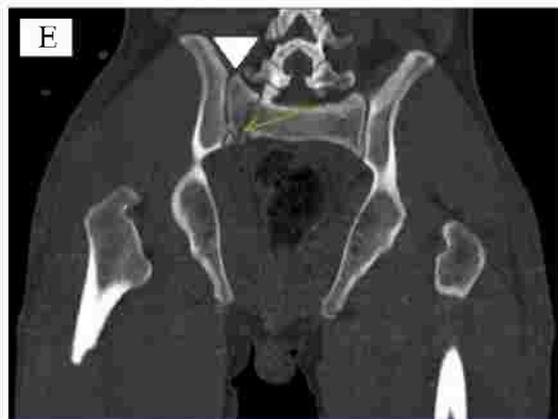
Case (2)

Fig. (31): 23 years old male with history of road traffic accident, (A) plain x ray anteriorposterior view, (B, C, D) axial CT, (E) coronal CT bone windows and (F,G,H, I) VR images they are showing right anterior SI joint diastasis (long arrow in B) with sacral fracture (arrow heads in A,B,E,F,G,H,I) .Both right and left superior and inferior pubic rami are fractured (short arrows in A,C,D,F,G,H,I) , with fragment (Green arrow in B,E,F,G,H). **Conclusion:** lateral compression pelvic fracture (Young classification), Type C1 (Tile classification).

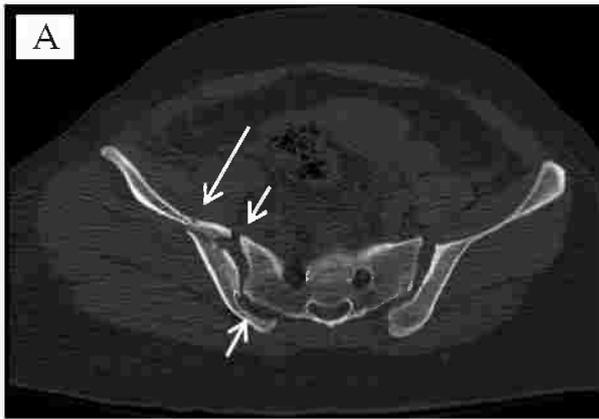
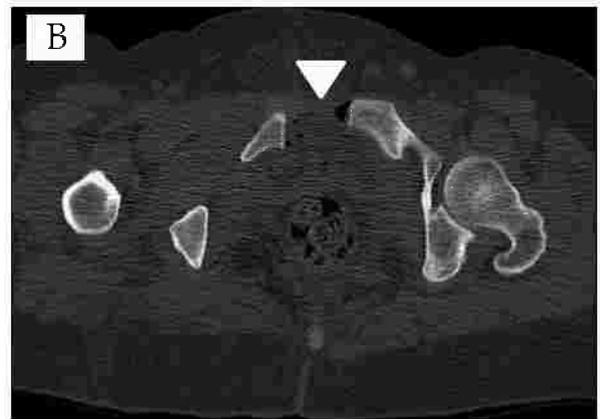
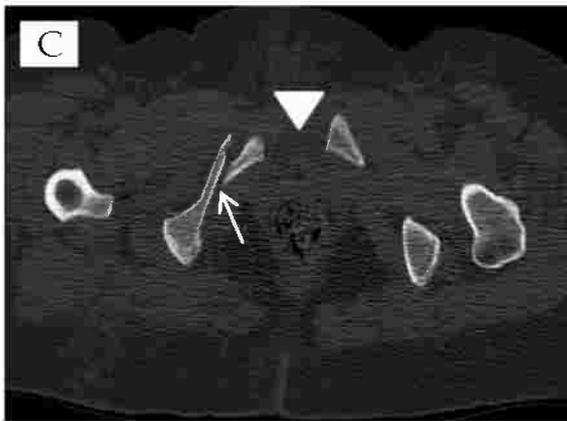
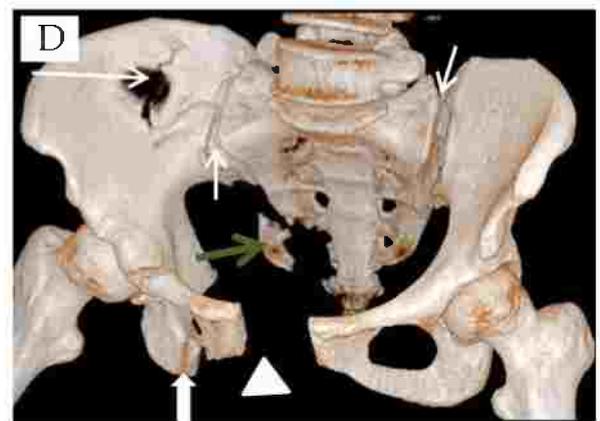
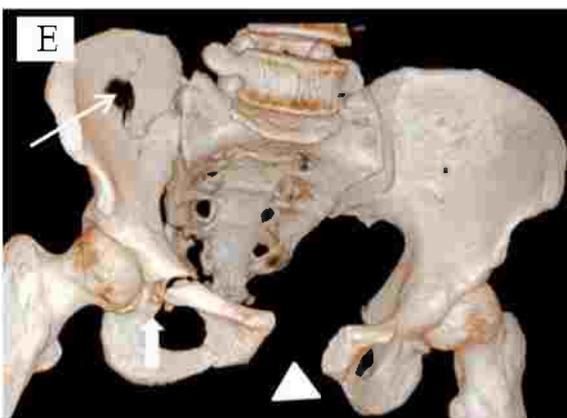
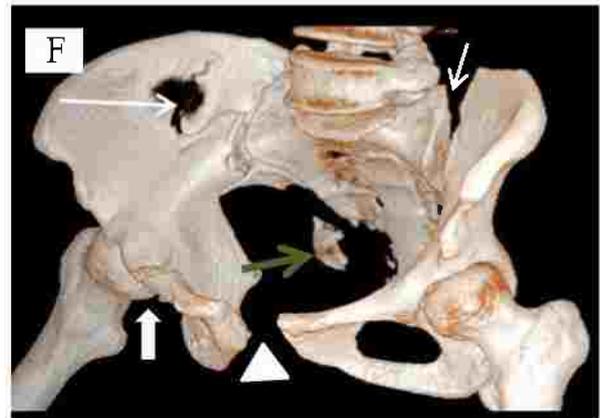
Case (3)

Fig. (32): 35 years old female with history of road traffic accident, axial bone window CT in (A,B,C) and VR in (D,E,F,G) show widening of the symphysis pubis (arrow head in B,C,D) , right iliac wing fracture (long arrow in A,) reach to right SI joint that showed diastasis (small arrow in A,D). There is fracture in both inferior and superior right pubic rami (arrow in C and thick arrow in D,E,F). Fragment is seen in D (Green arrow).
Conclusion: anteroposterior compression pelvic fracture (Young classification), Type B3 (Tile classification).

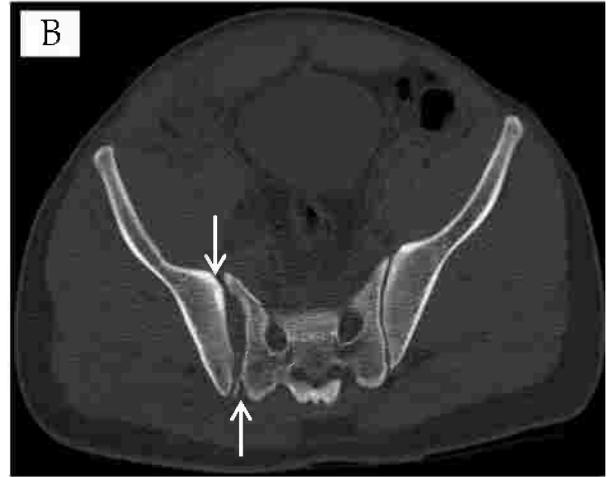
Case (4)

Fig. (33): 23 years old male with history of road traffic accident, (A, B, C, D) axial CT, (E, F) coronal CT bone windows and (G,H) VR images (anterior view in H and posterior oblique view in H) they are showing right iliac bone fracture reaches to the right SI joint (long arrow in A,G,H), the right SI joint diastasis in both anterior and posterior with (short arrows in B). Both right and left superior and inferior pubic rami are fractured (short arrows in D, E,G,H), with fragment (Green arrow in C).
Conclusion: lateral compression pelvic fracture (Young classification), Type C1 (Tile classification).
