AIM OF THE WORK

The ultrasonographic results of 30 patients with hyperechoic lesions

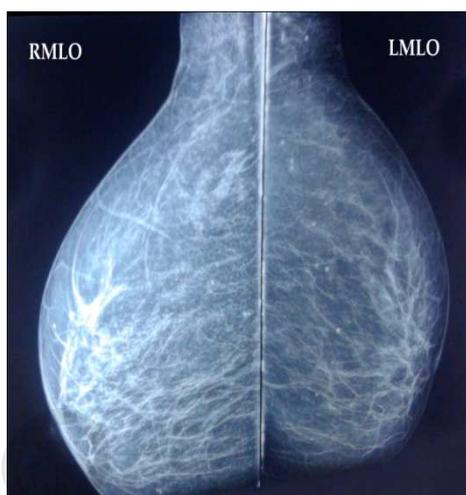
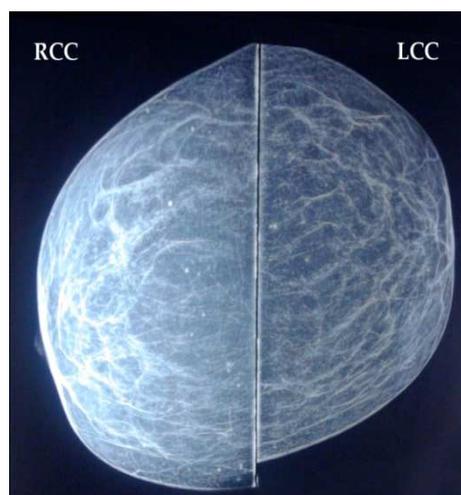
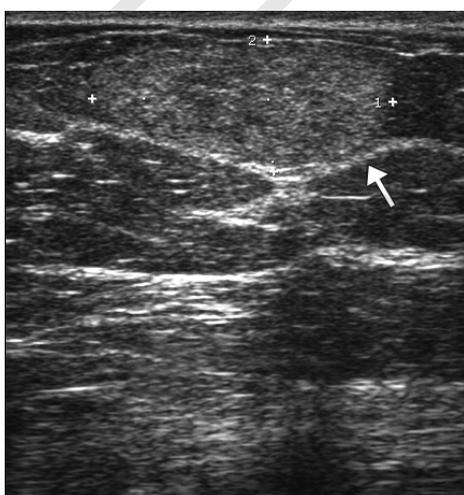
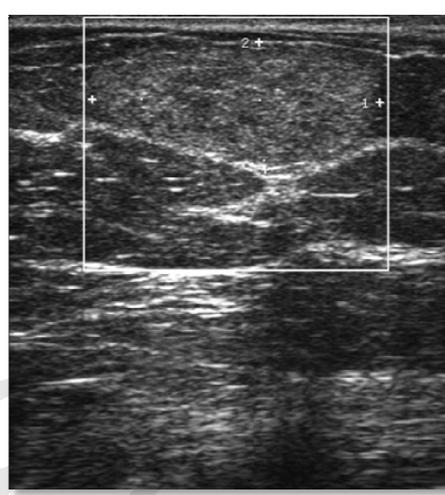
Figure (30): A female patient aged 39 years with breast lump in the upper outer quadrant of the right breast.

C- Sonomammography showed a mass lesion located in the upper outer quadrant sized 2.5 x1.7 cm with oval shape, well defined margins, homogenous pattern and hyperechoic echotexture, Histopathologically this lesion was diagnosed as capsulated breast lipoma.

D- Doppler ultrasound shows negative doppler signal.

Ten/ 30 patients were diagnosed histopathologically as lipomas, on US they showed oval shape, well defined margins, homogenous pattern and hyperechoic echotexture with no posterior shadowing and lack of Doppler blood flow. These sonographic findings came in concordance with the histopathological diagnosis as benign lesions. So US succeeded in prediction of the benign nature of the lesions (true negative) 100% US diagnostic accuracy (fig.30).

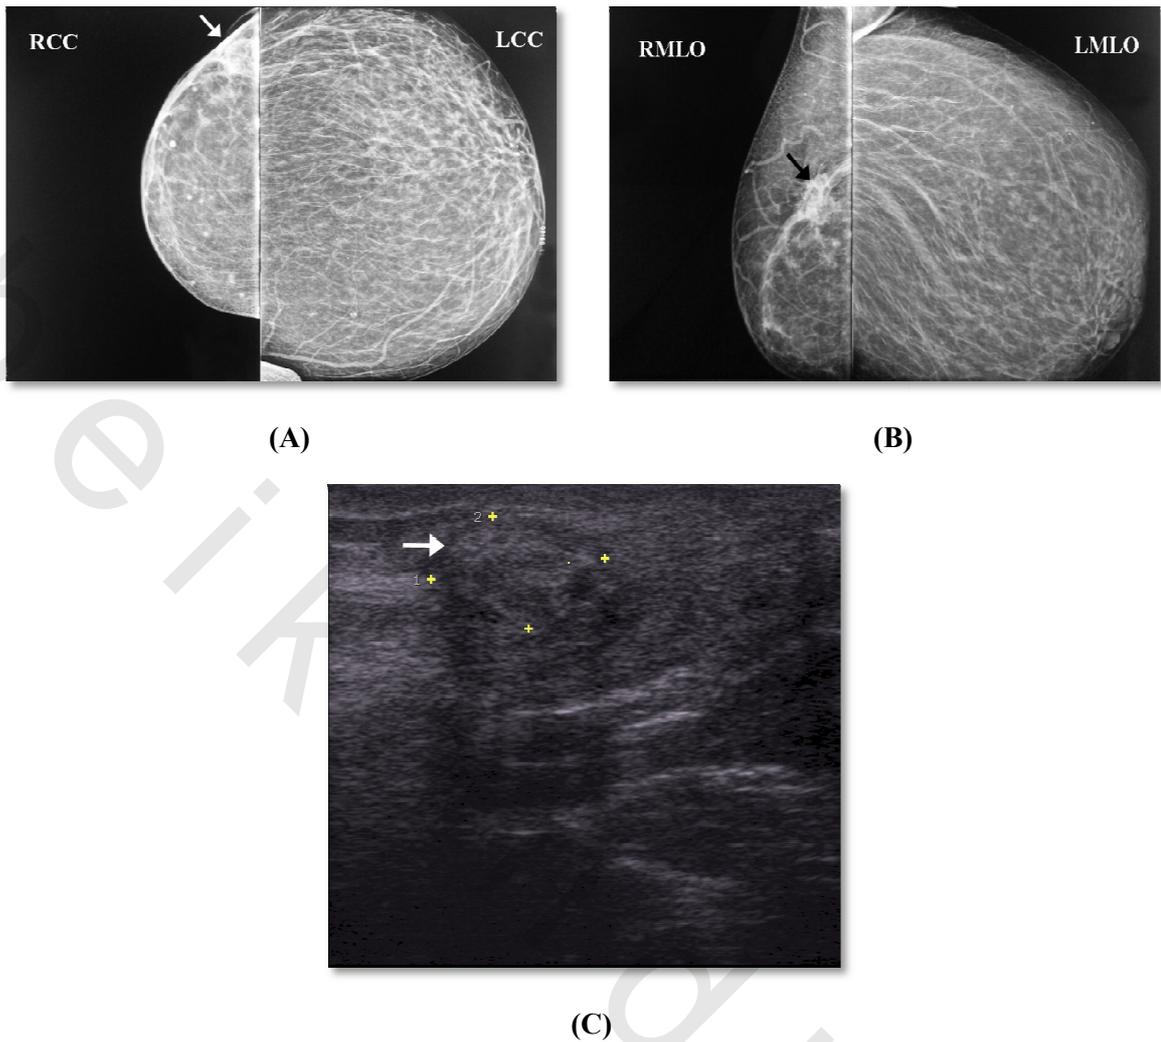
Figure (31): Female patient aged 62 years complaining of breast lump in the upper outer quadrant of the right breast and had history of lumpectomy for breast cancer in the same breast.

A&B- Mammography showed a globular fat containing lesion in the upper outer quadrant with surrounding fibrosis.

C- Sonography showed a mass lesion with oval shape, well defined margins and heterogenous predominately hyperechoic echotexture in the form of echogenic back ground with multiple oil cysts, depending upon these benign features a sonographic diagnosis of traumatic fat necrosis was established. This diagnosis was confirmed by histopathology.

Histopathological diagnoses in 7/30 hyperechoic lesions were traumatic fat necrosis, the sonographic findings of these patients' lesions were oval shape, well defined margins, heterogenous pattern but mainly hyperechoic and no posterior shadowing were detected in these lesions, Doppler blood flow was absent in such lesions. The sonographic findings and histopathological diagnosis were concordant, so US succeeded in prediction of the benign nature of the traumatic fat necrosis (true negative) 100% diagnostic accuracy (fig.31).

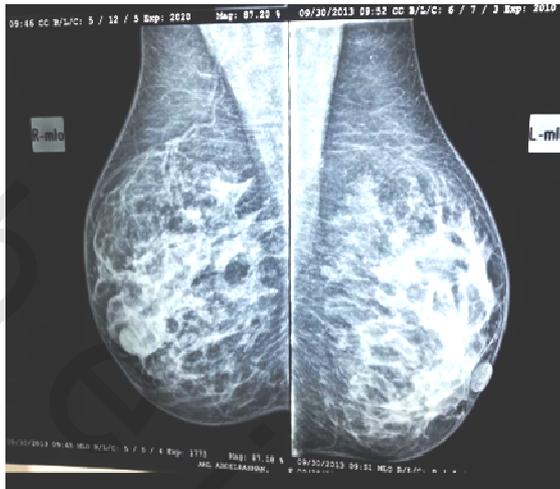
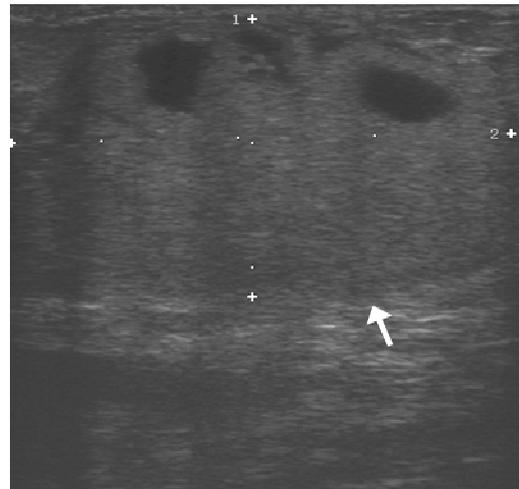
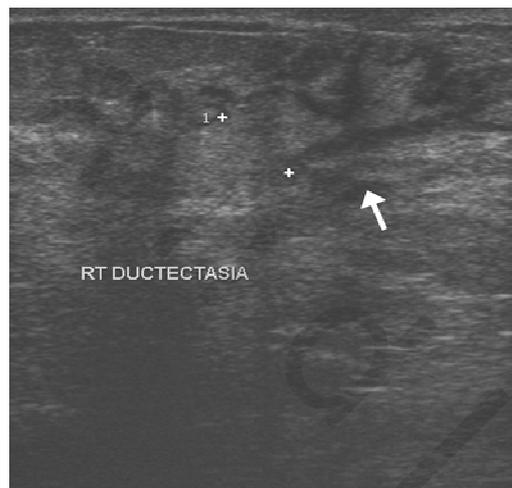
Figure (32): A female patient aged 25 years was complaining of breast pain , she was lactating.

A- Mammography: MLO view showed dense lactating breast in which there is no definite focal masses. (non conclusive)

B&C- A background of duct ectasia,, some of the ducts distended by echogenic contents forming rather well defined oval shaped echogenic mass lesion about 3.6 x 2.2 cm suggested by US and proved by histopathology to be lactational galactocele.

Focal mastitis was the histopathological diagnosis of 3/30 patients (fig.33), and galactocele was the histopathological diagnosis of other 3/30 patients (fig.32), in all of these patients US showed oval shaped, well defined, hyperechoic, homogenous lesion with no posterior shadowing, in these lesions there were no Doppler flow but vascularity and Doppler flow were prominent in inflamed tissues surrounding these lesions. These US findings predicted benignity of these lesions which was confirmed by histopathology, therefore US succeeded in prediction of the benign nature of these lesions (true negative for malignancy).

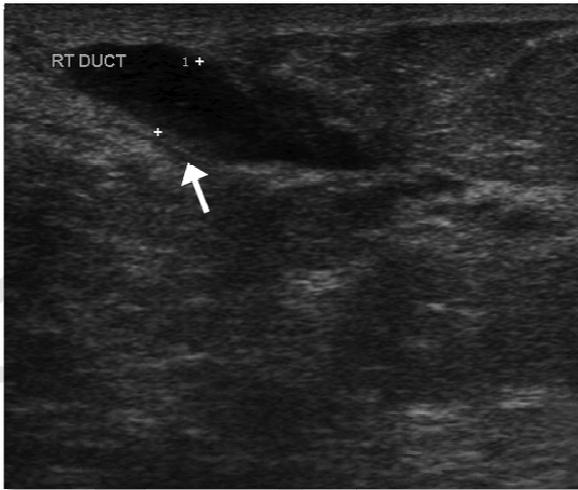
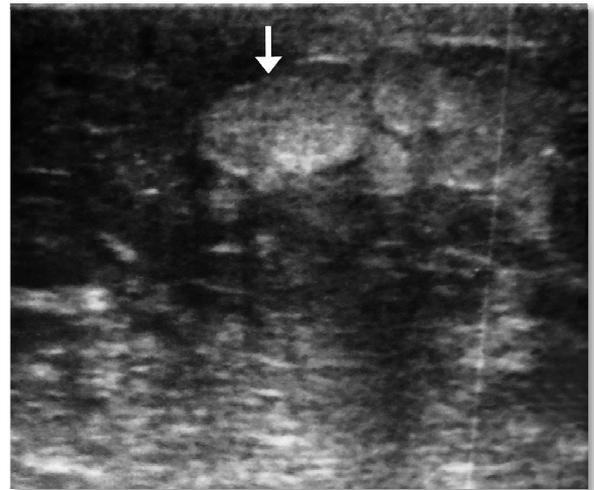
Figure (33): A female patient aged 23 years complaining of right mastalgia, with some focal skin change such as redness and oedema. She was lactating. Mammography was not done for this patient.

A&B: Ultrasound pictures of the right breast showing lactational duct dilatation associated with mild overlying skin thickening in (A), nearby interstitial oedema and hyperechoic fat lobules are demonstrated in B, no associated tissue necrosis nor abscess formation. Features were interpreted as purpural mastitis confirmed by histopathological findings.

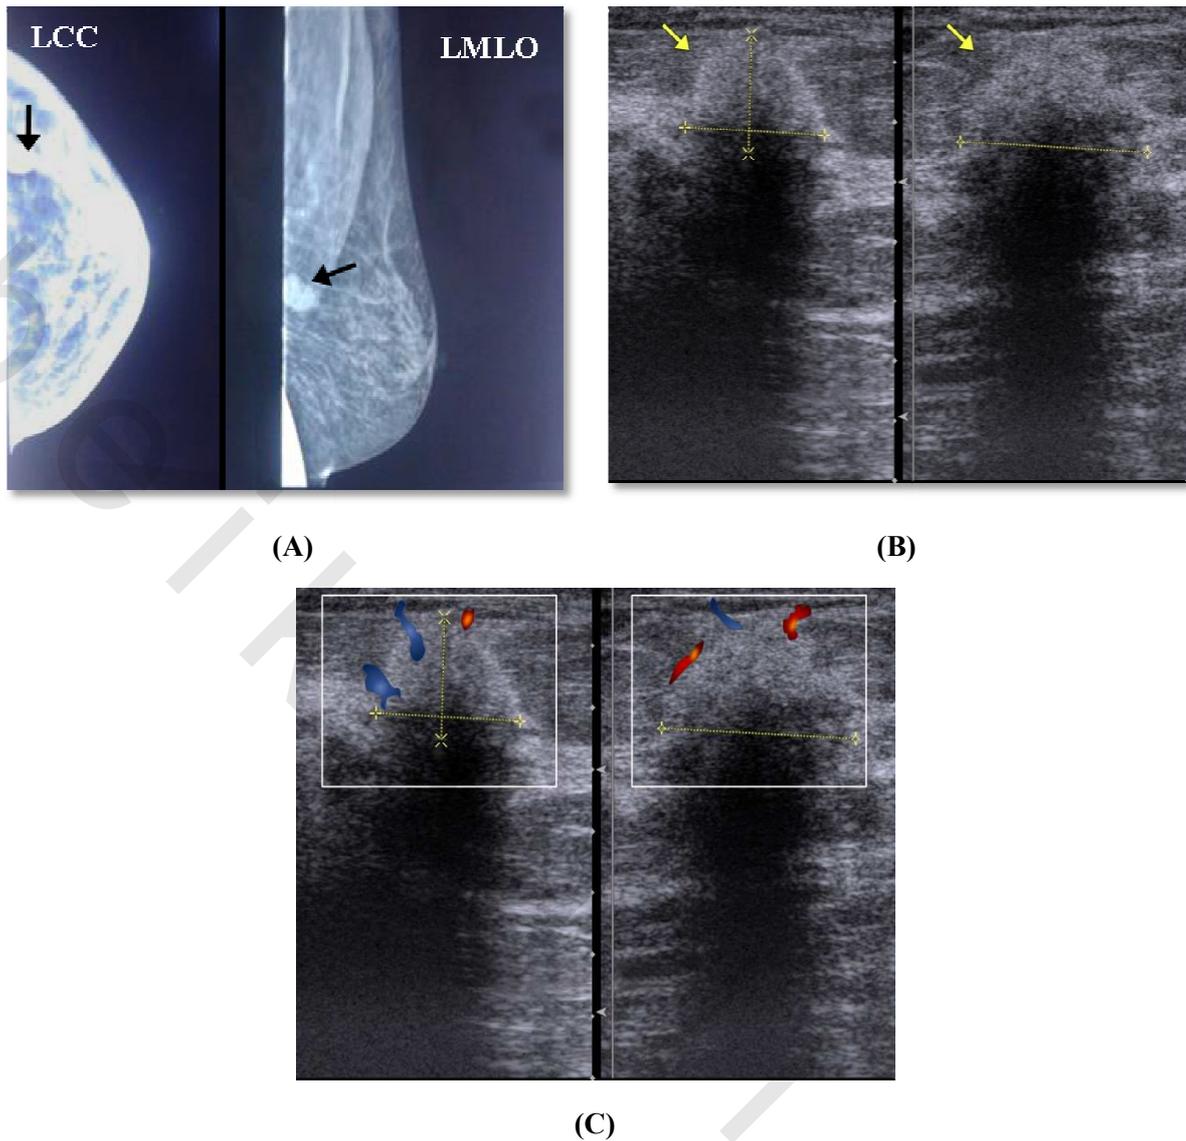
Figure (34): A female patient aged 71 years complaining of breast lump in the upper outer quadrant of the left breast, she had a history of breast cancer on the contralateral breast which was managed by mastectomy followed by radiotherapy.

A- Mammogram of the left breast showed an irregular mass lesion diagnosed as infiltrating ductal carcinoma.

B- Ultrasonographic picture of the lesion showed its irregular ill defined margins, hyperechoic pattern with hypoechoic nidus inside and posterior wall loss of definition with dense posterior shadowing. Ultrasonographic diagnosis was infiltrating ductal carcinoma which was confirmed by histopathology.

C- Doppler ultrasound shows positive intralesional doppler signal.

Infiltrating ductal carcinoma was the histopathological diagnosis of 4/30 patients whose ultrasonographic findings were irregular shape, ill defined margins, heterogenous pattern and hyperechoic echotexture was the main, posterior shadowing was also found in these lesions, these lesions showed prominent vascularity and increased Doppler blood flow. The sonographic findings here succeeded in prediction of the malignant nature of these lesions (true positive for malignancy) (fig.34).

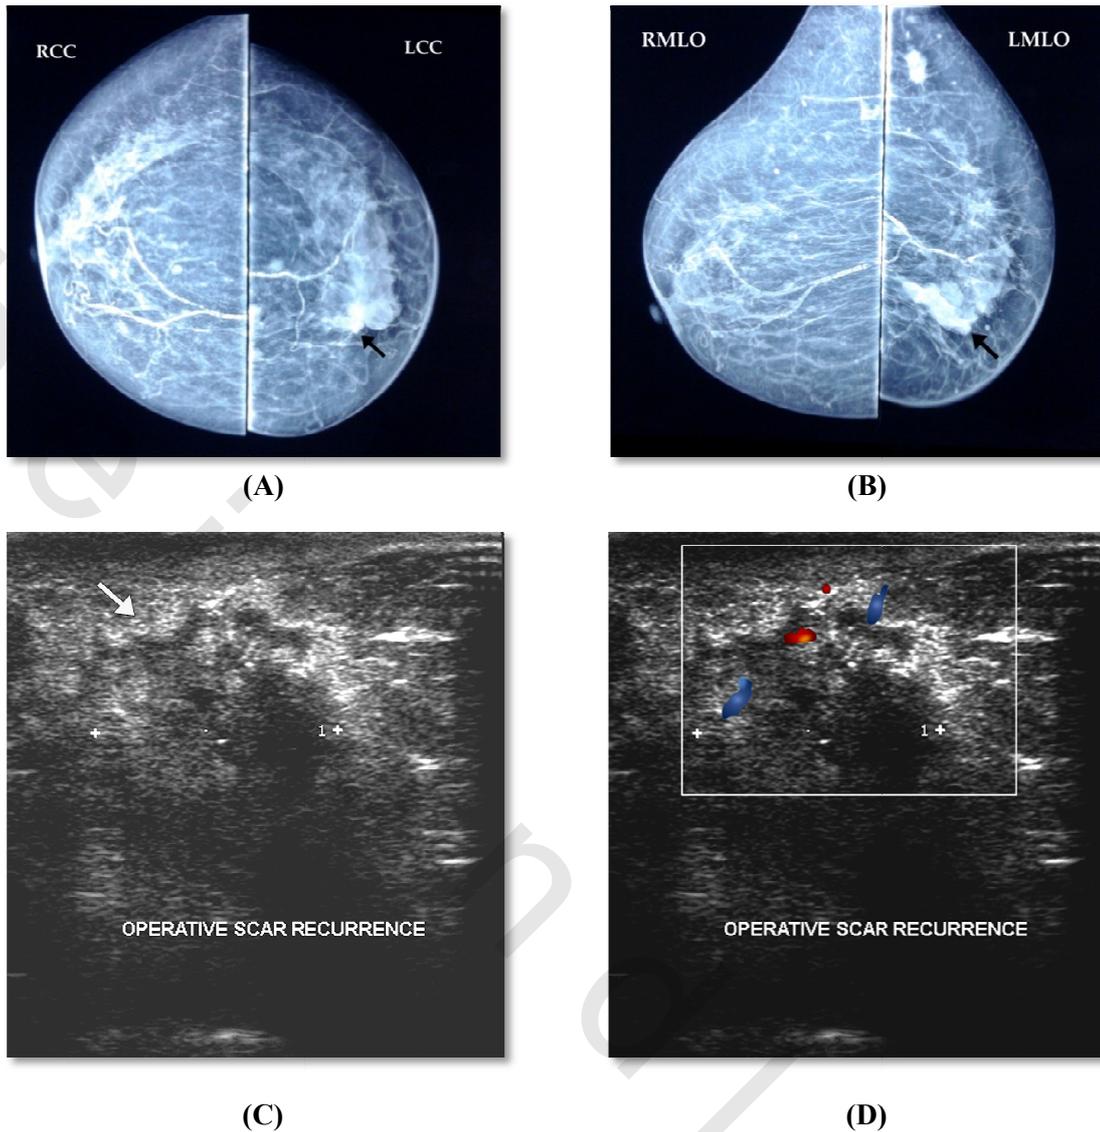
Figure (35): Female patient aged 72 years she had a history of breast cancer managed by lumpectomy followed by radiotherapy during follow up of the surgically managed side it was found that:

A&B- Craniocaudal and mediolateral oblique mammographic images of both breasts. The left breast showed multiple irregular mass shadows occupying retroareolar and upper lateral sector expressing spiculated margins with peritumoral lipomatosis features favor the diagnosis of multicentric recurrent malignancy, noted also mild diffuse left breast skin thickening attributed to previous surgery and radiotherapy.

C- Ultrasonographic picture of the retroareolar mass shadow detected by mammography showing shaggy ill defined irregular margins hyperechoic pattern with a hypoechoic central nidus inside, loss of definition of the posterior wall and posterior acoustic shadowing (diagnosed as infiltrating ductal carcinoma).

D- Doppler ultrasound showed intralésional doppler signal and prominent vascularity.

The other upper outer quadrant malignant mass detected by mammography was hypoechoic on US, so not included in the study. Histopathology confirmed the diagnosis of infiltrating ductal carcinoma of heterogenous hyperechoic retroareolar lesions.

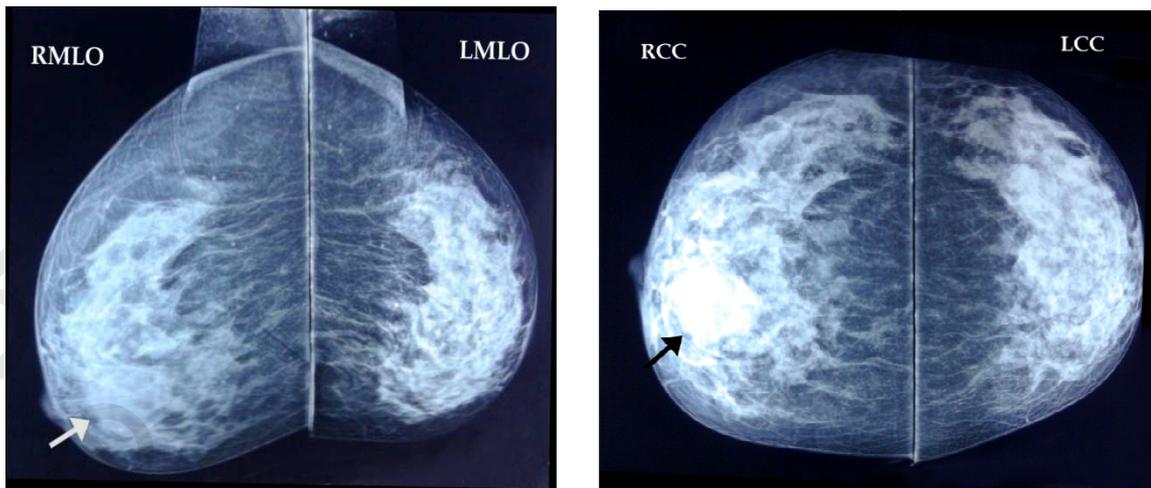
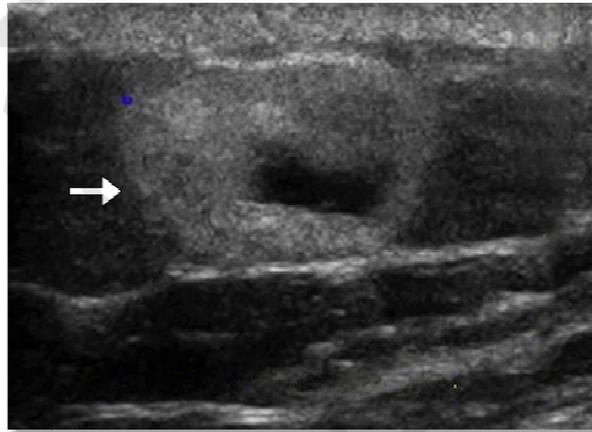
Figure (36): A female patient aged 53 years complaining of breast lump in the retro areolar region, she gave a history of breast trauma.

A&B- Mammography showed a well defined mainly oval shaped mass occupying the inferomedial sector of the right breast and heterogeneously increased mammographic density with no calcifications or overlying breast changes.

C- Ultrasonographic picture of the lesion revealed an oval shaped well defined predominately hyperechoic mass showing an irregular internal hypoechoic component showing ill defined margins with morphological dependent fluid fluid level suggested by ultrasound to be organized hematoma. A diagnosis which was not reported by mammography although the lesion was mammographically diagnosed as benign lesion.. Aspiration cytology findings confirmed the diagnosis of breast hematoma.

Hematoma (fig.36) and infected seroma were the histopathological diagnoses of 2/30 hyperechoic lesions, sonographically they were oval, well defined, heterogenous (mainly hyperechoic). These sonographic findings were confirmed by histopathology so US succeeded in prediction of these lesions' benign nature (true negative for malignancy).

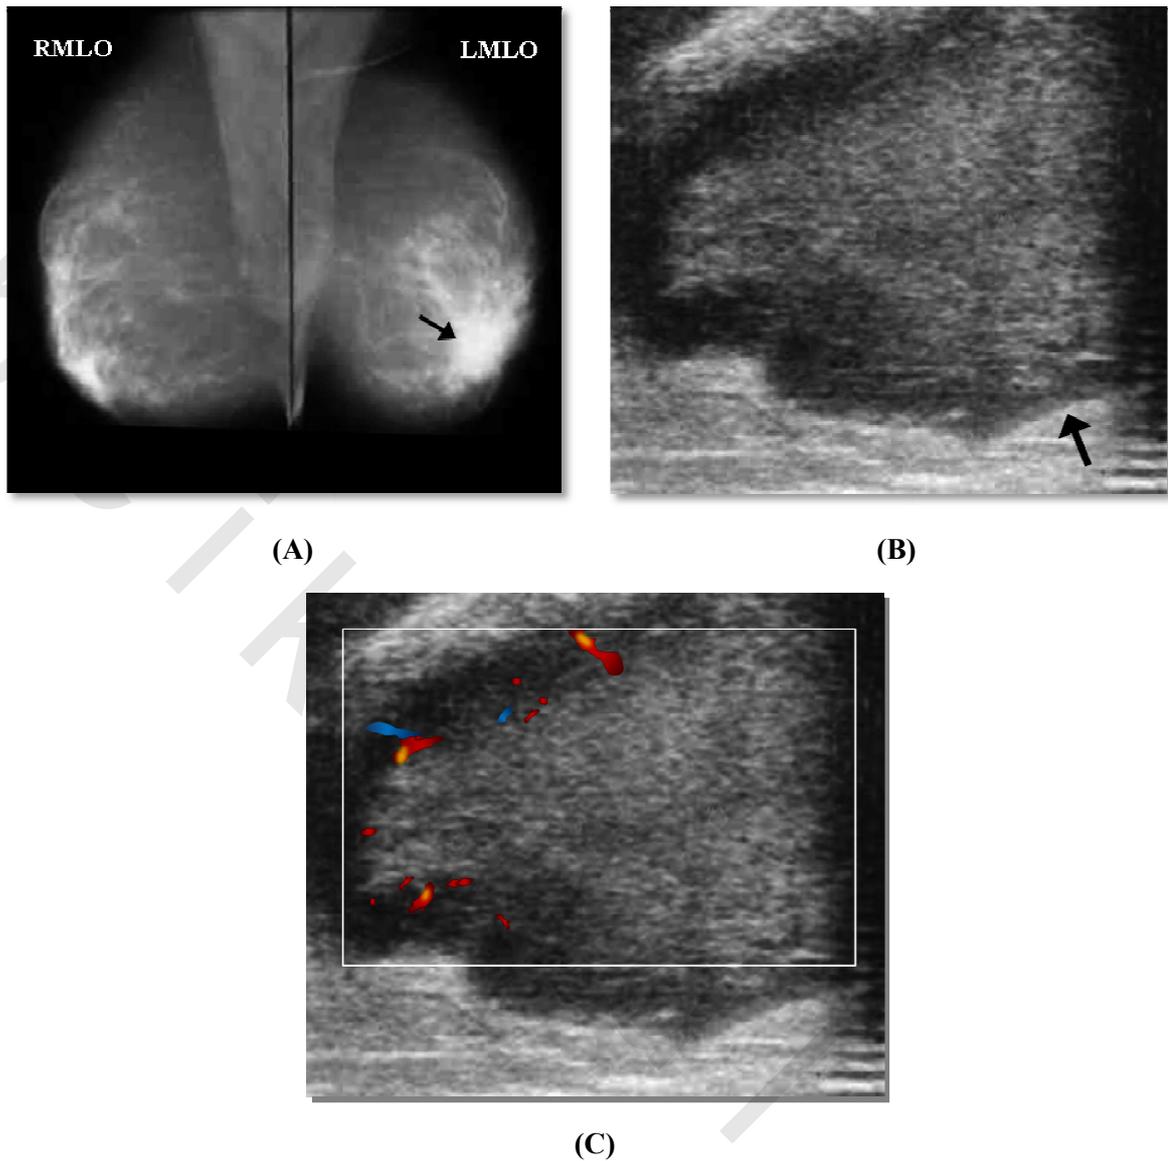
Figure (37): A female patient aged 64 years complaining of left mastalgia.

- A- A bilateral mediolateral oblique mammography showed an oval ill defined retro areolar mass shadow, increased parenchymal density, breast tissue oedema, thick trabeculae and mild skin thickening. So provisional mammographic diagnosis was left breast inflammatory lesion.
- B- Sonography showed an oval, lobulated, hyperechoic homogenous mass with posterior enhancement with.
- C- Increased perilesional colour Doppler signal at the lesion's wall. So ultrasonographic diagnosis was necrotizing inflammatory breast lesion (breast abscess) which was confirmed by histopathology as breast abscess.

Breast abscess (1/30 lesions) was sonographically oval shaped, with macrolobulated margins, homogenous, hyperechoic with posterior enhancement and prominent Doppler vascularity at the periphery or at the wall of this lesion; these findings suspected benignity of the lesion and histopathological diagnosis as breast abscess confirmed this suggestion, so US succeeded in prediction of the benign nature of this lesion.(true negative for malignancy) (fig.37).
