# **AIM OF THE WORK**

The aim of this work will be directed to study the role of Multi-Detector Computed Tomography (MDCT) over Conventional Radiography in evaluation and clearing the diagnosis of osseous injuries of the pelvis.

The present prospective study included 30 patients known or clinically suspected pelvic fracture referred to the radio-diagnosis department at Alexandria University Hospital.

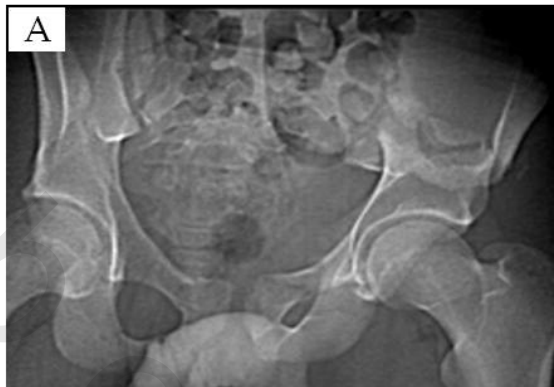
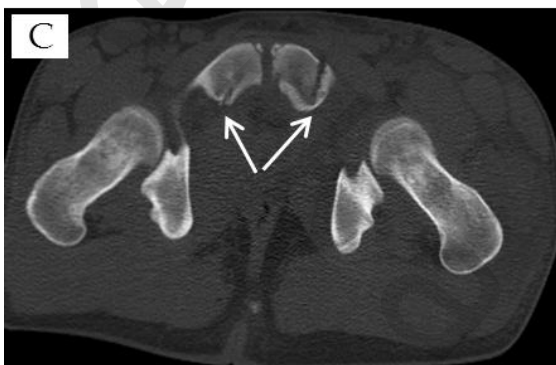
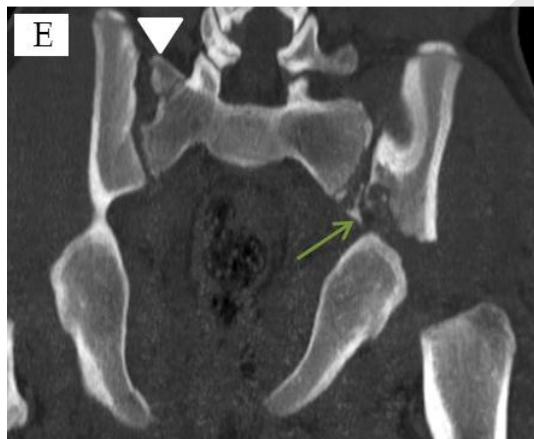
### Case (1)

**Fig. (30):** 16 years old male with history of Falling from height, (A) plain x ray anteriorposterior view, (B, C, D) axial, (E) coronal CT bone windows and (F,G,H) VR images they are showing left iliac wing bone fracture reach the SI joint (long arrows in B,F,G,H) with diastasis anterior of the left SI joint, and sacral fracture (arrow head in B,E,F). Fragment is noted in B and E (Green arrow). There is fracture in both right and left inferior pubic rami (short arrows in C,D,F,G,H).  
**Conclusion:** Lateral compression pelvic fracture (Young classification), Type B2 (Tile classification).

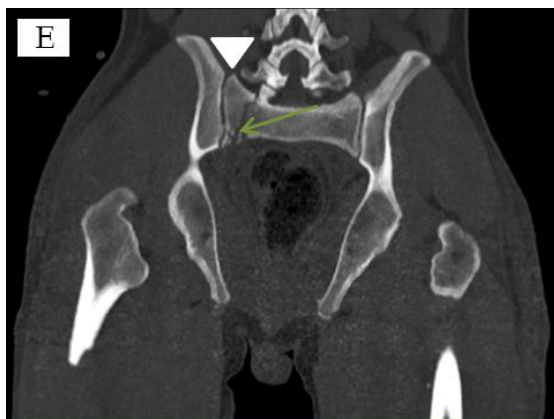
## Case (2)

**Fig. (31):** 23 years old male with history of road traffic accident, (A) plain x ray anteriorposterior view, (B, C, D) axial CT, (E) coronal CT bone windows and (F,G,H, I) VR images they are showing right anterior SI joint diastasis (long arrow in B) with sacral fracture (arrow heads in A,B,E,F,G,H,I) .Both right and left superior and inferior pubic rami are fractured (short arrows in A,C,D,F,G,H,I) , with fragment (Green arrow in B,E,F,G,H). **Conclusion:** lateral compression pelvic fracture (Young classification), Type C1 (Tile classification).

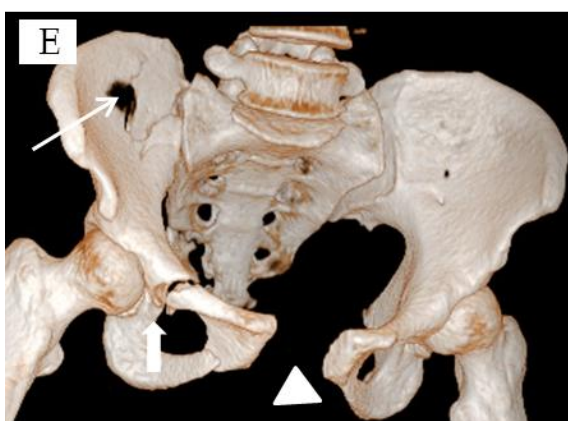
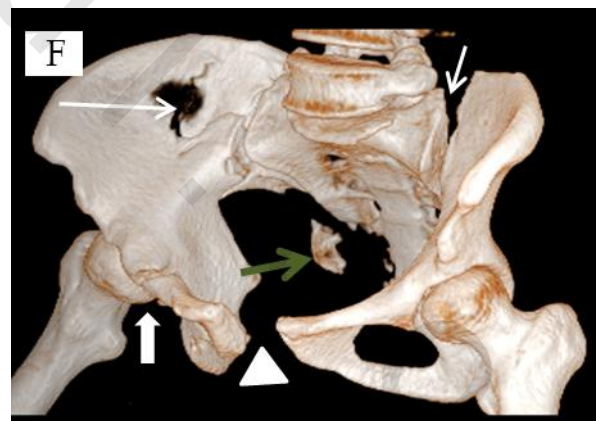
### Case (3)

**Fig. (32):** 35 years old female with history of road traffic accident, axial bone window CT in (A,B,C) and VR in (D,E,F,G) show widening of the symphysis pubis (arrow head in B,C,D) , right iliac wing fracture (long arrow in A,) reach to right SI joint that showed diastasis (small arrow in A,D). There is fracture in both inferior and superior right pubic rami (arrow in C and thick arrow in D,E,F). Fragment is seen in D (Green arrow).

**Conclusion:** anteroposterior compression pelvic fracture (Young classification), Type B3 (Tile classification).

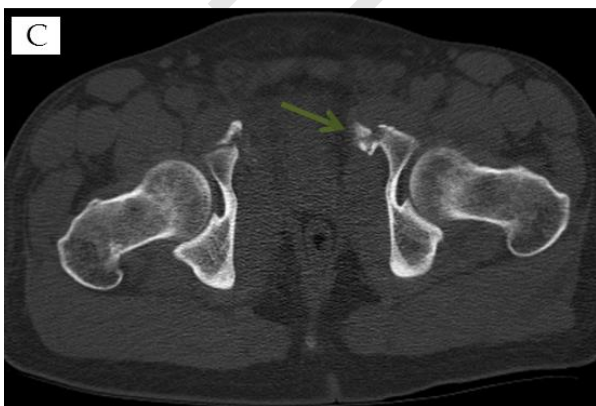
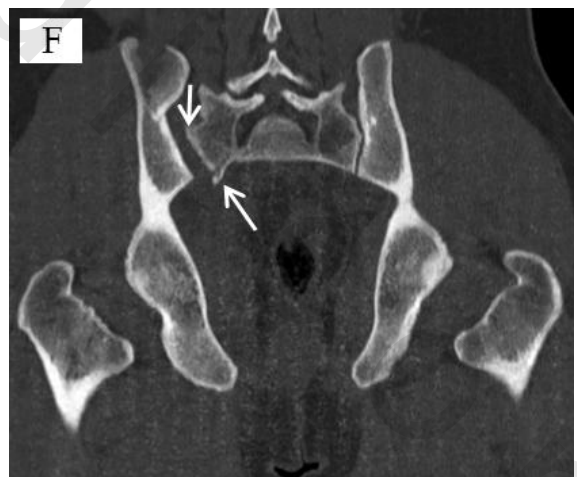
### Case (4)

**Fig. (33):** 23 years old male with history of road traffic accident, (A, B, C, D) axial CT, (E, F) coronal CT bone windows and (G,H) VR images (anterior view in H and posterior oblique view in G) they are showing right iliac bone fracture reaches to the right SI joint (long arrow in A,G,H), the right SI joint diastasis in both anterior and posterior with (short arrows in B). Both right and left superior and inferior pubic rami are fractured (short arrows in D, E,G,H), with fragment (Green arrow in C).

**Conclusion:** lateral compression pelvic fracture (Young classification), Type C1 (Tile classification).
